Commercial Roof-top Units in Minnesota

Characteristics and Energy Performance

**Conservation Applied Research & Development (CARD)
INTERIM REPORT**

Prepared by: Seventhwave and Center for Energy and Environment

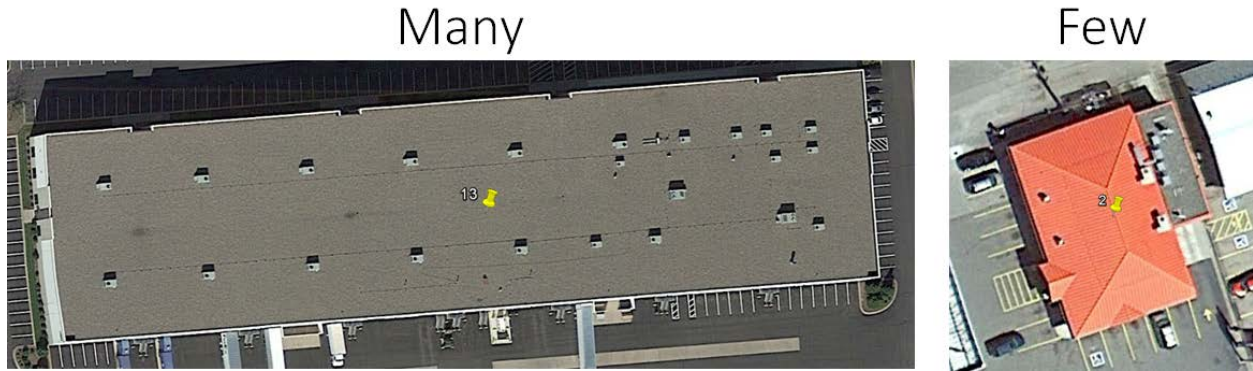
where we identified RTUs, we counted the number of apparent RTUs and gave the building an identification code and associated placemark. Figure 3 illustrates the aerial imagery of two example buildings with RTUs.

Figure 3: Example aerial imagery of buildings with RTUs.

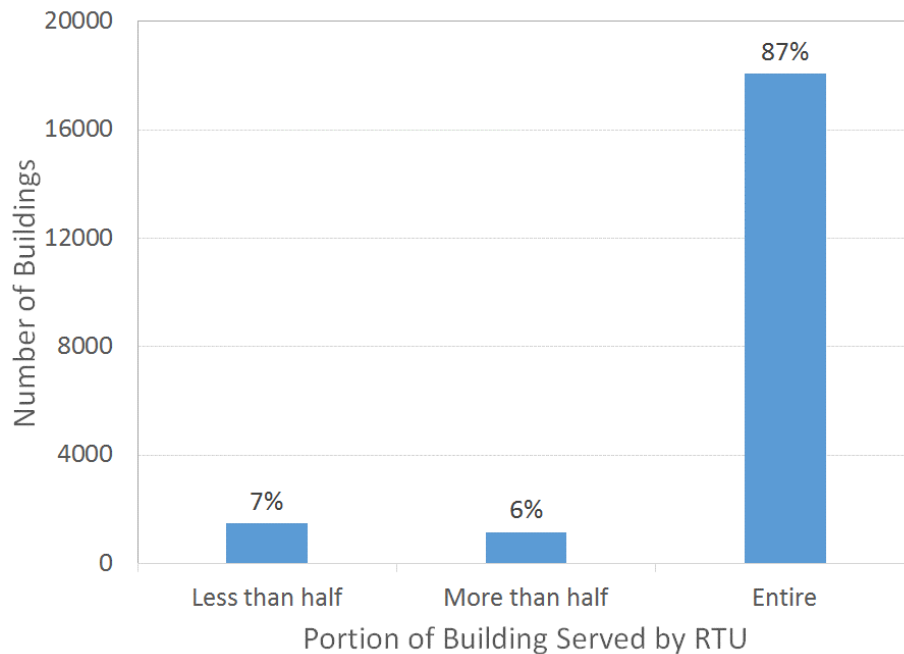
Figure 7: Portions of buildings served by RTUs (n=20,700).

approximately 80% or 730 million square feet are served by RTUs. The remainder of these buildings are served by another HVAC system type, or none at all. Figure 7 shows the distribution of the portion of buildings served by RTUs throughout Minnesota.

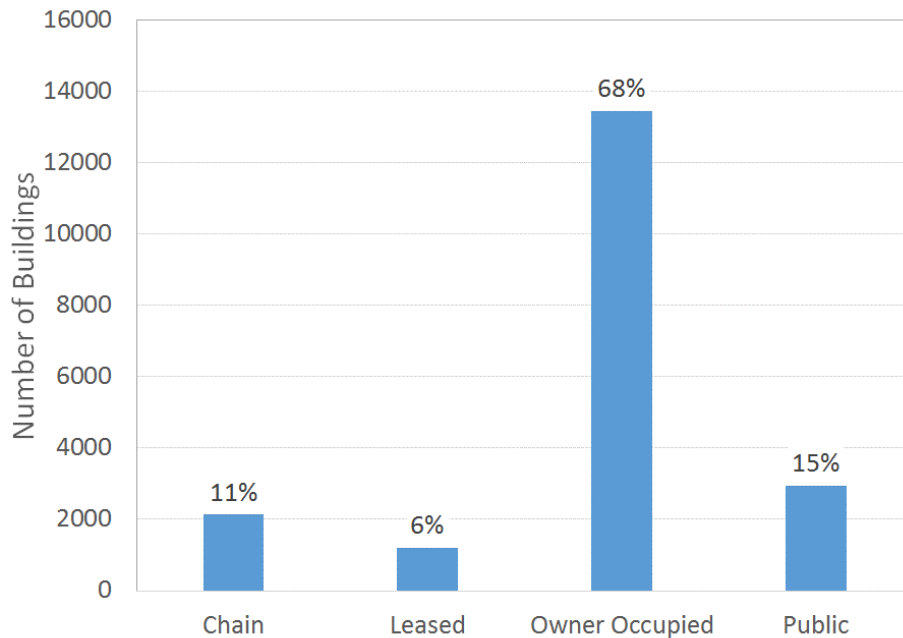
Over four-fifths (83%) of commercial buildings served by RTUs in Minnesota are owner occupied or public. Chain stores are an interesting owner type, in that they may have more sophisticated facility staff. However, they often have approved designs with associated bureaucratic hurdles to overcome in order for CIPs to influence efficiency decisions.

Figure 10: Owner type for buildings served by RTUs (n=19,751).

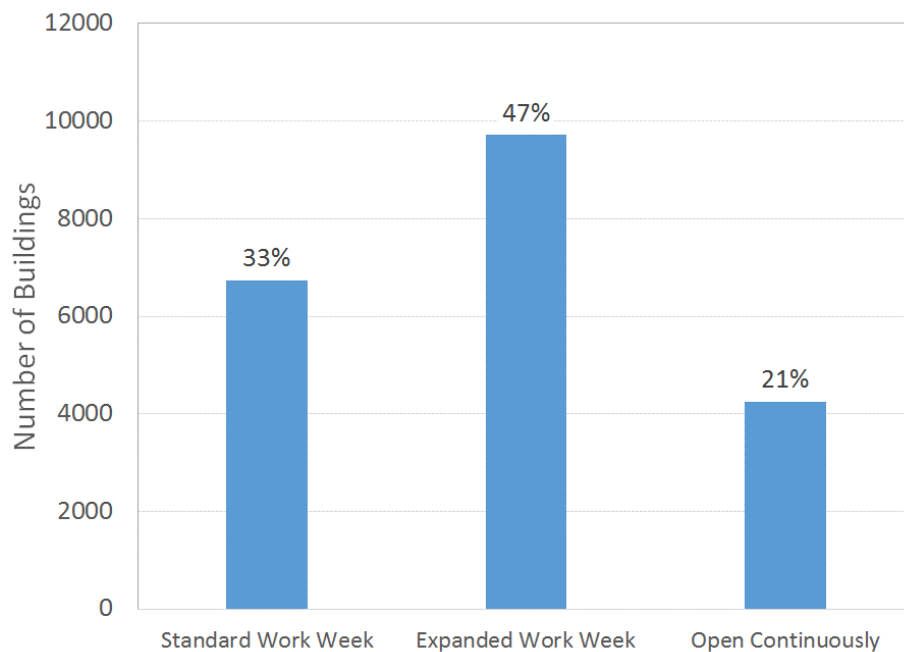
Figure 12: Weekly occupied hours for buildings served by RTUs (n=20,700).

Approximately two-thirds (67%) of buildings with RTUs had occupied hours exceeding what would be considered a standard work week. The buildings with standard occupied hours (40 to 60 per week) were dominated by offices, but the other building types were also well-represented. Buildings with expanded occupied hours (61 to 167 per week) were those that were open on the weekends or had multiple shifts. This category was predominantly education, food service, retail and public assembly. Buildings that were open continuously had a significant proportion of food sales, health care and lodging.

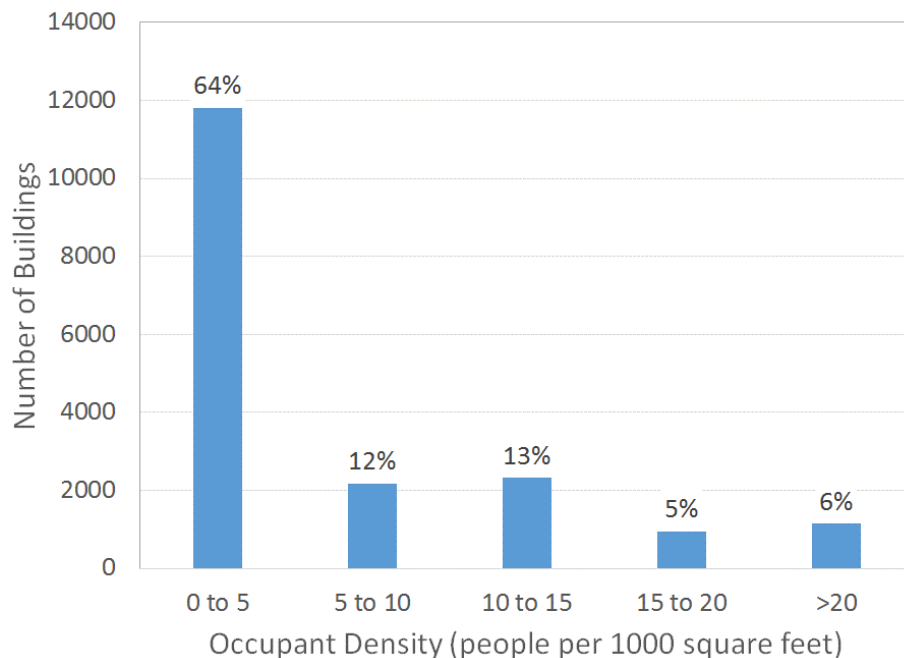
Figure 13: Occupant density for buildings served by RTUs (n=18,386).

Nearly two-thirds (64%) of buildings had relatively low occupant densities of between 0 and 5 people per 1000 square feet. Put another way, the median occupancy density of this range is 2.5 people per 1000 square feet. By inverting this number it becomes 400 square feet per person or the equivalent of each person having an average of 20 feet by 20 feet of space around them. These buildings were mostly office, retail and warehouse. Buildings with occupant densities higher than 20 people per 1000 square feet (approximately 7 feet by 7 feet of space) tended to be food service.

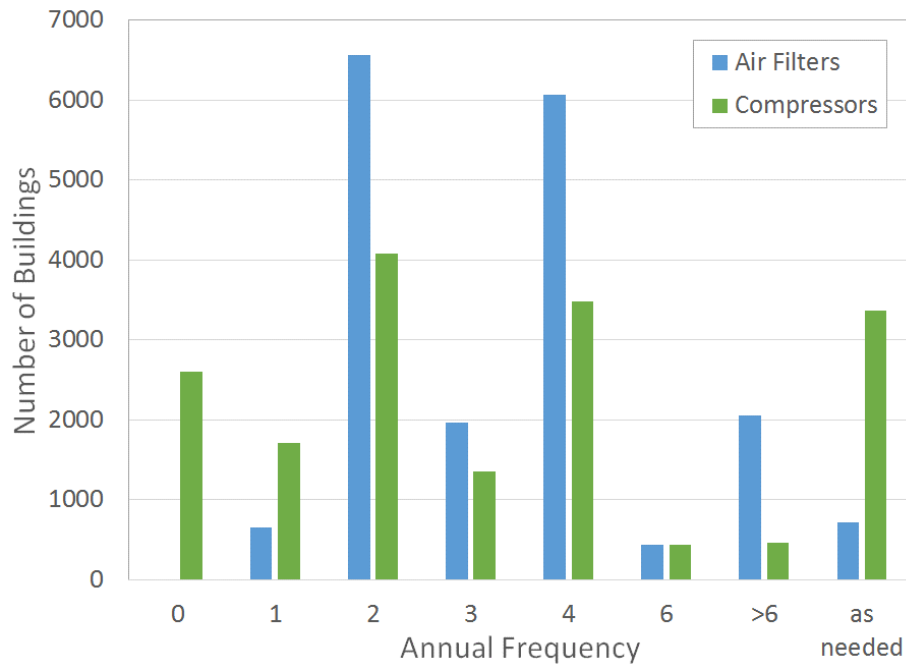
We also asked about the frequency with which filters were changed and compressors were cleaned. Figure 16 shows the annual frequency of maintenance for buildings served by RTUs throughout Minnesota that change air filters and clean compressors.

The best practice for replacing air filters is to track the pressure drop across the filter and replace the filter when the pressure drop exceeds some threshold when it becomes too dirty. A more common recommendation is that air filters be changed on a quarterly basis or four times each year. Nearly half (46%) of buildings had their air filters changed at this level of frequency or above. In some cases higher frequency was driven by site-specific needs such as very dusty adjacent parking lots. Compressors were less likely to be cleaned on a frequent basis with over one-third (34%) never being cleaned or only being cleaned as needed.

Figure 16: Annual frequency of air filter replacement and compressor cleaning (n=18,473).

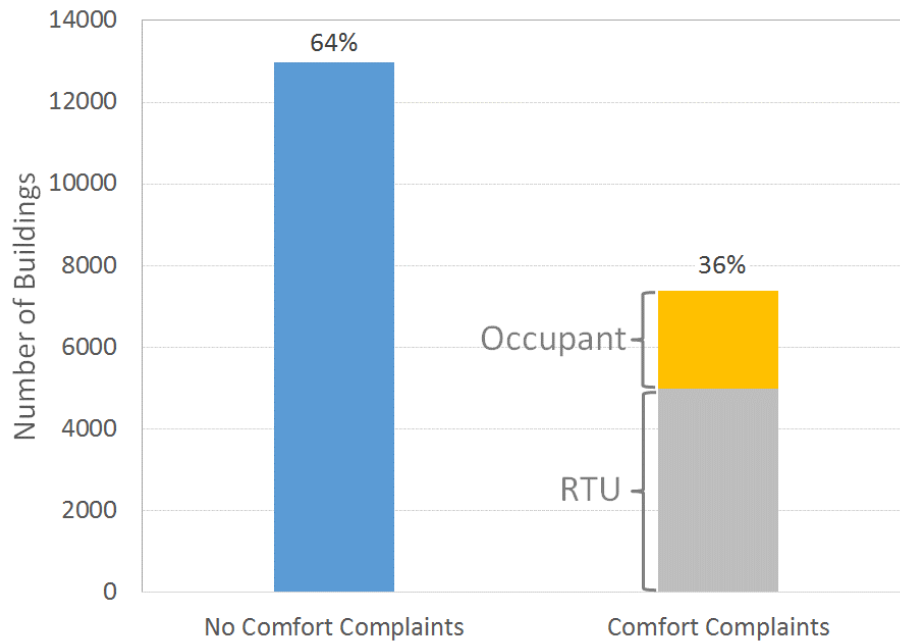
Figure 17: Comfort complaints in buildings served by RTUs (n=20,354).

Over one-third (36%) of buildings served by RTUs in Minnesota experience occupant comfort complaints. The cause of these complaints fell into two categories; the RTUs were not properly maintaining temperature and/or humidity setpoints, or the occupants personal preferences diverged from the setpoints. In the second case, the RTUs were working properly. We are not able to ascertain the cause of a given complaint without further research. However, from the information the interviewee provided, we estimate that two-thirds of complaints were based on RTU performance while one-third were dependent on an occupants personal preferences. Some of the reasons given for why the RTU was unable to maintain setpoints include:

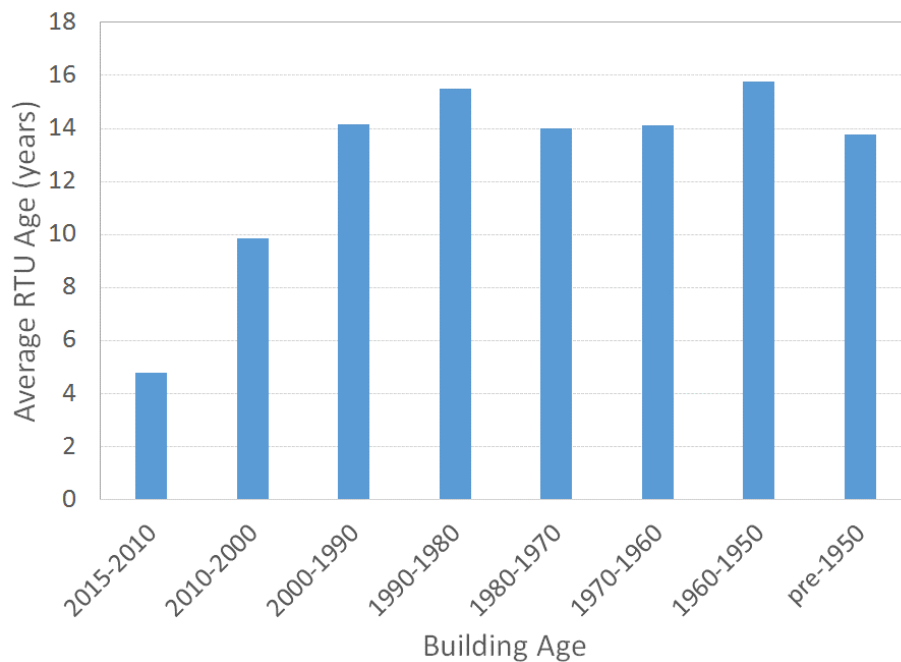
Figure 19: Dependence of RTU age on building age.

Since we collected both RTU age as well as the age of the building they serve, we can look at the relationship between them. Figure 19 shows the average age of RTUs for ranges of building age.

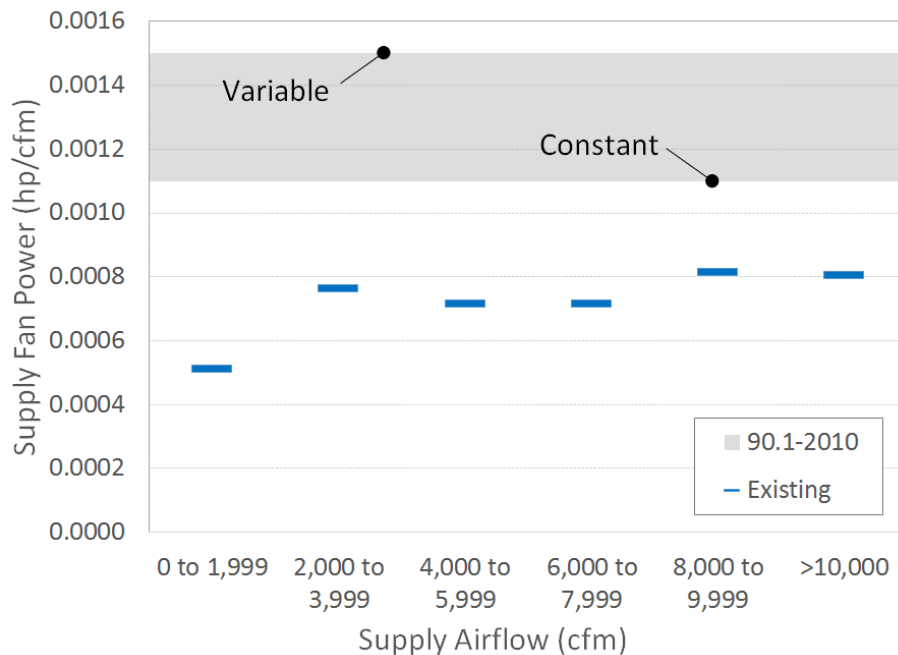
Figure 25: Supply fan power normalized by supply airflow rate.

staff proved too difficult. Figure 25 shows the fan power normalized by supply airflow over a range of different airflows.

Supply airflow is related to RTU fan energy in that the fan should be properly sized to effectively distribute the required air. Oversizing fans can result in increased energy consumption. Gathering accurate information about supply airflow proved particularly difficult. Similar to fan power, our approach looked at manufacturer specifications, only some of which contained any information about supply airflow. The supply airflow reported on manufacturer specifications does not account for the actual distribution system accompanying the RTU on a given project, and is therefore an approximation. A more accurate approach would be to gather the mechanical design drawings themselves on which the supply airflow is often called out on the RTU schedule. However, getting this information from building facility
