R & C INSPECTIONS CO.

PROPERTY INSPECTION REPORT

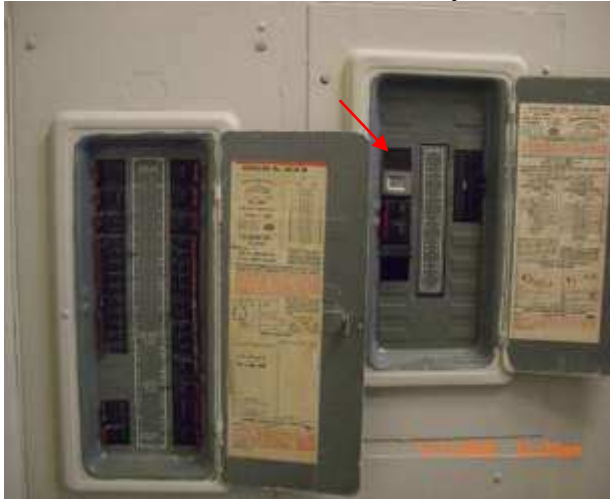
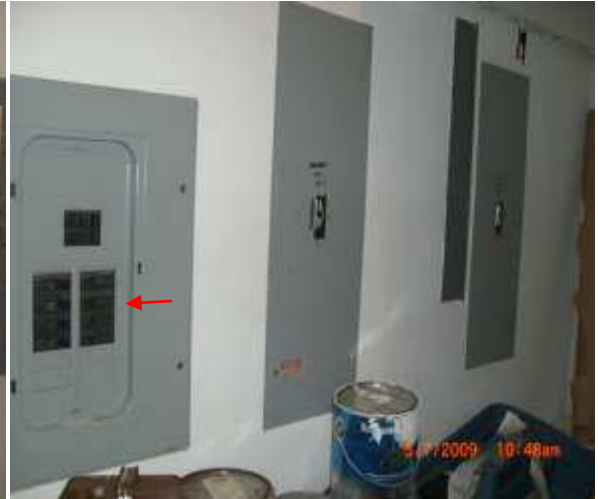
Comments: 200 AMP & 125 AMP PANELS (Federal Pacific Electric & General Electric)

OBSERVATION OF SERVICE ENTRANCE AND PANELS NOTED THE FOLLOWING DEFICIENCY:

1. Missing Knockouts in Panel Box
2. Panel Box not Fully Labeled.

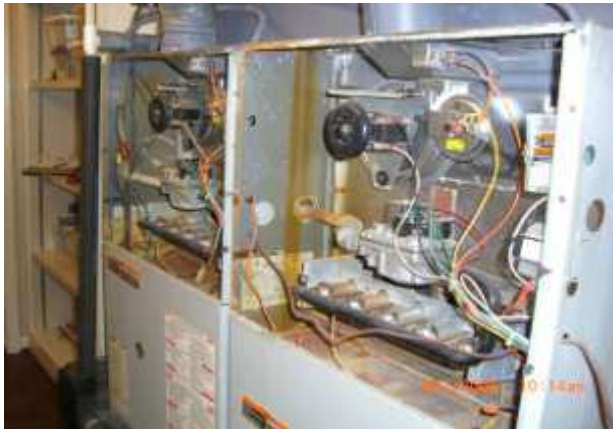
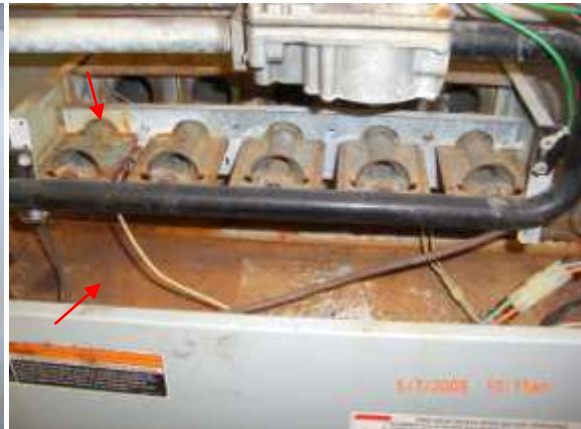
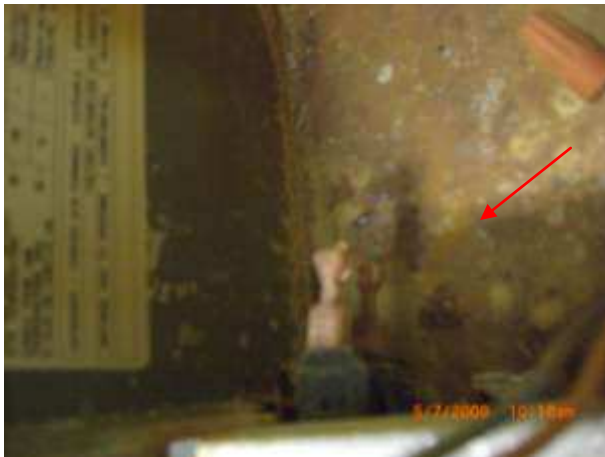
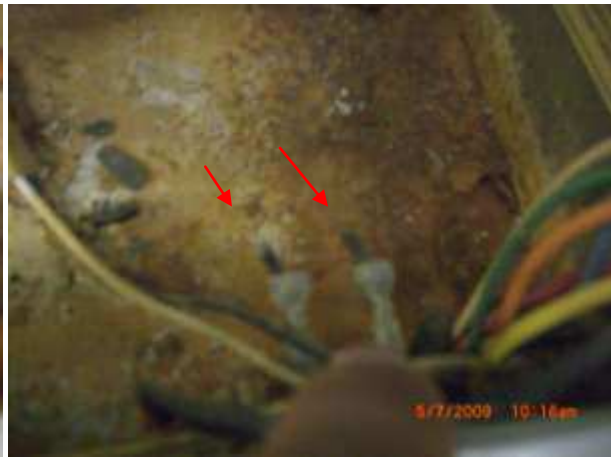
Comments: UNIT 1 & 2) 110,000 BTU (Dual System) MFG. DATE 1999

NOTED THE FOLLOWING DEFICIENCY:

1. Rust & Scale build up in Units (Previous Primary Drain Line Leak) –Needs to be Cleaned & Exchangers Checked.
2. Both Safety Door Switches have been cut.

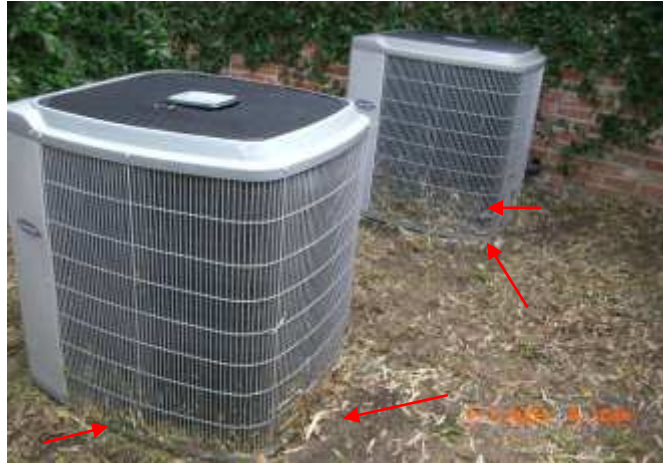
Comments: UNIT 1) 5 TON MFG. DATE 2002

UNIT 2) 5 TON MFG. DATE 2000

NOTED THE FOLLOWING DEFICIENCY:

1. Both Units – No Electrical Disconnects.
2. Both Units – Clean Coils
3. Both Units – Raise Pads or Lower Soil Levels (Ponding)

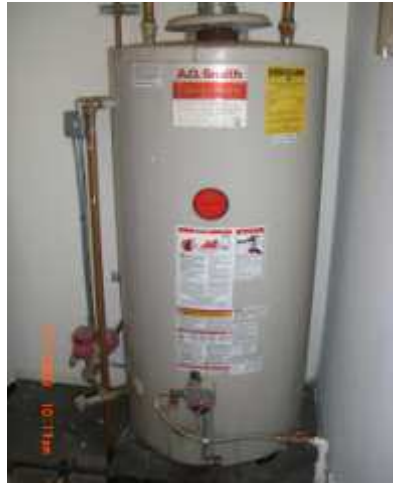
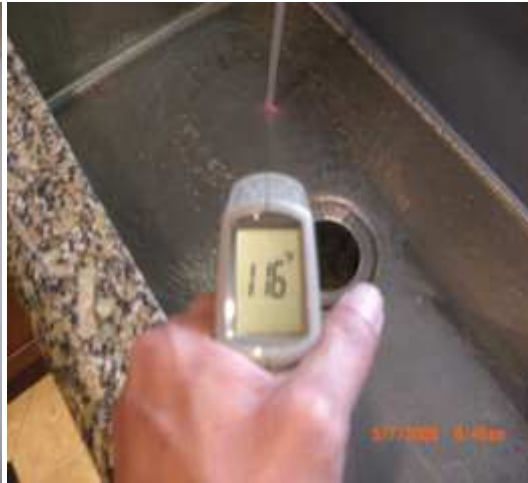
Capacity: 75 GALLON UNIT MFG. DATE 1999

Comments. NO VISIBLE INDICATION OF LEAKS OR PROBLEMS AT THE TIME OF THIS INSPECTION.

REPCIRCULATING PUMP – NO VISIBLE INDICATION OF PROBLEMS.

WATER TEMPERATURE AT THE KITCHEN SINK IS 116 DEGREES.

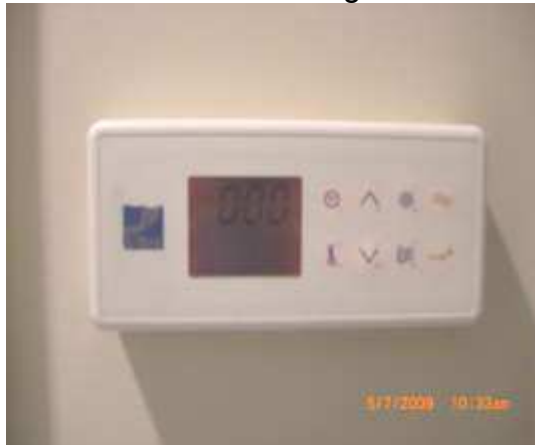
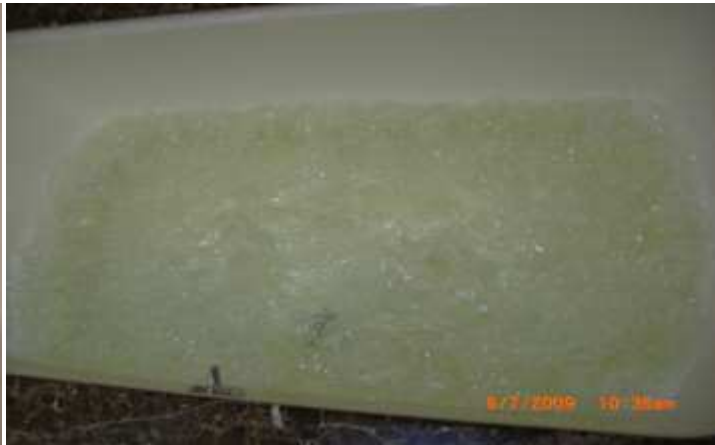
Comments: OPERATION OF UNIT APPEARS TO BE FUNCTIONING. NOTED THE FOLLOWING DEFICIENCY:

1. No Sign of G.F.C.I. Protection.

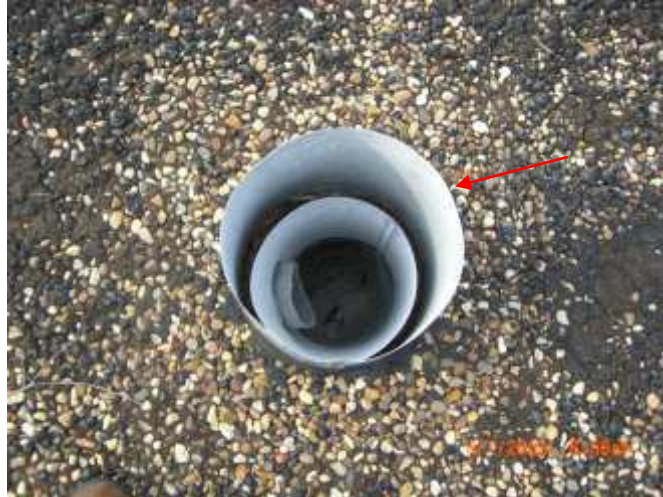
Comments: NOTED THE FOLLOWING DEFICIENCY:

1. Vent Cover missing at Roof.
2. Lint collecting in Pipe – Need to be cleaned.

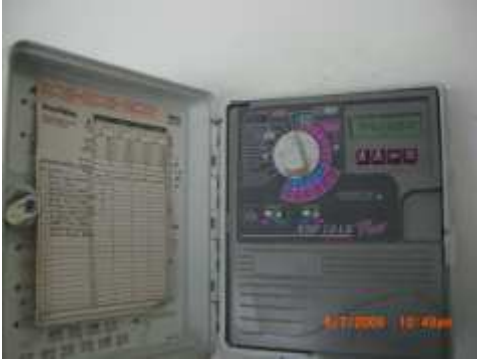
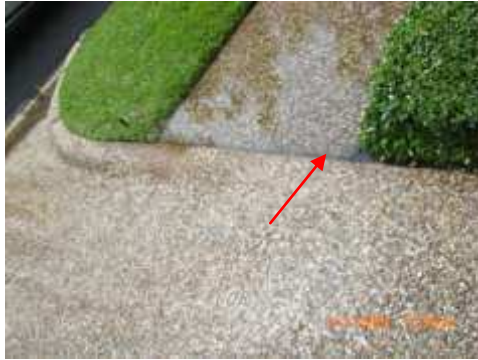
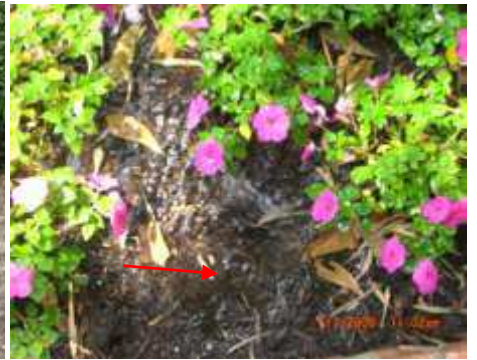
Comments: CHECKED IN MANUAL MODE ONLY. 11 ZONES.

ALL ZONES RESPONDED TO TEST. NOTED THE FOLLOWING DEFICIENCY:

1. NO SIGN OF ANTI-SIPHON VALVE LOCATED.
2. Break in Lines at Zone 3 at Left Front by Sidewalk & 2 & 4 at Left Side House
3. Divert Water away from House.
