## PROPERTY INSPECTION REPORT

Prepared For: Happy Homeowner  
(Name of Client)

Concerning: 1234 Sunshine Street  
(Address of Inspected Property)

1234567  
(TexInspec Report #)

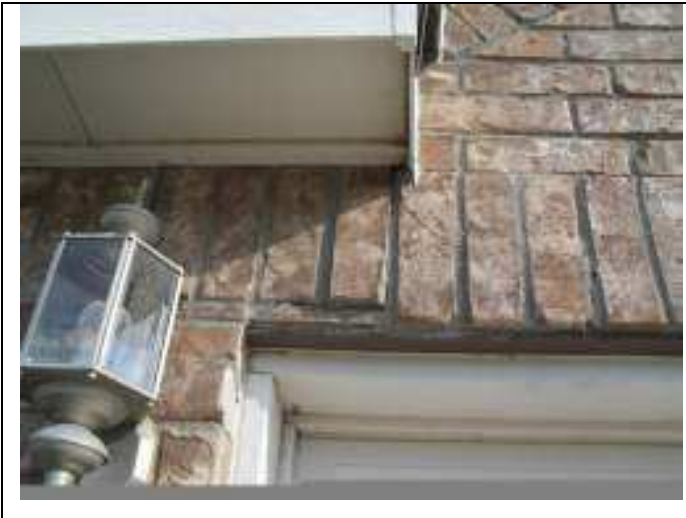
1. The foundation has shifted in one or two areas evident mainly by a couple of exterior brickwork cracks, including a crack above on the overhead garage doors and a few interior sheetrock cracks. The laundry room door does not latch properly. There is poor drainage in some areas around the perimeter of the foundation, mainly along the garage side and the rear of the house. Recommend this be corrected to help minimize future foundation movement. However, I do not believe foundation repairs are warranted at this time. Proper maintenance should be maintained to minimize foundation movement.

Sample of exterior brickwork crack

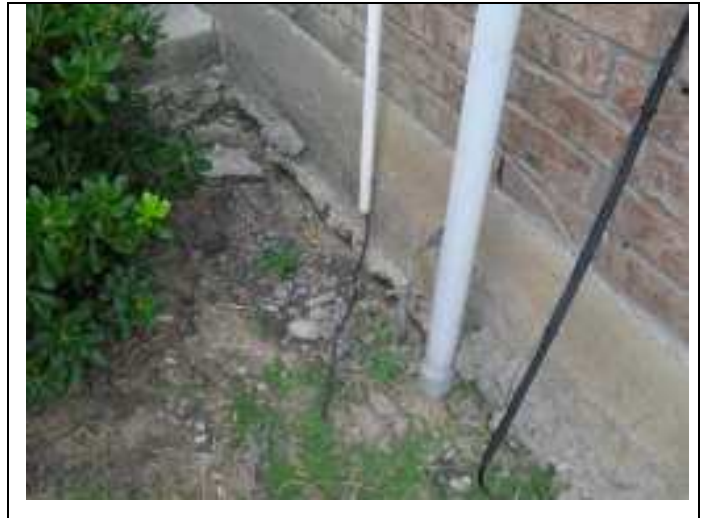
1. The sprinkler control wire on the garage side of the house is exposed and unprotected.
2. Zones three and six of the sprinkler system did not respond when tested.

Exposed sprinkler control wire on garage side

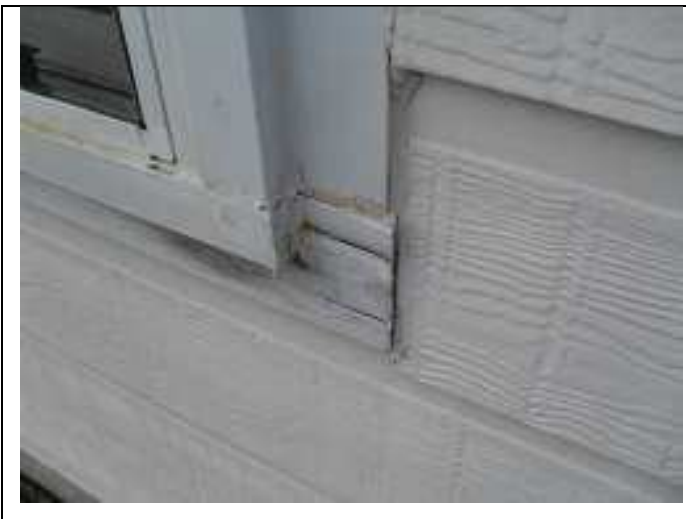
3. Wood rot was noted at the rear exterior trim around one of the living room windows and at the base of the trim on the rear living room side corner of the house. Unable to determine the condition of the underlying materials.

Sample of wood rot of rear exterior trim

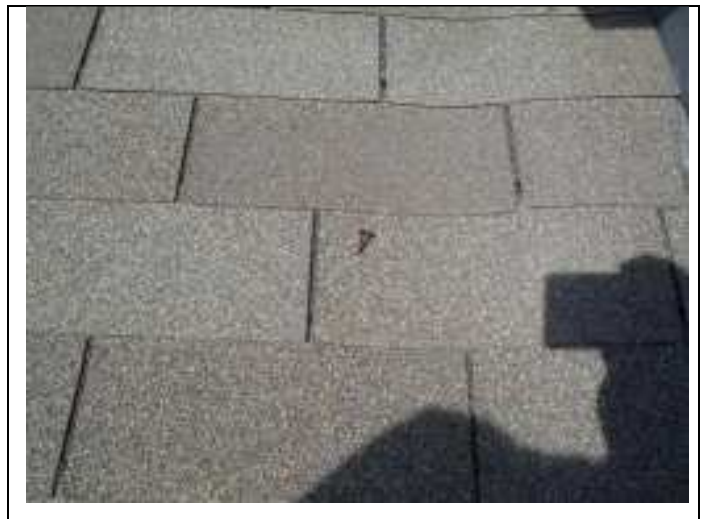
2. There is at least one exposed nail on the roof, by the front entry. Recommend a roofer be consulted for further evaluation/repairs and check for other repairs that may be needed at that time.

Sample of exposed nail in the roof

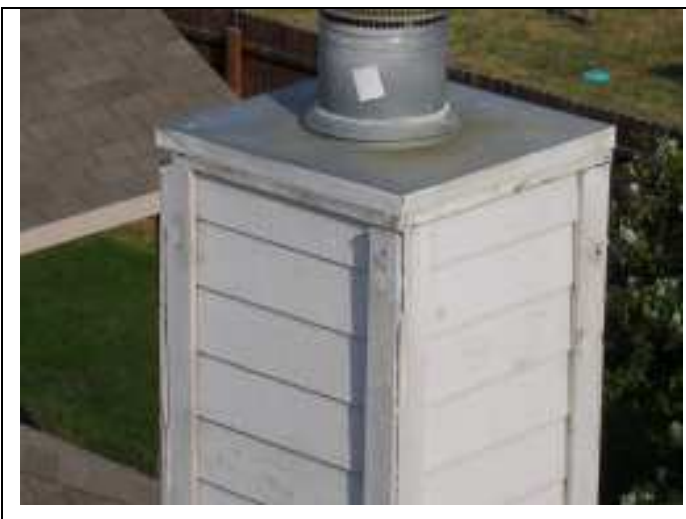
4. The trim on the chimney is damaged. The paint on the trim is peeling and the trim is separating from the chimney. Unable to determine the condition of the underlying materials.

Sample of damaged and separated trim at chimney

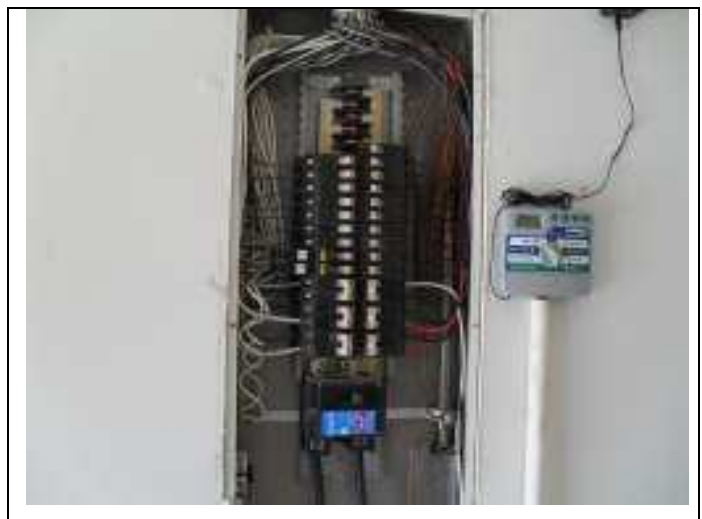
Photo of main electrical panel with cover removed
