# Kaiser Permanente Largo Medical Office Building – Largo, MD

Technical Assignment 1

September 21, 2012

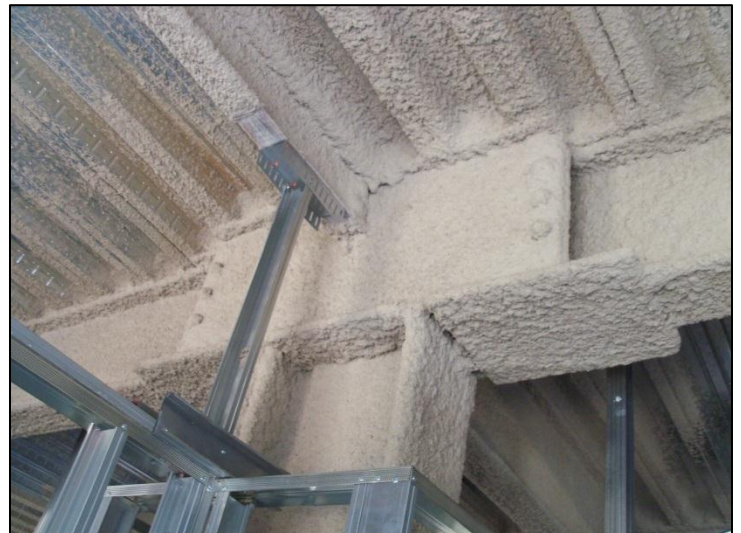
**Figure 2 – Photograph of a Sideplate system. This is a moment frame that connects columns to beams and girders and can be single or double sided, shown above is a double-sided connection. Spray-on fireproofing has already been applied to the structural steel at this point of construction. Personal photograph taken by Chris Pozza.**

A unique aspect of this project is the structural steel connections. A Sideplate Frame System, seen in Figure 2, has been selected. This is much more popular on the west coast, not traditionally being done on the east coast. This system will be discussed in more detail in the Structural Steel section to follow.

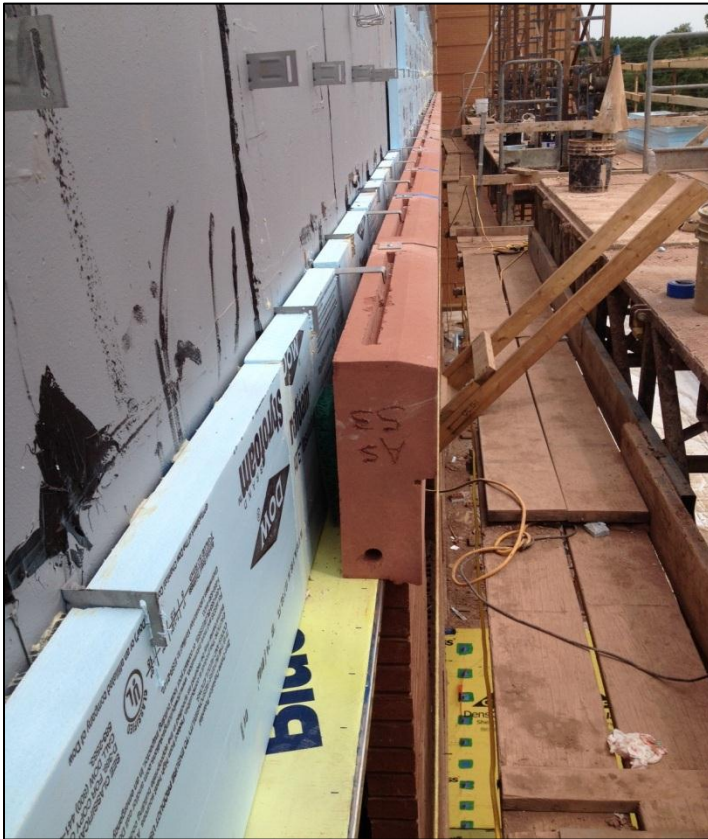
Figure 6 - Precast concrete can be seen above which make up the accent band along with east elevation. Personal photograph taken by Chris Pozza.

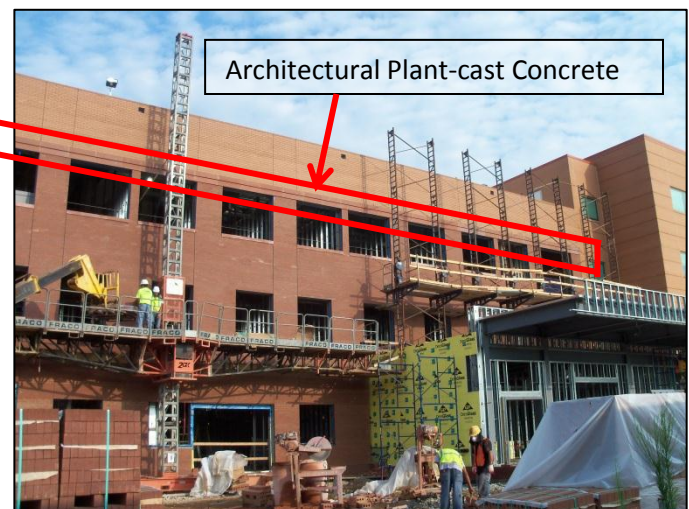
Figure 1, Below - Architectural precast concrete is seen under window sills and spanning the addition on the left above the third story windows. Personal Photograph taken by Chris Pozza.

Although the neighboring parking deck is predominantly brick-clad architectural precast, the addition uses very little precast; however, precast concrete was used as an architectural feature to make a smooth transition from the existing to new structure. This accent band can be seen going in place in Figure 6, along with the vapor barrier, insulation and necessary steel tie-backs. The band itself is called out in red below in Figure 7. It can be seen that a color near that of the brick used blends nicely with the window sills and accent bands. An all-terrain forklift was used to lift precast to Fraco Lifts from which pieces are placed.

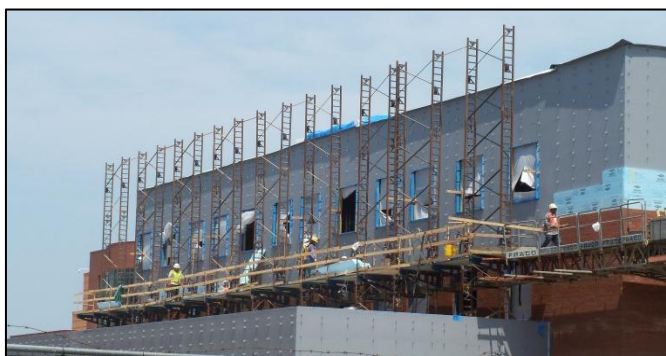
Figure 9 - View looking at southwest elevation. A MasonKing lift is required in areas where work is done above rooftops. These lifts have to be simultaneously cranked by hand to be lowered or raised. Personal photograph taken by Chris Pozza.

Fraco Lifts were set up around the perimeter of areas placing brick. MasonKing lifts were required in areas where veneer work was done above rooftops, which are shown and described below in Figures 9 and 10.

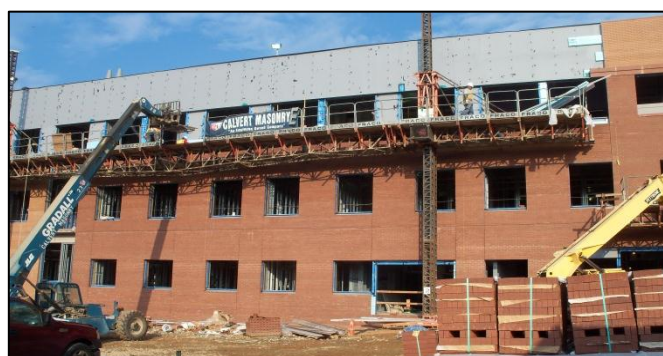
Figure 10 - View looking at east elevation. Fraco Lifts are used around exterior to provide efficient flow of construction along a large percentage of elevation at a time. Materials are lifted into place with a boom lift. Personal photograph taken by Chris Pozza.

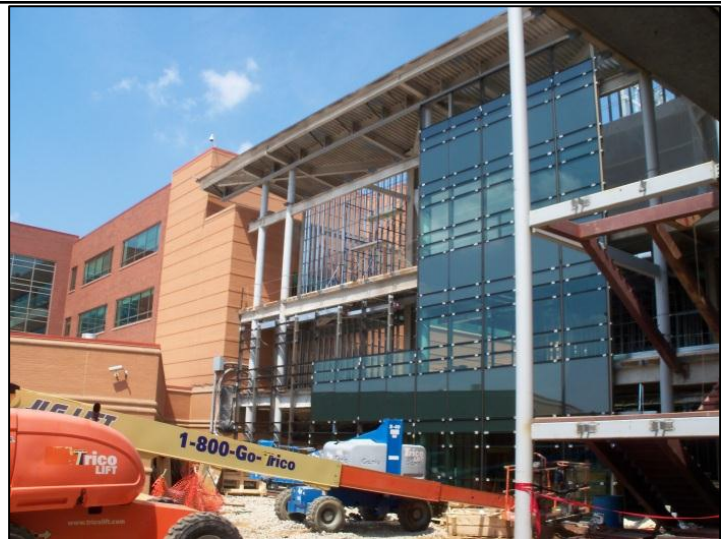
Figure 11 - View of west elevation curtain wall system under construction. The boom lift used during construction of the façade system can be seen at the bottom of the photo. Personal photograph taken by Chris Pozza.

An exterior view of glass curtain wall going in place is shown above in Figure 11. To the left is Figure 12, an interior view looking at the same area on the second floor is seen. Eventually, this area will be a corridor into the existing building (straight ahead) with waiting areas to the right, getting plenty of natural daylight.

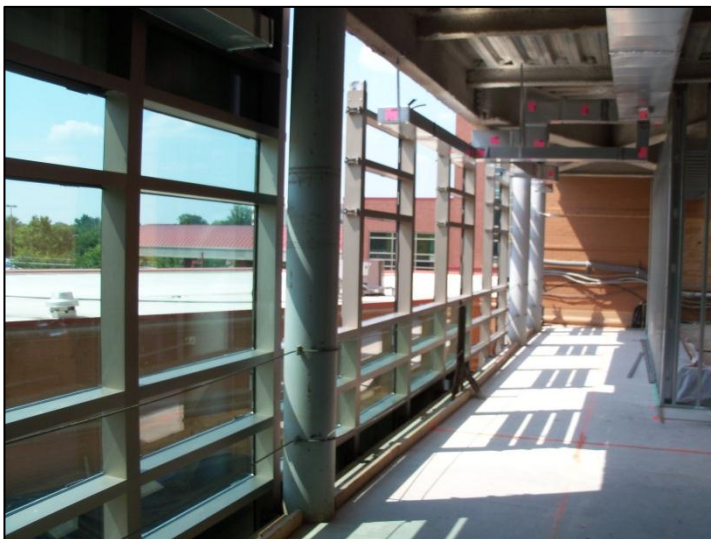
Figure 12, left – Interior view of west elevation curtain wall system under construction. Personal photograph taken by Chris Pozza.
