Incidental Take Permit Application for Least Tern

FDEP File No. 0313002-001-JC
Summer Haven River Restoration

Prepared by
Taylor Engineering, Inc.

July 30, 2013

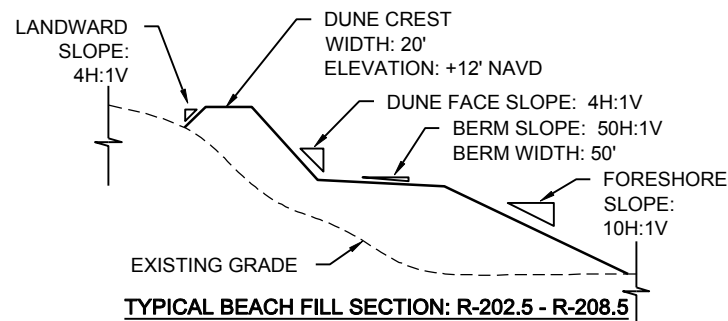
TYPICAL BEACH FILL SECTION: R-202.5 - R-208.5

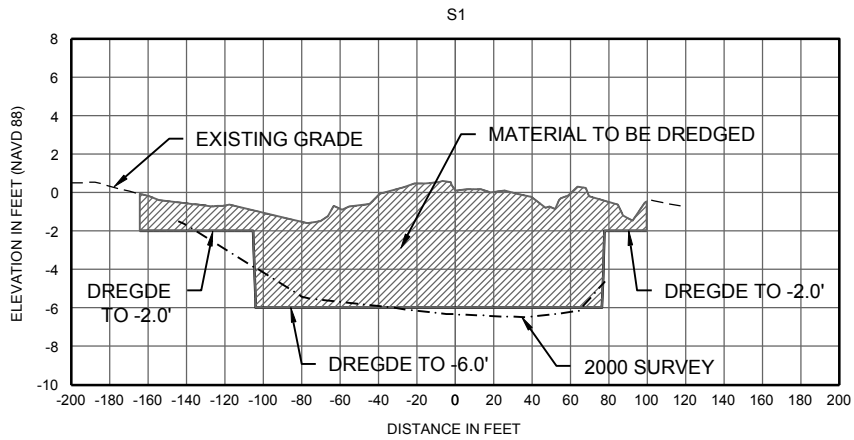
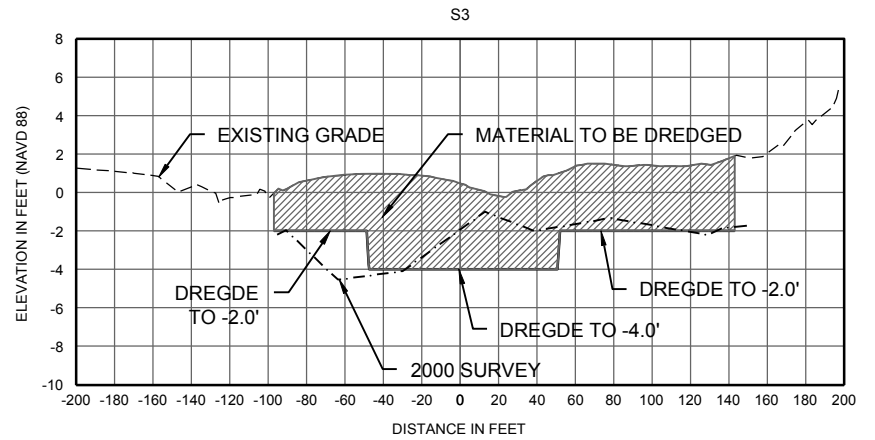
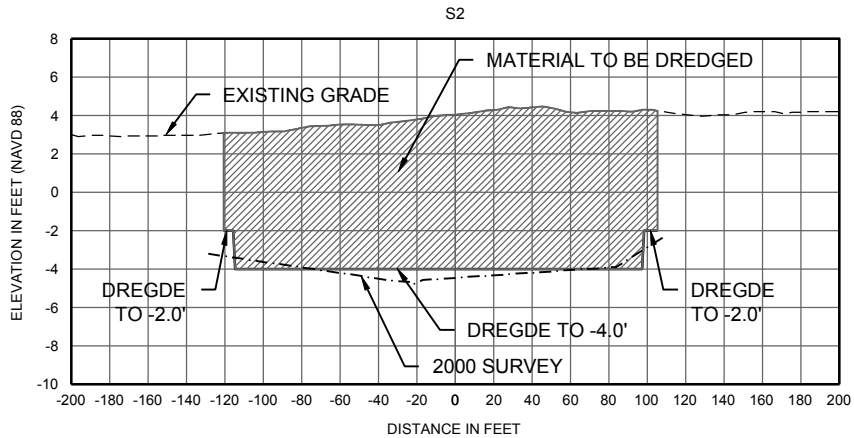
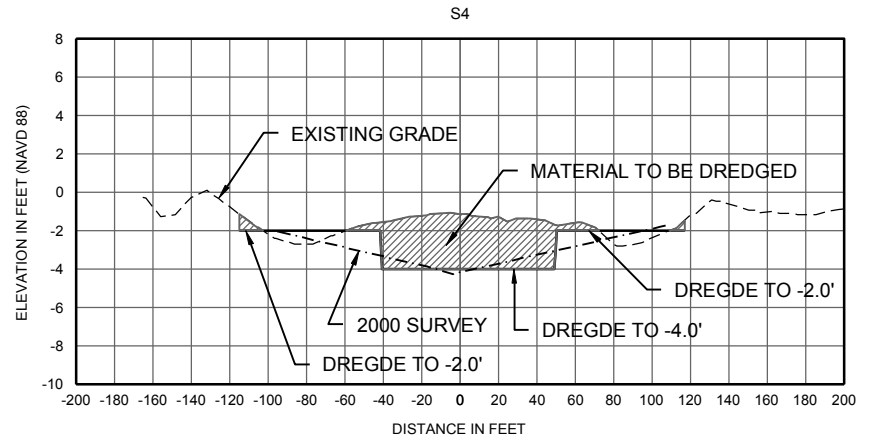
PROPOSED RIVER DREDGE SECTIONS

SCALE: 1" = 100'
V-SCALE: 1" = 10'

Historic and recent bathymetric surveys and field observation provide the data needed to set the river restoration template. The proposed restoration project will remove about 216,000 cubic yards (165,144 cubic meters) of sand from the river to re-establish river depths to a pre-breach condition, restore tidal circulation, and allow the recovery of the natural resources. The restoration will recreate about 32 acres of open water and shallow water estuarine habitat. The sand removed from the river will be placed on the dune and beach system from FDEP range monument R-200 — R-208 in a template similar to that now in final review by the FDEP for JCP File Number 0289228-001-JC.

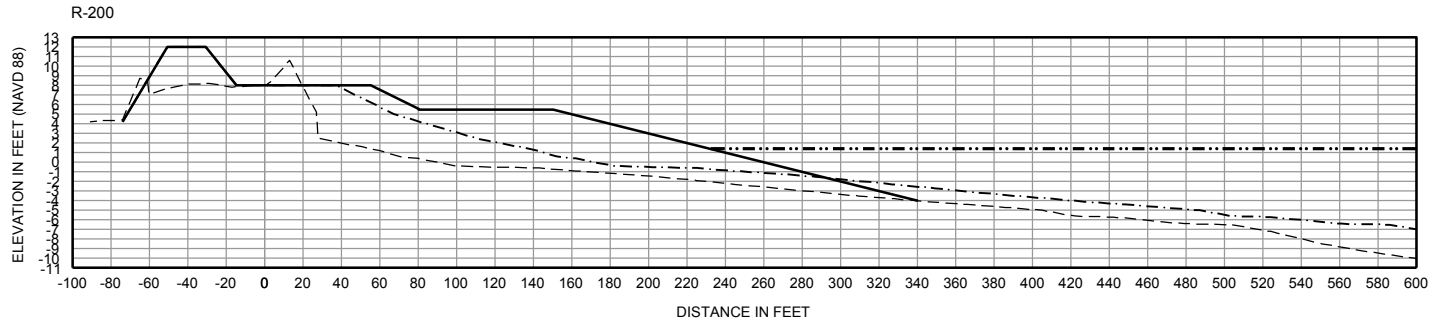
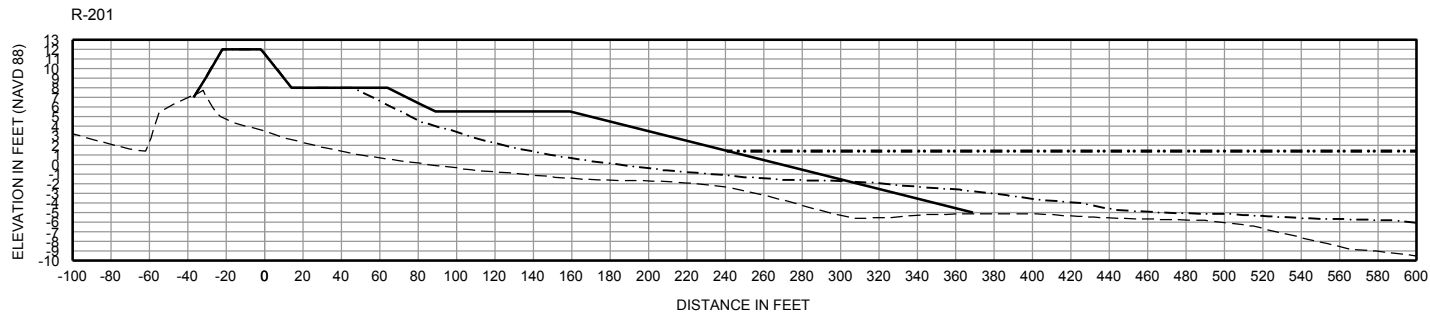
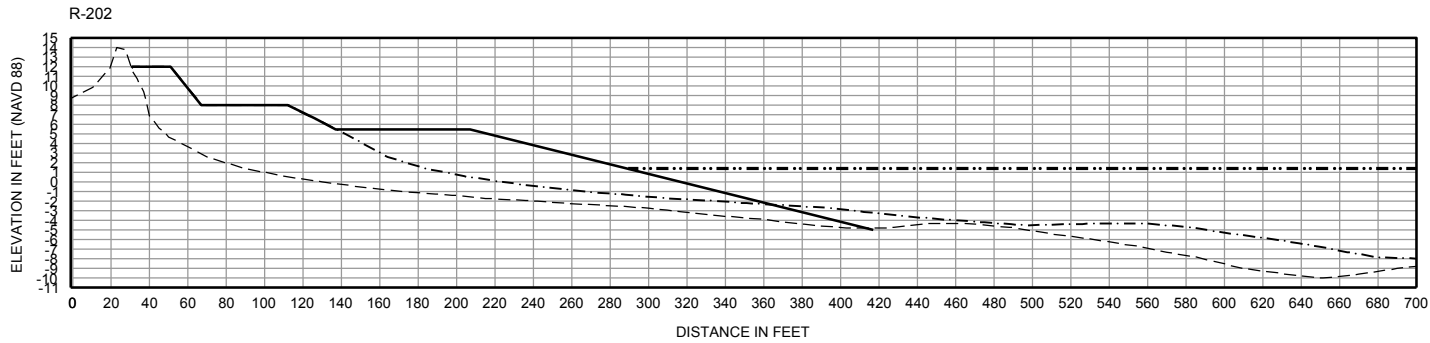
DUNE CONSTRUCTION SECTIONS

SCALE: 1" = 100'
 VERTICAL EXAGGERATION: X5

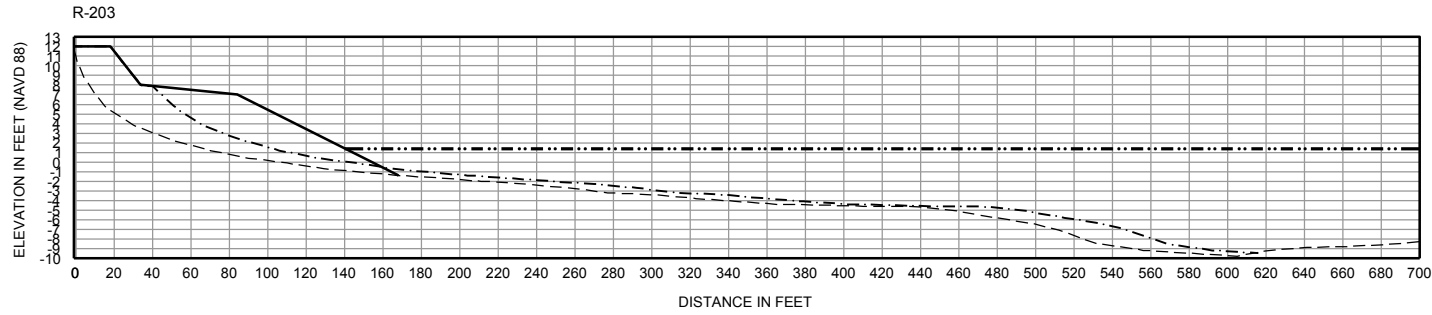
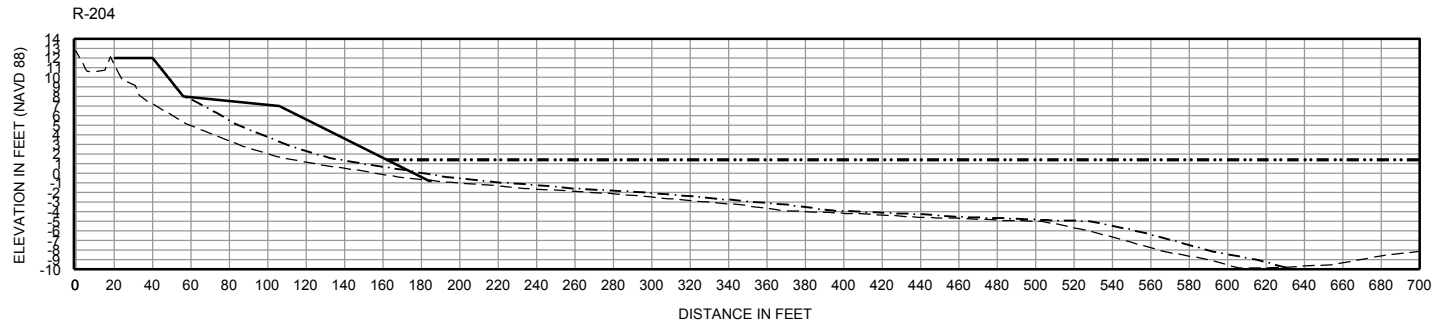
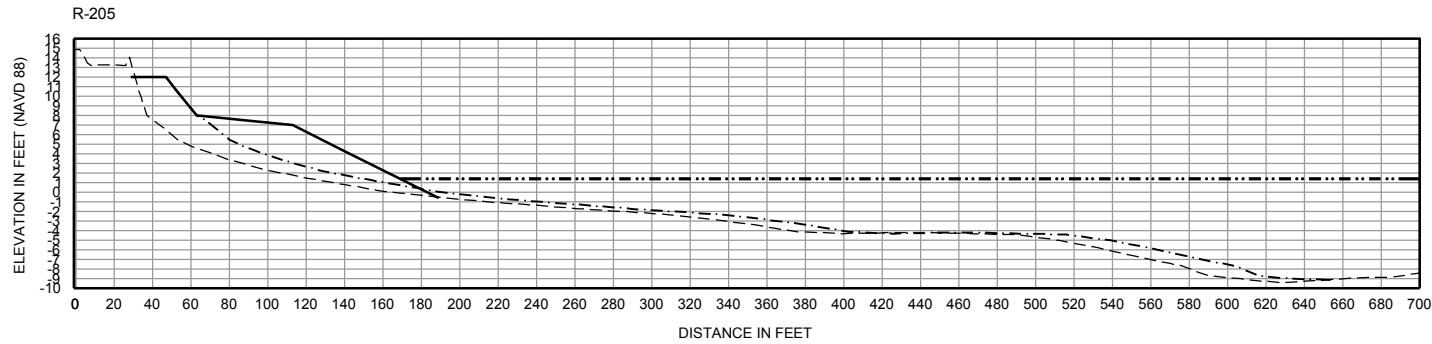
DUNE CONSTRUCTION SECTIONS

SCALE: 1" = 100'

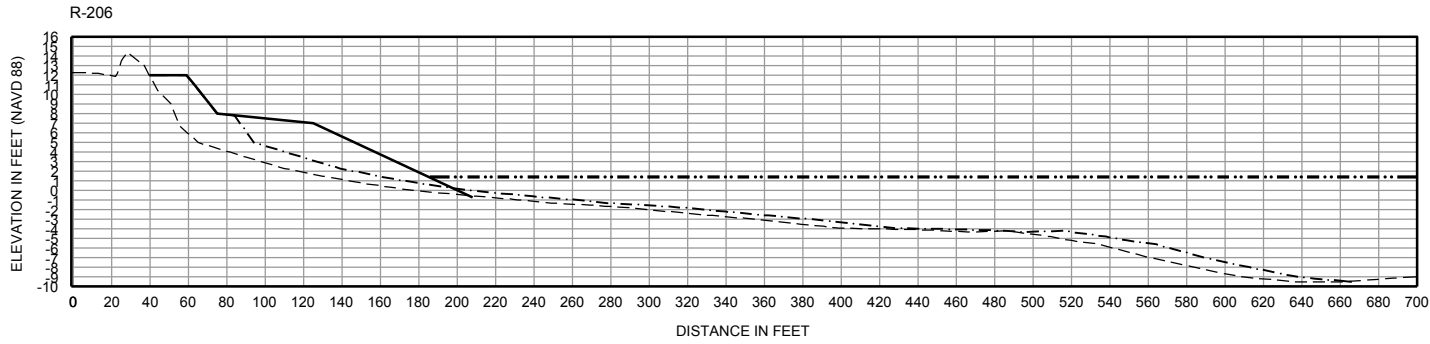
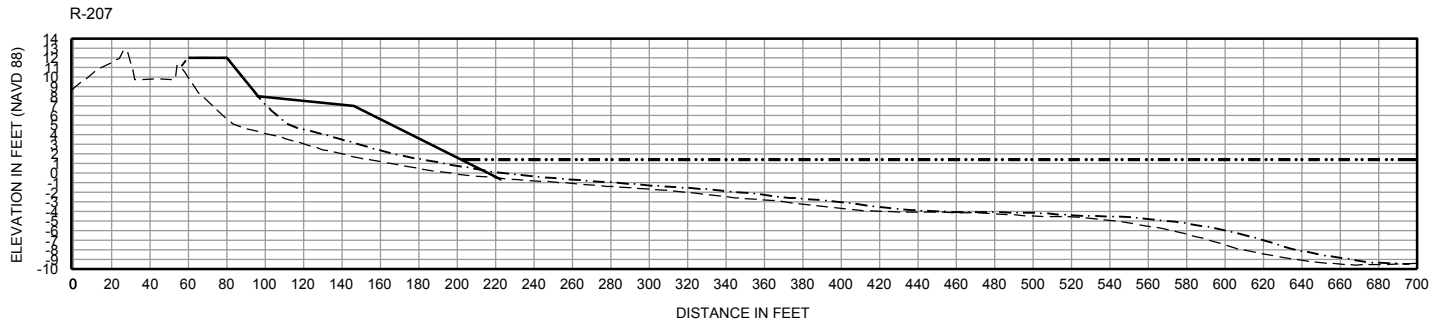
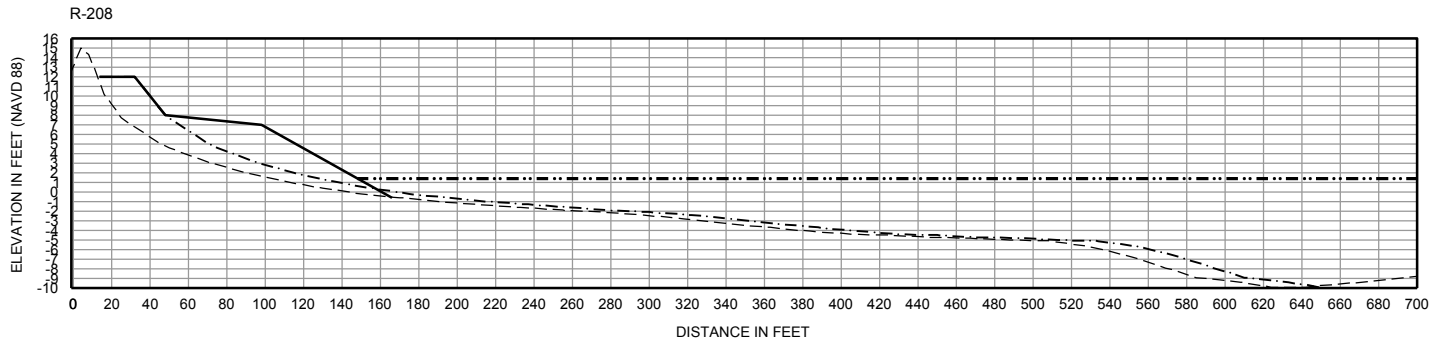
DUNE CONSTRUCTION SECTIONS

SCALE: 1" = 100'

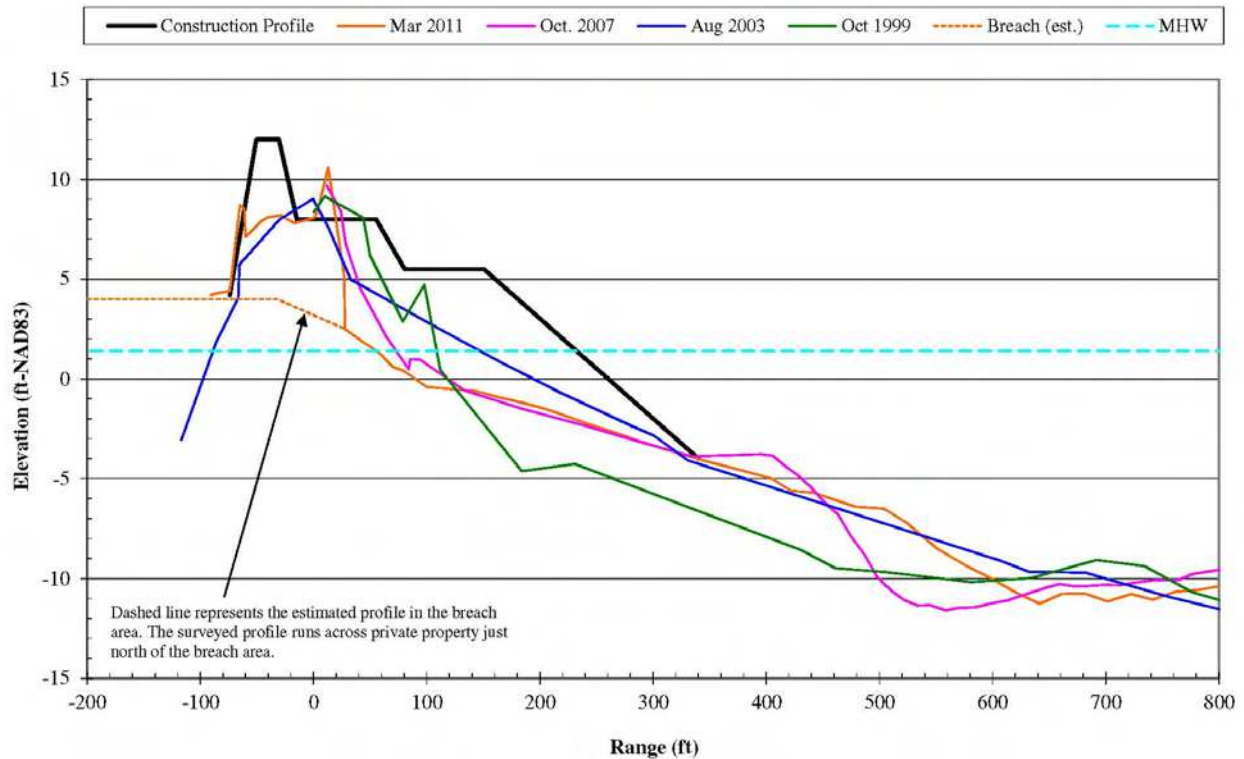
Figure 1 Historic Dune and Beach Conditions at R-200

Distinct differences in the existing dune conditions differentiate the two reaches. The northern reach (R-200 to R-202.5), which includes the beach segment directly affected by the breach, primarily contains a low-lying berm at an elevation of roughly 4 feet (ft) NAVD with no significant dune feature. The southern reach (R-202.5 to R-208.5) contains a narrow beach and continuous dune with significant elevations (12 ft – 15 ft NAVD) but depleted volume, providing little storm protection to the existing roadway and residences. The permit drawings in Attachment D to the permit application contain beach cross sections with the proposed fill template and predicted equilibrium profiles at each reference monument.

In the northern reach, the proposed fill template will generally restore the dune system to historic conditions, except the dune crest is set further back to accommodate the back berm. The dune is critical for providing protection against future storms and minimizing the risk of a future breach, and the back berm protects the dune while providing shorebird habitat. Figures 1 – 3 contain historic beach profiles from 1999 – 2011 and the proposed construction fill templates at R-200, R-201, and R-202. Note the surveyed dune at R-200 represents conditions on the private property just north of the breach area rather than the fill placement area; however, a March 2011 survey of the breach area and Summer Haven River

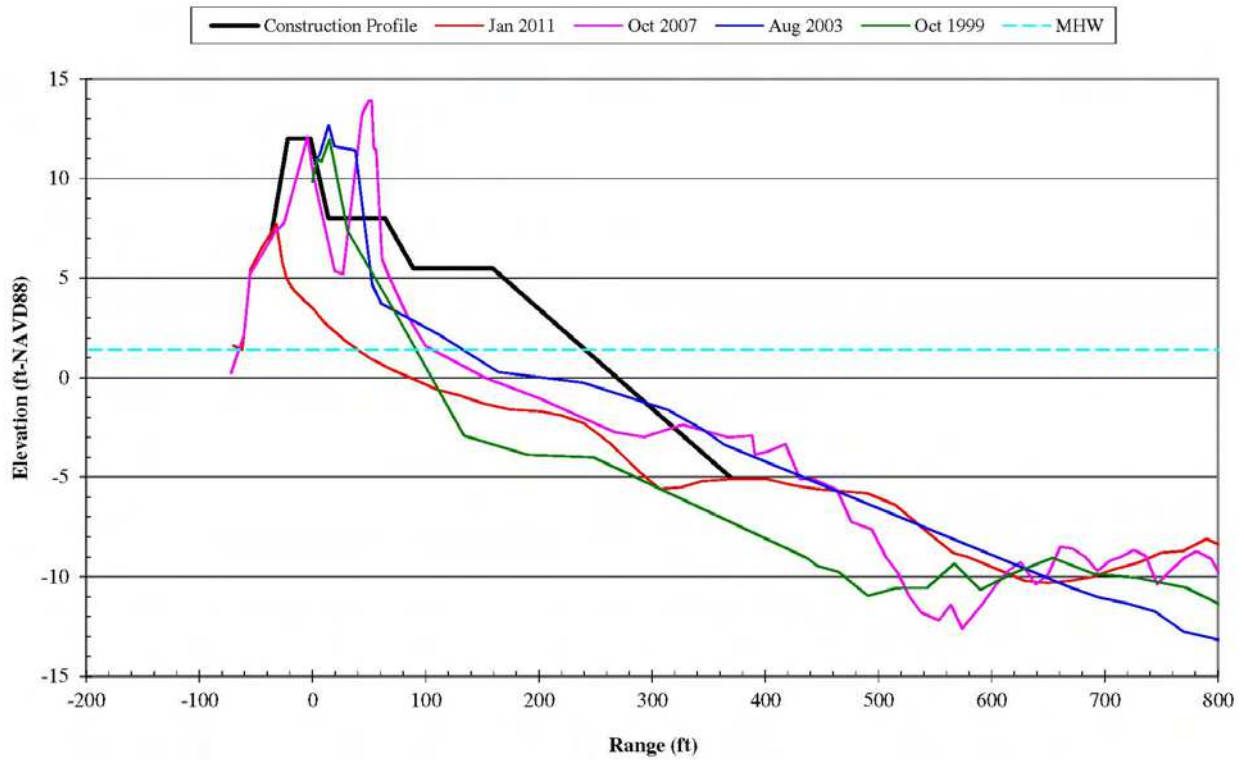
Figure 2 Historic Dune and Beach Conditions at R-201

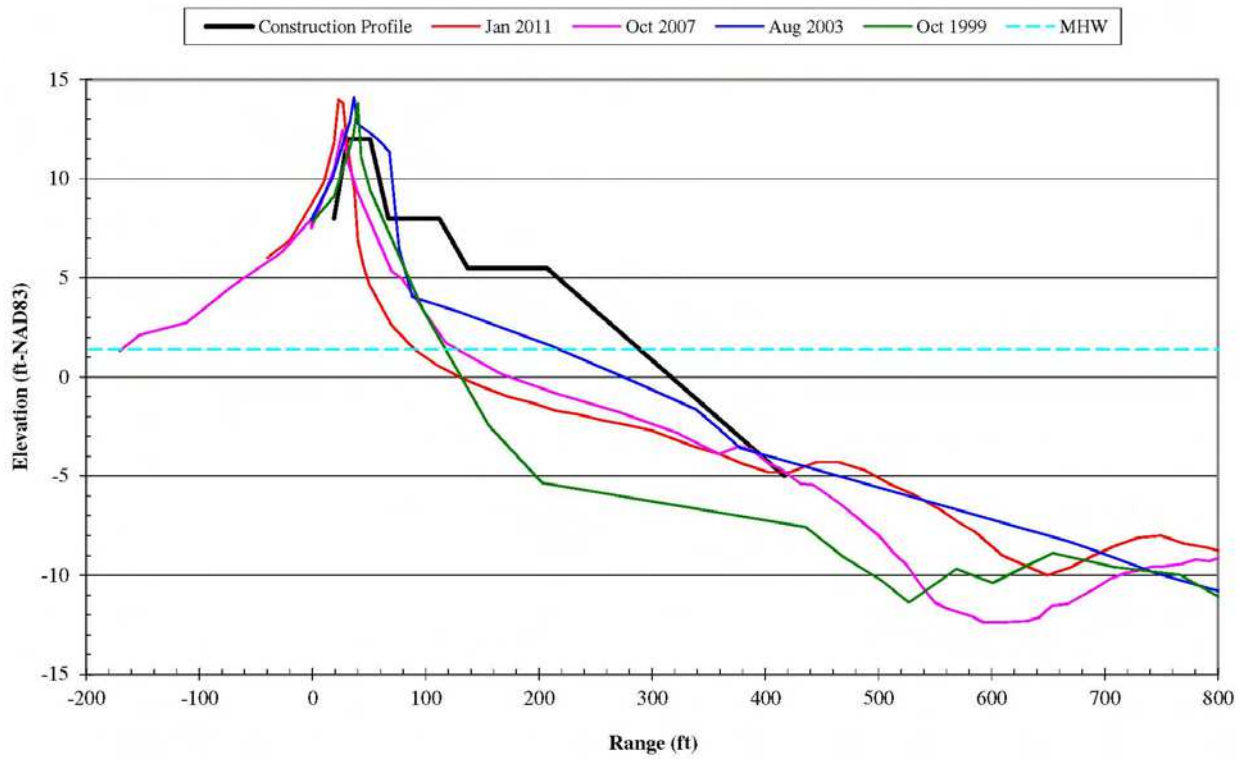
Figure 3 Historic Dune and Beach Conditions at R-202

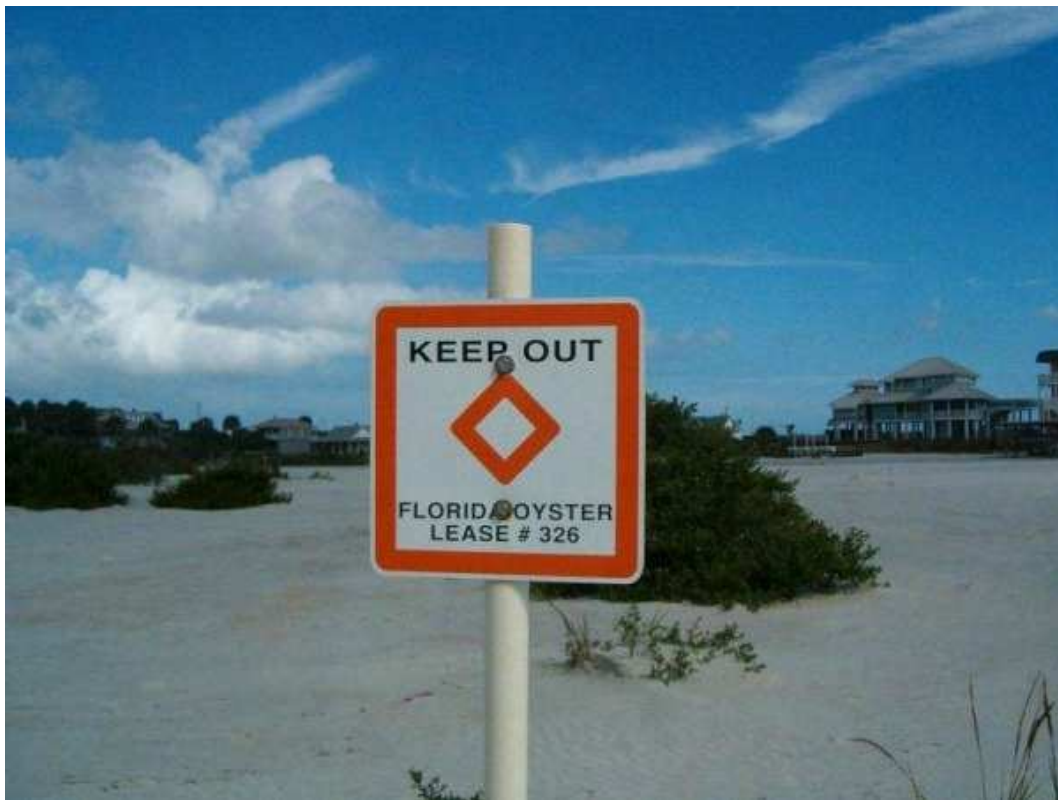
Fig 33-1. Sign for oyster lease area buried by breach and subsequent sand fill plugging Summer Haven River.

Attachments G and H describe the natural wetland communities that existed prior to the filling of the river. SAV does not occur in this area of the state. Oyster reefs occurred in the area, and part of Summer Haven River buried by the breach and resulting overwash include active oyster lease areas (Figure 33-1, Figure 33-2).

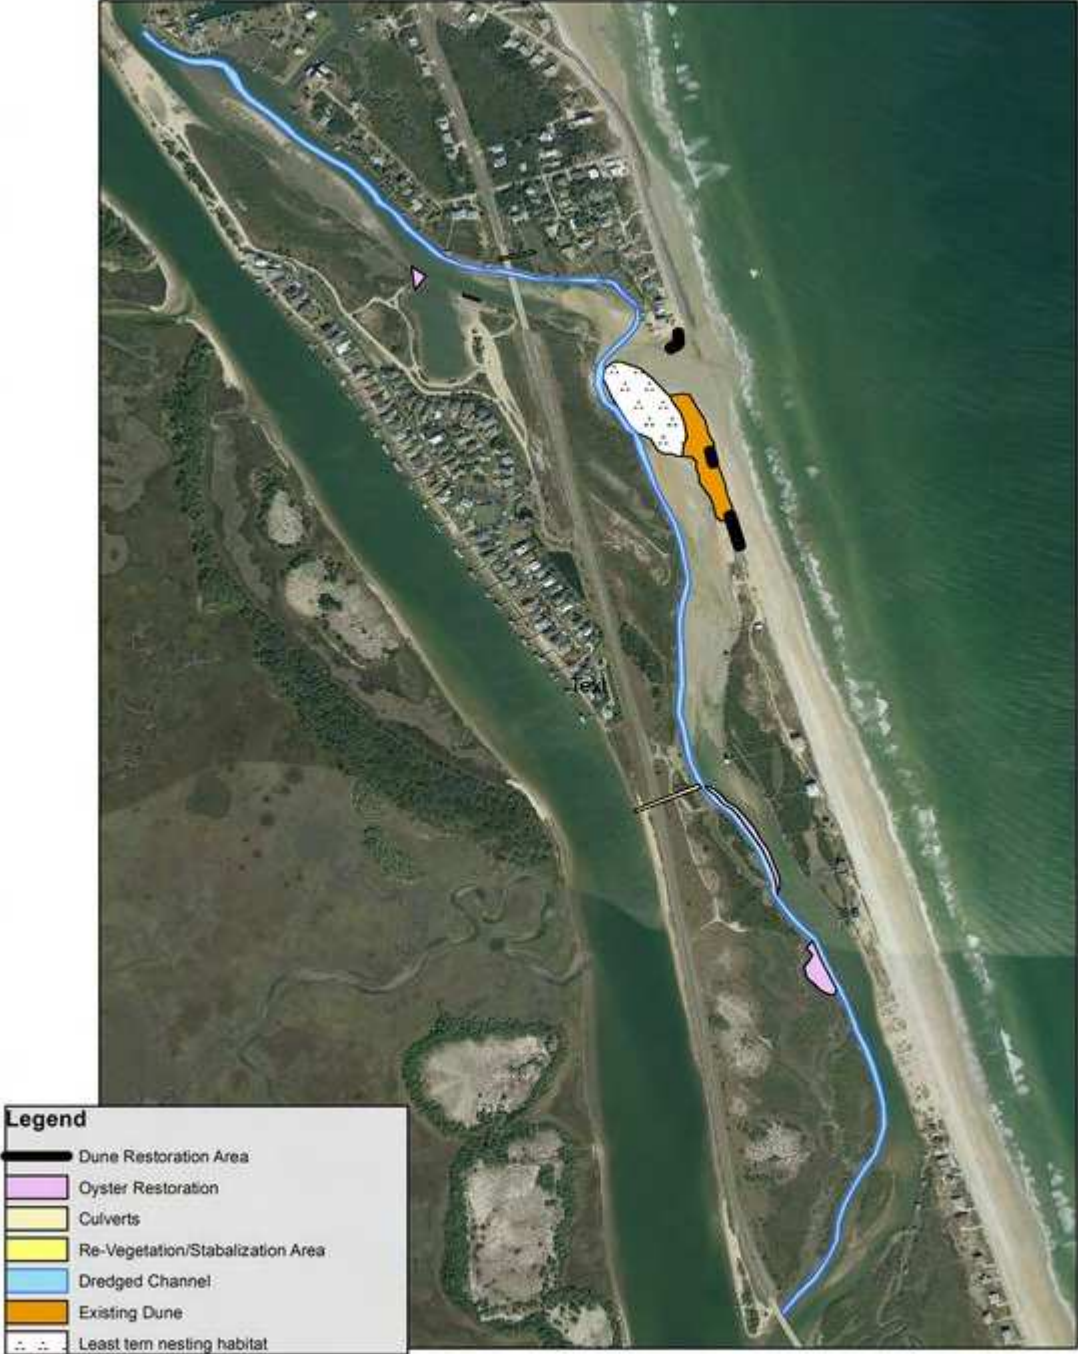
Figure 38- 1. GTMNERR Suggested Restoration Plan

The applicant's preferred plan comprises an ecosystem restoration focused on returning the habitats covered with sand to their former elevations. Other sections of this application package detail the applicant's preferred plan and the means of constructing the plan. FNAI land categories proposed for elevation restoration include beach dune, coastal grassland, coastal strand, salt marsh/mangrove, and unconsolidated substrate. See **Attachment I** (Natural Communities) for descriptions of each habitat type. Dune plantings will provide the basis for a stable beach dune. Based on observations of ongoing succession in areas with very little sand cover, the applicant expects that the salt marshes, coastal strand and coast grasslands will revegetate naturally. Unlike the other habitats, the dune will not have a seed pool in the soil as the basis for plant community redevelopment. To ensure redevelopment of a sustainable dune plant community, dune planting will include sea oats (90%) and 10% other species will provide the basis for restoration of the dune.

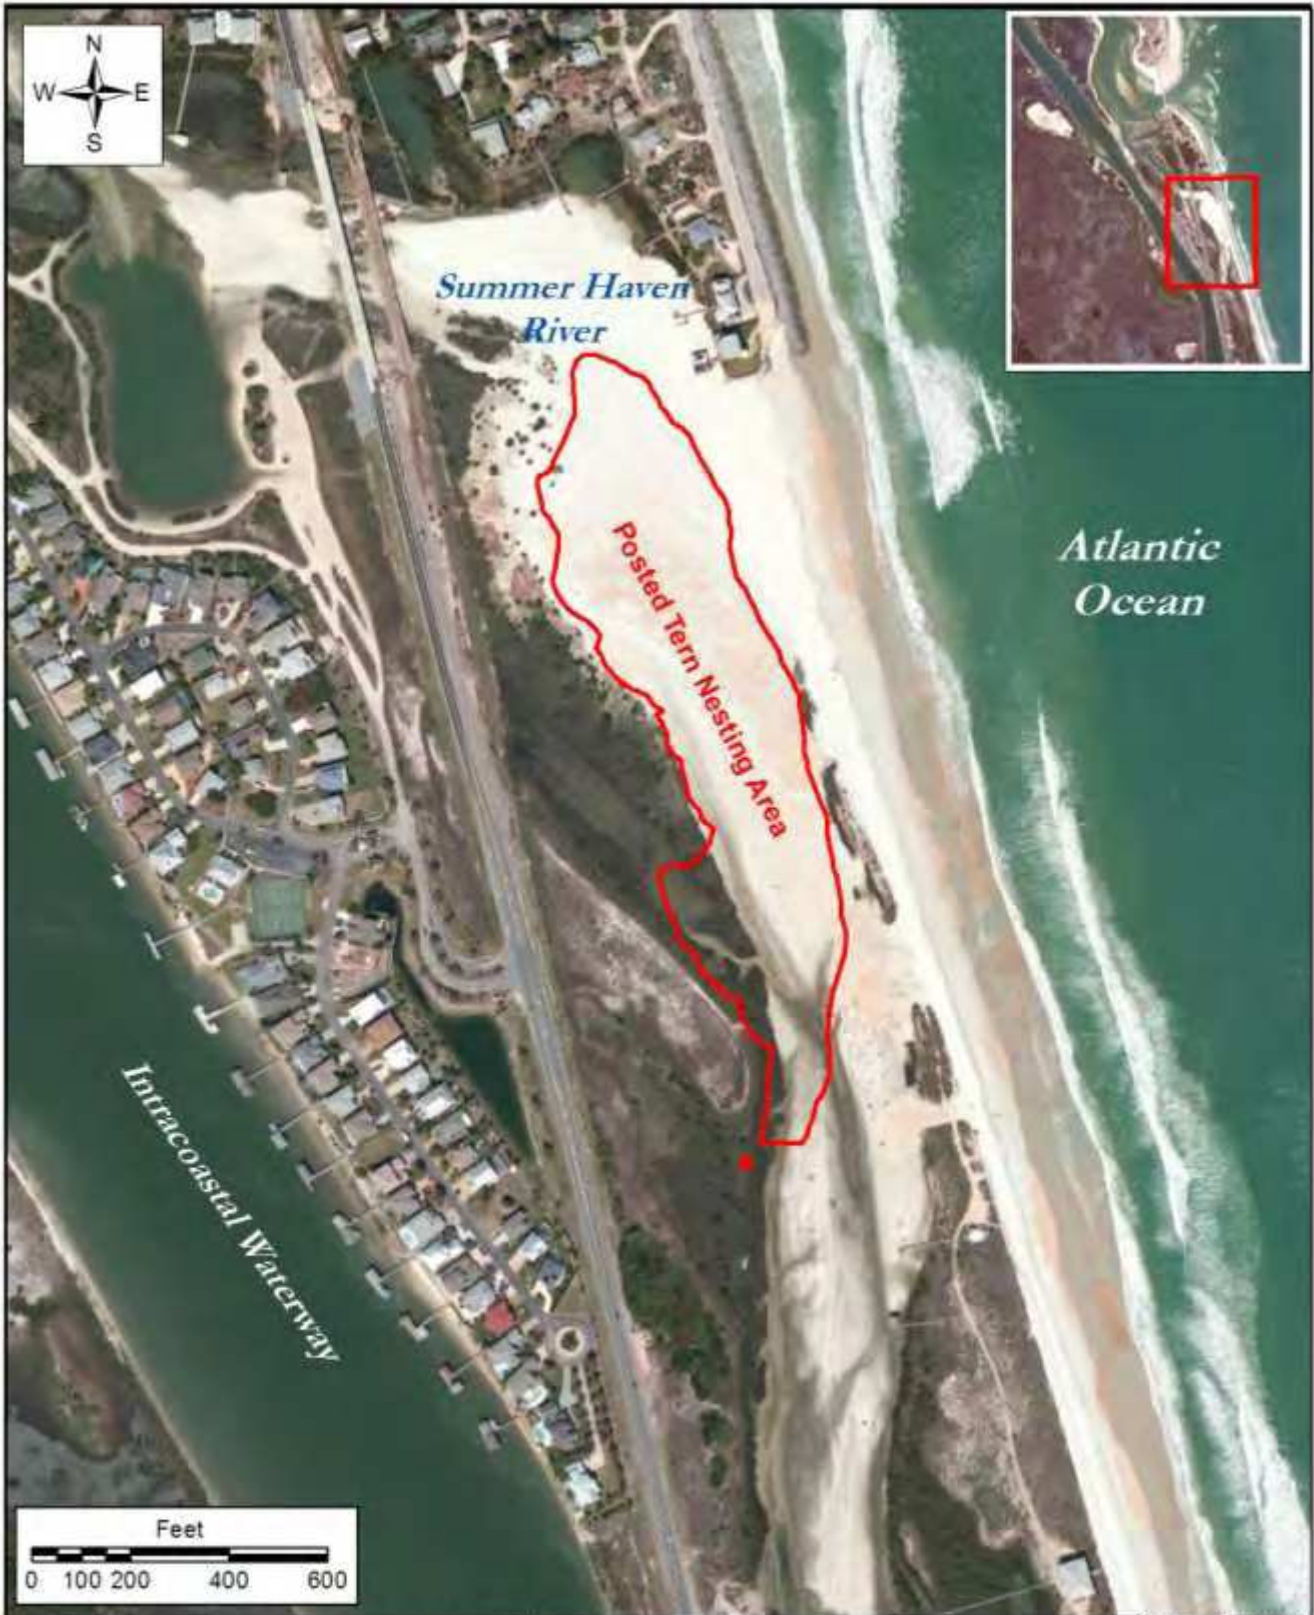
**Figure 1. Posted Least Tern Nesting Area
 Summer Haven River
 2013**

This mitigation plan provides alternate tern nesting habitat to replace the Summer Haven River nesting area that will be removed by the river restoration. The mitigation plan consists of two components:

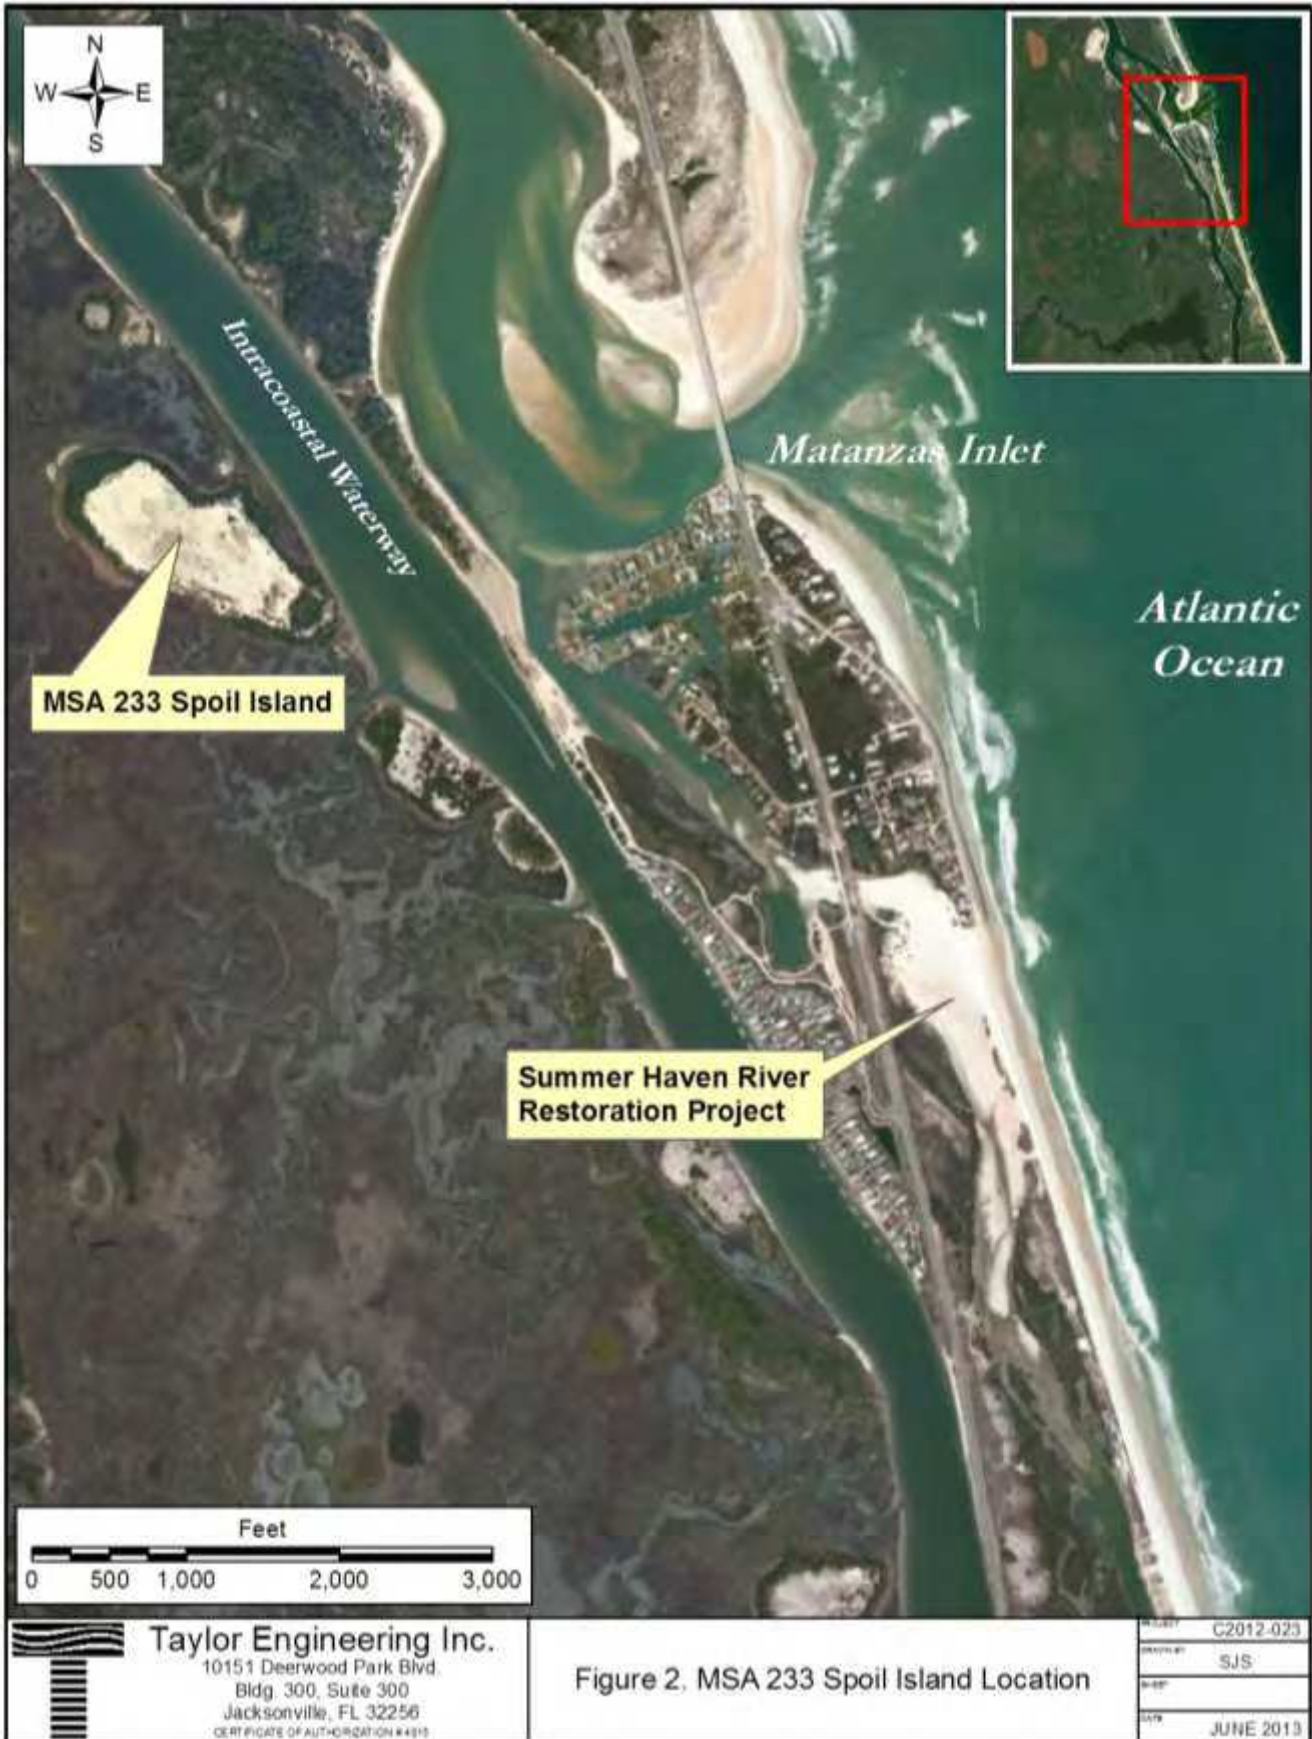
Figure 2. MSA 233 Spoil Island Location

Staff from the FWC and Guana Tolomato Matanzas National Estuarine Research Reserve (GTMNERR) identified a second site for creation of tern nesting habitat on a spoil island near Matanzas Inlet. The MSA 233 spoil island lies immediately west of the Intracoastal Waterway (ICWW), about one mile northwest of the Summer Haven River restoration site (Figure 2). Taylor Engineering, FWC, and GTMNERR staff visited and observed the island on April 8, 2013. The island is a typical diked spoil island created during construction and maintenance of the ICWW. It has not been used for dredged material disposal for many years. Remnant dikes define the perimeter of the island. The interior contains sandy dredged material which generally slopes from the highest elevations at north end of island down to the remnant weir structures at the south end. The sandy dredged material throughout the site appeared suitable substrate for tern nesting. The photographs in Attachment B illustrate the current condition of the MSA 233 island. Based on the observation of several gopher tortoise burrows on the south half of the site and the general topography of the island, the observers concluded that the north half of the site appeared suitable for reshaping to create tern nesting habitat.
