Bearing Currents and Their Mitigation in Frequency Converter-driven Induction Motors

Toni Heino

Bachelor's thesis
Electrical Engineering
Vaasa 2014

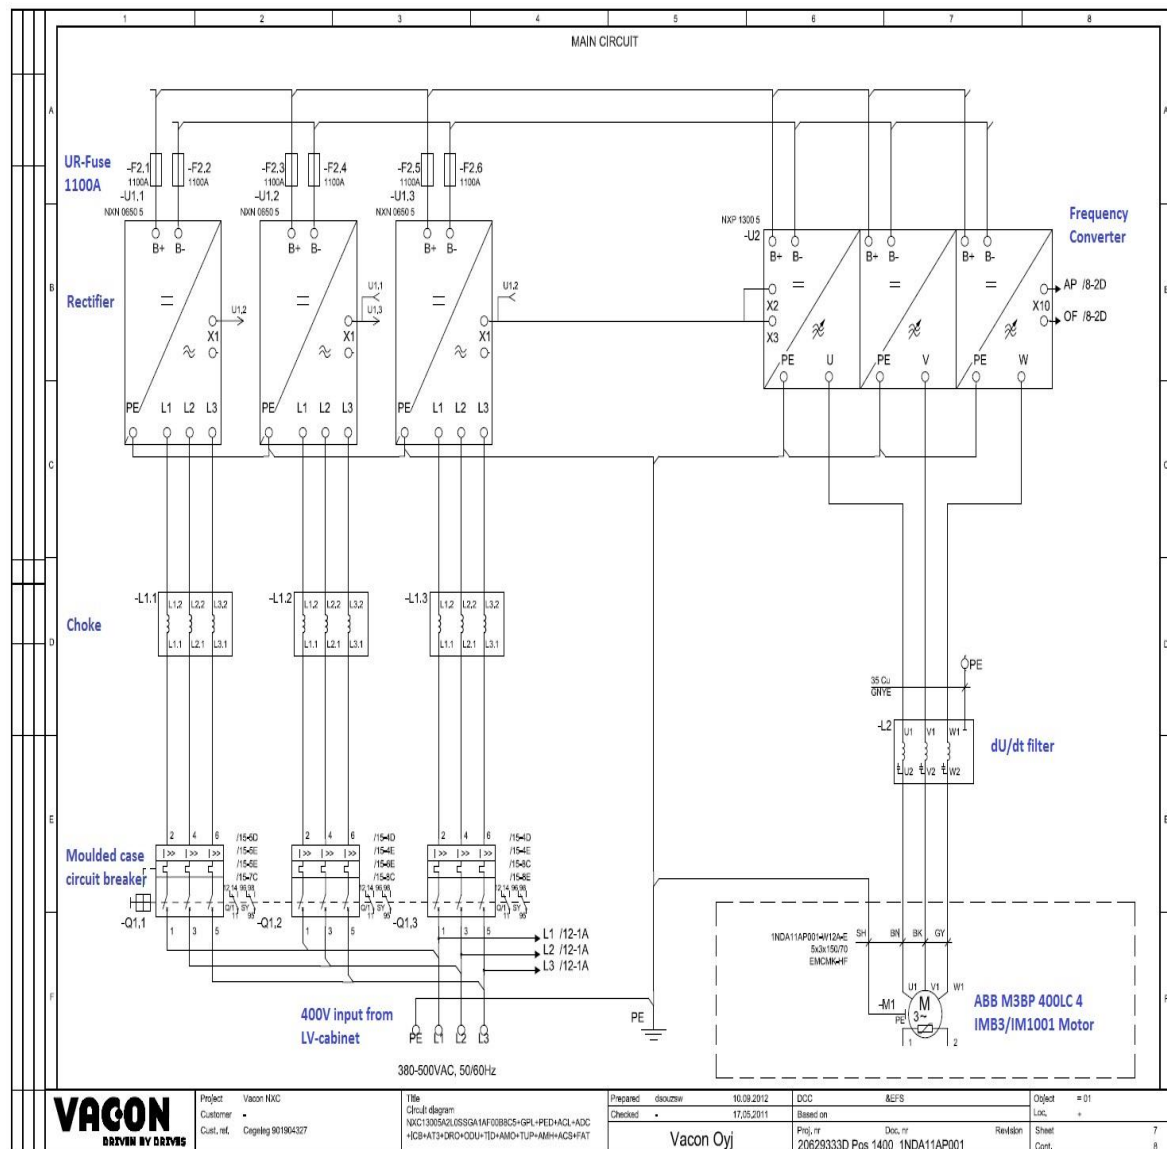
The main function of a VDF is to convert a constant AC signal to a variable AC signal. The most common type of VFD rectifies the constant AC signal to a DC signal. This DC signal is then converted with a diode bridge to a pulsating output signal with variable amplitude or width. In modern drives the diodes are replaced with Insulated Gate Bipolar Transistors (IGBT) with fast switching frequency. (Cronqvist A. 2003, 326)

Figure 7. Circuit diagram of three Vacon VFDs connected to an ABB M3BP-series motor. This motor has an output power of 710 kW and is used to control a district heating pump. Internal documentation.

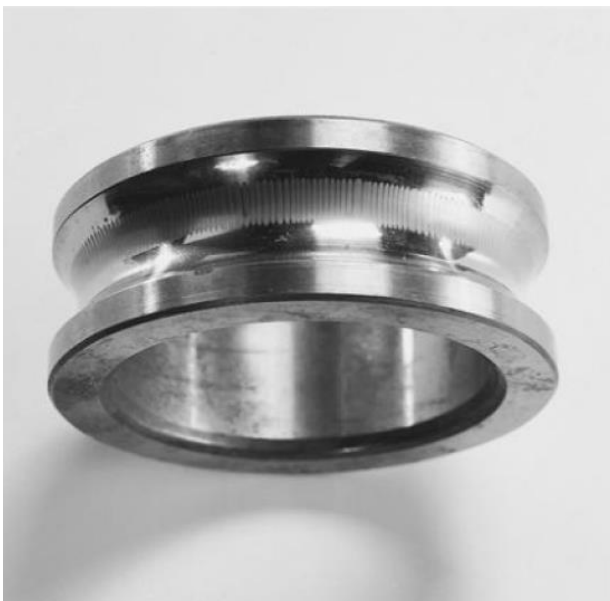
When an electric current flows through a bearing it jumps from one ring to the other damaging the contact surface on the balls and the rings of the bearing. The metal is heated to the melting point and small craters and discoloration will appear on the surface of the material. Eventually, the deterioration will lead to complete bearing failure. This could be noticed in bearings already replaced by ABB.

Figure 10. Damaged inner ring of bearing. Noticeable fluting pattern caused by bearing currents. (Ahola J. 2011, 6)

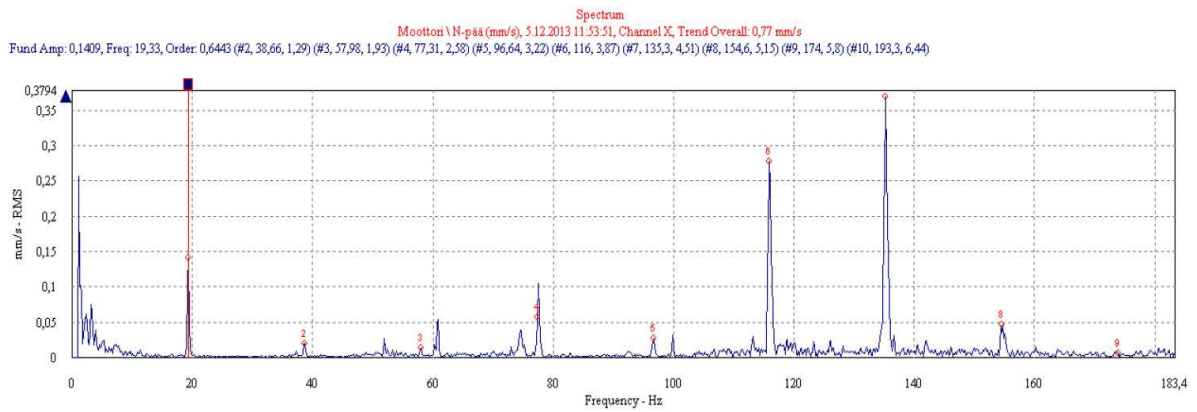
Figure 18. Vibration velocity measurement from the INDA11AP001 (District heating pump 1) motor. Amplitude spikes occurring with constant intervals are marked with red.

The vibration velocity measurement is measured in mm/s, and it is used to analyse the low end of the frequency spectrum. Bearing damage can be observed in this end of the spectrum if there are serious amounts of damage. In this motor the damage is minor and hence the damage can only be seen in higher frequencies. In the vibration velocity measurement we can observe spikes occurring with 19 Hz intervals. This is the rotational speed of the motor and is considered normal.

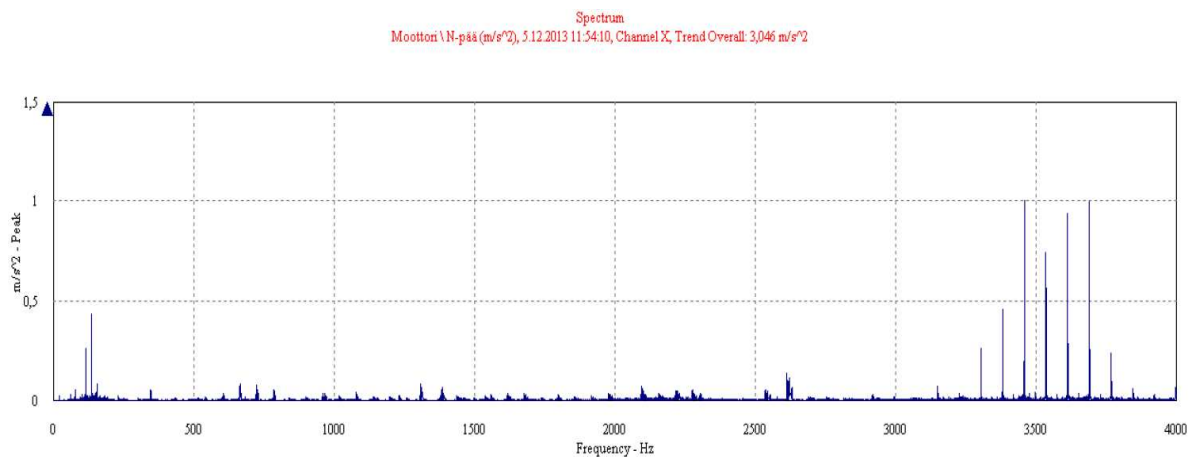
Figure 19. Vibration acceleration measurements from the INDA11AP001 (District heating pump 1) motor.

The vibration *acceleration* measurement is measured in m/s^2 , and it is used to analyse the high end of the frequency spectrum. The switching frequency of the VFD used to control the motor is 3.6 kHz. This can be seen as amplitude spikes around that frequency and is considered normal. To determine if there is any fault in the bearing we can analyse more closely the amplitudes at lower

frequencies. If there are spikes occurring at constant intervals, there might be a fault in the bearing. Spikes occurring with 19.26 Hz intervals are normal because of the rotational speed of the motor during the measurements.

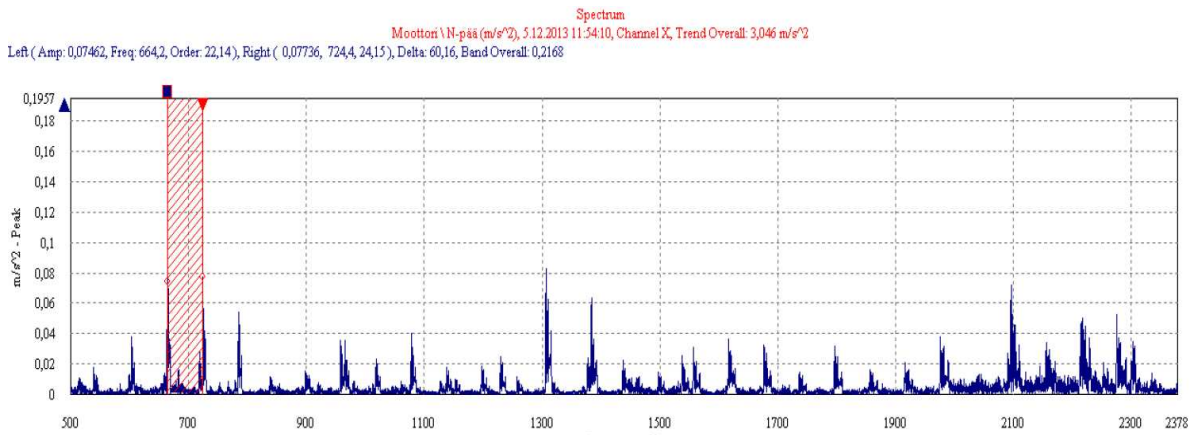
Figure 20. Zoomed in picture of figure 19. Interval of the harmonic overtones marked with red.

These harmonic overtones are occurring with ~ 60 Hz intervals. The bearing used in the motor is an SKF 6319. A data sheet from SKF reveals that the bearing has a plain race, 8 rolling elements, a ball diameter of 38.5 mm and a distance between the balls of 147.5 mm. Calculation of the defect frequencies as mentioned previously gives us:

$$\text{Outer race defect: } \frac{8}{2} \left(1 - \frac{0.0385}{0.1475} \cos 0^\circ \right) * 19.26 = 56,9 \text{ Hz}$$

$$\text{Inner race defect: } \frac{8}{2} \left(1 + \frac{0.0385}{0.1475} \cos 0^\circ \right) * 19.26 = 77.0 \text{ Hz}$$

$$\text{Ball defect: } \frac{0.1475}{2 * 0.0385} \left(1 - \left(\frac{0.0385}{0.1475} \cos 0^\circ \right)^2 \right) * 19.26 = 34.4 \text{ Hz}$$

$$\text{Cage defect: } \frac{1}{2} \left(1 - \frac{0.0385}{0.1475} \cos 0^\circ \right) * 19.26 = 9.0 \text{ Hz}$$

60 Hz is close enough to 56.9 Hz that we can safely assume that there is outer race damage in the bearing. This bearing has only been in operation for a couple of months, as the bearing has already been replaced once. The damage is very minor and doesn't need any maintenance at the moment. These results clearly indicate the presence of bearing currents in the motor because it's not normal for a bearing to show damage this soon.

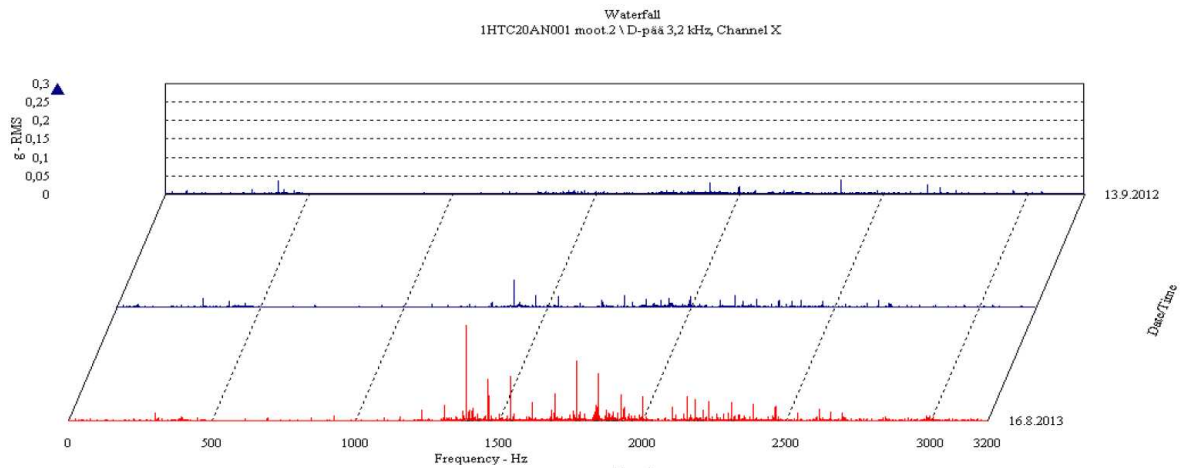
Figure 21. Acceleration spectrums from 1HTC20AN001 (Bag filter preheating fan) motor. Bearings had to be changed after about one year in operation. First measurement was made at the start of the plant and the last measurement just before the bearings were changed.

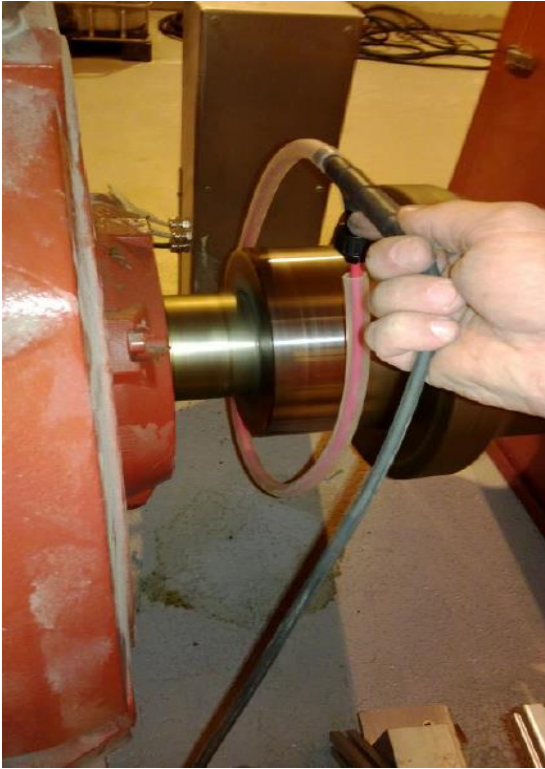
Figure 25. Measuring the shaft grounding current from the axis. A Rogowski probe is held around the rotating axis.

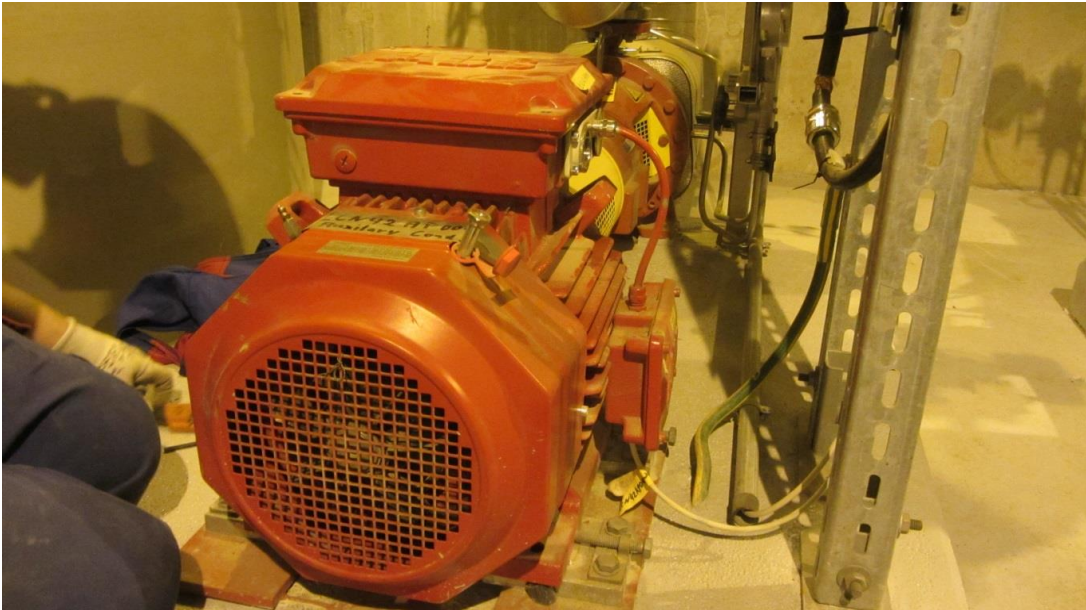
Figure 27. Some of the motors were only grounded through the incoming supply cable at the cable terminal box, like the 1LCN41AP001 (Cond Pp 1 AuxCondSys) motor in the picture. An additional grounding cable was connected to the case.

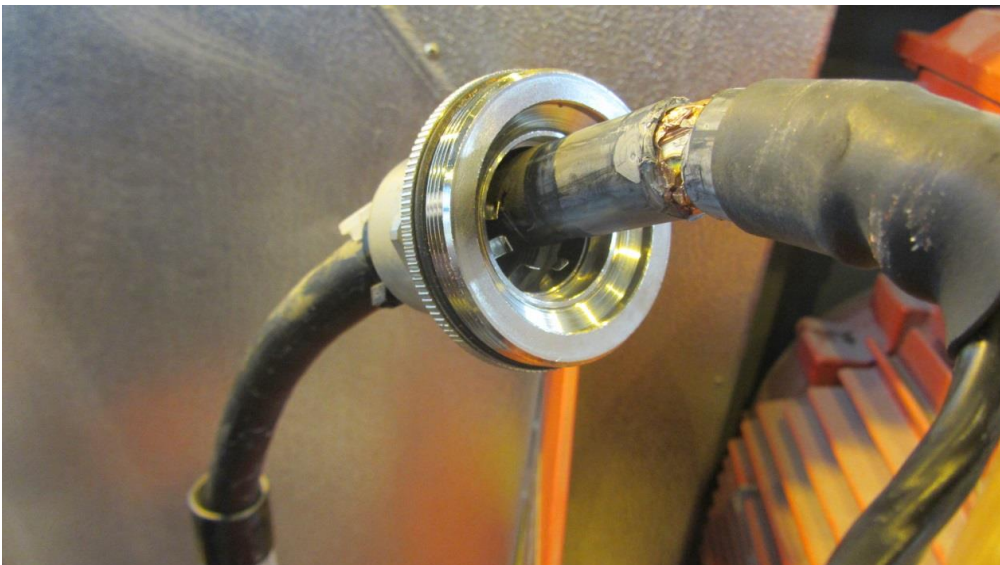
Figure 28. An EMC cable gland is used for connecting the supply cable to the cable terminal box. Many of the connection pins to the cable screen were broken at the 1HTC20AN001 (Bag filter preheating fan) motor. This gland was replaced.
