# ESTCP Cost and Performance Report

(WP-0407)

## Infrared Reflectance Imaging for Environmentally Friendly Corrosion Inspection Through Organic Coatings

June 2008

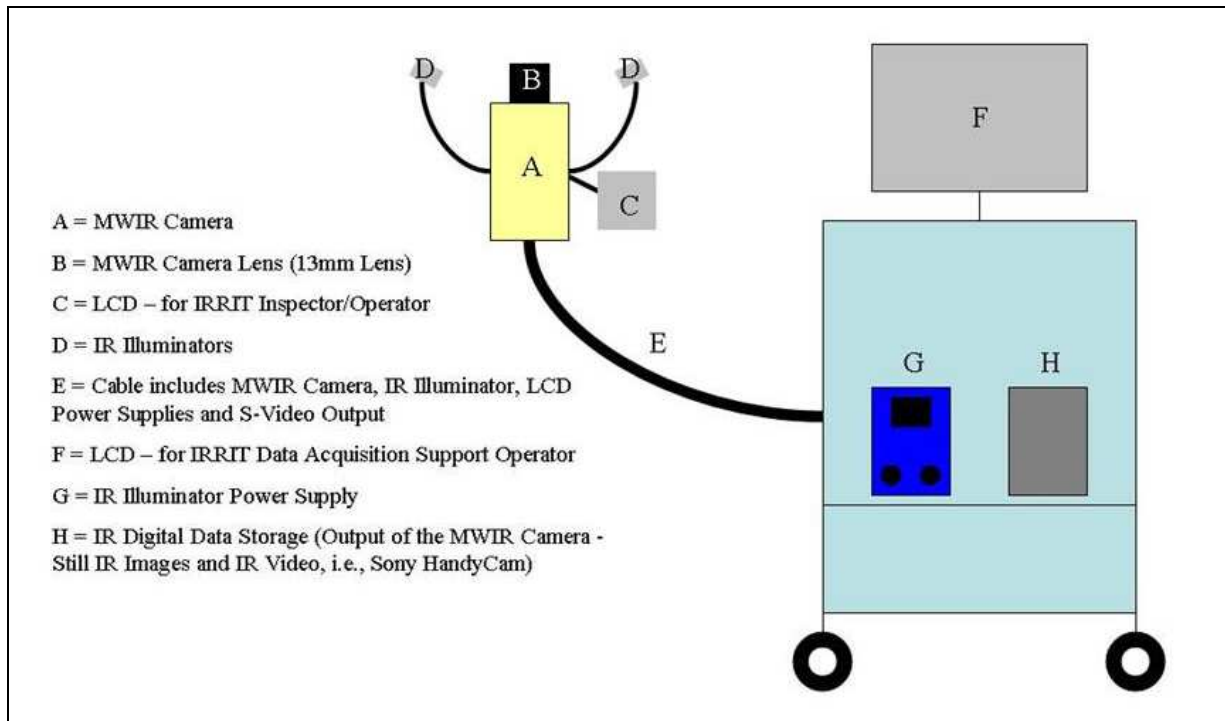
Figure 1. Schematic of IRRIT System, Including Optional Displays.

The IRRIT system is man portable. It currently consists of a single IR camera, small IR lamps, and a conventional liquid crystal display (LCD) (see schematic in Figure 1). The system used in the Dem/Vals was a 13-pound IR camera, but substantial size reductions are possible and alternative cameras were investigated during the effort. Analog/digital video output is compatible with most commercial off-the-shelf (COTS) displays (a 17-in LCD monitor was typically used, and a 5-in screen was also mounted on the camera, and a heads-up display was demonstrated). Figure 2 shows the IRRIT system in use.

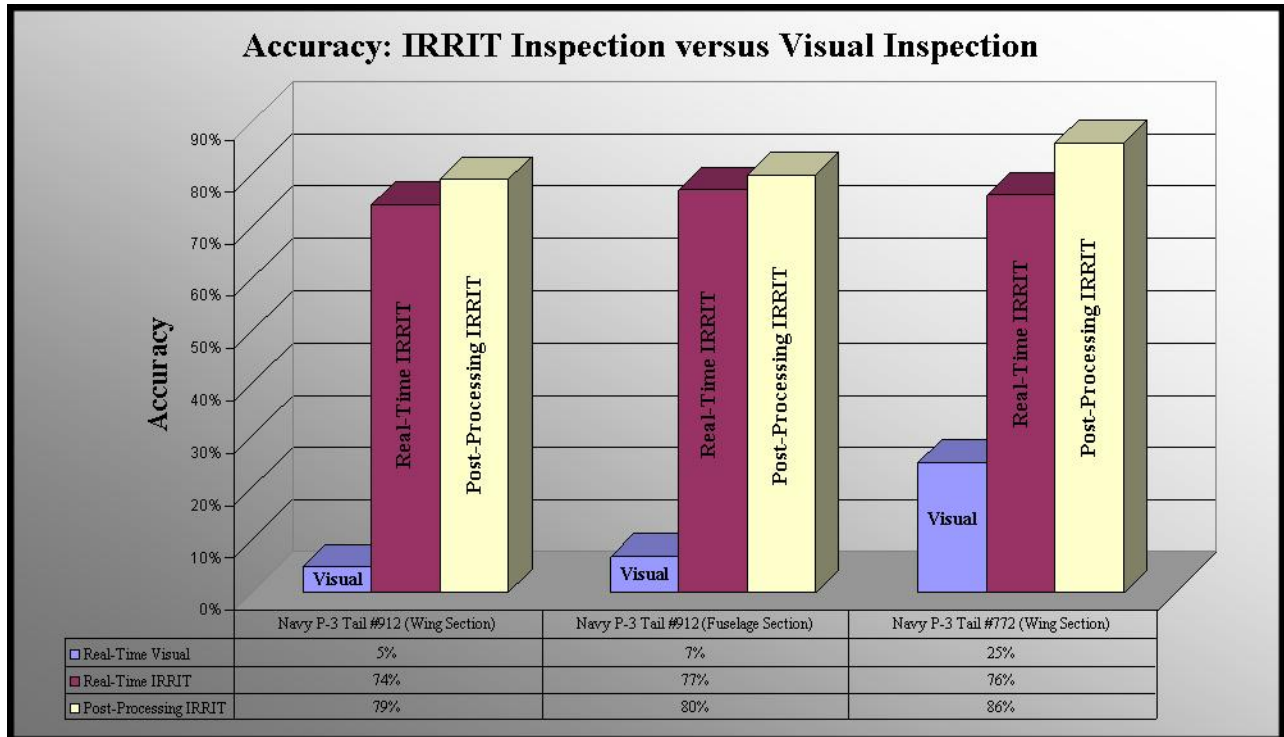
**Figure 5. Summary of IRRIT and Visual Inspection Results on P-3 OMLs.**

Figure 5 illustrates the high level of accuracy of the IRRIT inspection method as compared to the visual inspection method during the Navy P-3 OML Dem/Val. The IRRIT inspection identified three times (3X) the amount of corrosion located by visual inspection. The IRRIT as compared to the visual inspection method allows for postprocessing the images after the inspection, which identifies corrosion that may have gone unnoticed during the real-time inspection. The reasons corrosion may have gone undetected by the IRRIT can be found in Section 6.2, Performance Observations.

Overall, IRRIT obtained 70-80% accuracy during demonstrations, which is significantly higher than the 5-25% accuracy of the visual inspection method.
