# Union Pacific Railroad Bridge 60.97 Reconstruction

Mansoor Ahsan, P.E.  
Bridgefarmer & Associates, Inc. Dallas, Texas

**ABSTRACT:** Union Pacific Railroad Bridge 60.97 crosses the Trinity River near Goodrich, Texas. The railroad parallels U.S. Highway 59 at this location, and the railroad bridge is immediately upstream from the highway structure. The original bridge was built around the turn of the last century, and consisted of steel truss and plate girder spans on stone masonry and steel cylinder piers. The piers were founded on timber piling. Over the years several spans had been replaced. The main river crossing in early 2004 consisted (from south to north) of steel beam span approaches, a steel pony truss, a through-plate girder swing span, and a 150'-0" long through truss. The swing span dated from the period when the Trinity River was a navigable waterway, prior to the construction of Livingston Dam upstream of the bridge. The Trinity River has a history of flooding, and the railroad has experienced prior damage to several of its crossings. Steel sheet pile cofferdams were built around each of the existing piers to provide protection for the timber piles.

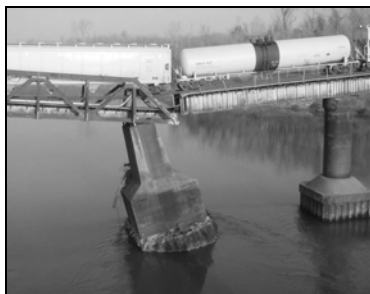
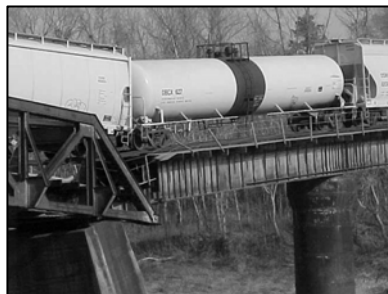
Figure 1

The Trinity River experienced severe flooding in 2004. Scour at the bridge site extended below the pier protection and undermined the timber pile foundations. This led to failure of a pier and partial collapse of the structure (*Figure 1 & 2*). A train was crossing the bridge at the time of the failure, and had to be removed prior to repair work. This line is a critical part of the Union Pacific system, so repair crews worked around the clock to restore the bridge to service (*Figure 3*). Union Pacific and contracted forces removed the pony truss span (to the left in *Figure 1*) and cut back the end of the swing span (to the right in *Figure 1 & 2*). Two new pile bents were constructed to support new superstructure spans. One important time-saver in this process was the use of a replacement span that had originally been fabricated for a project in Louisiana on a different railroad. The Louisiana project had been delayed, making the span immediately available. The Union Pacific "borrowed" this span, agreeing to pay for fabrication of a replacement for it (*Figure 3*).

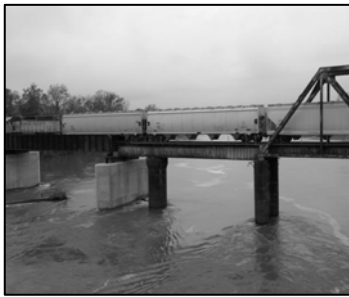
Figure 4

After the emergency repairs were completed and traffic restored to the line (*Figure 4*), Union Pacific planned further work on the bridge to prevent future problems. The plans for further work included replacement of the pier supporting the truss span and swing span, and replacement of the remaining portion of the swing span. Minimizing track outages was the major operational consideration for this work. Preventing any further damage to the existing pier during construction (that would affect its ability to support train traffic) was a critical structural concern. The original foundation design for the pier utilized large diameter drilled shafts upstream and downstream of the existing foundation (*Figure 5*). Single columns of the same diameter would be constructed atop the drilled shafts to near the bottom of the existing structure. A steel cross beam was designed to be placed across the tops of these columns to support bearings for the existing truss span and the new replacement span. Union Pacific selected D.H. Blattner & Sons, Inc. as the general contractor for this work. Union Pacific selected Bridgefarmer & Associates, Inc. to provide construction engineering and construction monitoring services.

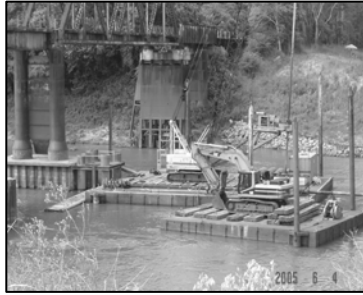
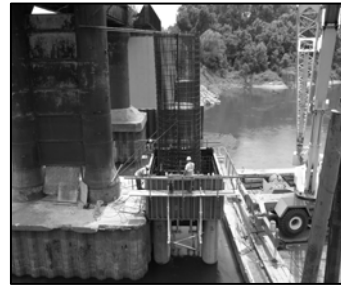
Figure 6

An initial concern was installation of the large diameter (10'-0") drilled shafts in close proximity to the existing pier. Given the uncertainties of the existing conditions following the flooding and the criticality of the pier, it was decided to replace the single large diameter shaft on each side of the pier with a group of five smaller diameter (36") shafts (*Figure 5*). This would reduce the volume of earth displaced by any single shaft and also reduce the vibratory action on the foundation material. Bridgefarmer worked with Blattner and the Union Pacific to redesign the foundation for this concept. During construction of the drilled shafts, cross-hole sonic testing was used to verify the integrity and adequacy of the shafts. Nine of the ten shafts tested satisfactorily following final placement of the concrete fill (*Figure 5*). The tenth showed indications of voids or some other form of discontinuity through several zones of the shaft. The drilled shaft subcontractor attempted repairs to this shaft, but a second round of testing still showed the anomalies in the shaft. Delay caused by the shaft condition threatened to push construction into high-water periods. Bridgefarmer engineers consulted with the Railroad and the Contractor on this issue, and two additional H-piling were driven adjacent to the problem shaft to provide additional support for the footing and allow construction to continue.

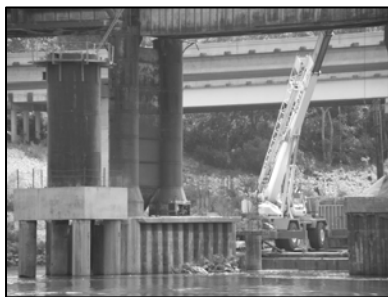
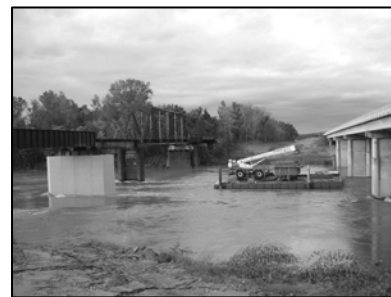
Figure 8

Events in the fall of 2005 showed that the construction schedule concerns were correct. Hurricane Rita struck southeastern Texas on September 24, 2005. The Lake Livingston Dam was damaged, leading officials to release very large quantities of water into the Trinity River to prevent a feared failure of the structure. Within hours, river flow rose from typical levels of 1,000 to 5,000 cfs to 79,200 cfs, causing high currents in the river, sudden water level increases, and significant downstream flooding. The Trinity River Bridge survived this sudden onslaught of water. However, one of the work barges was carried by the high water into the adjacent U.S. 59 Bridge, causing concern for that structure (*Figure 8 & 9*). Within several days, the pressure on the Lake Livingston Dam was relieved and the water levels returned to normal. After some clean-up, the Contractor was able to resume work on the pier replacement.

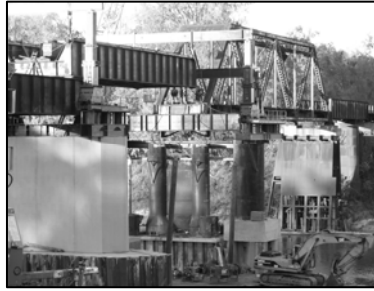
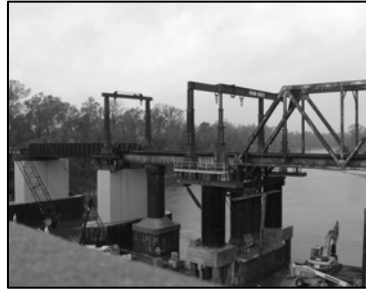
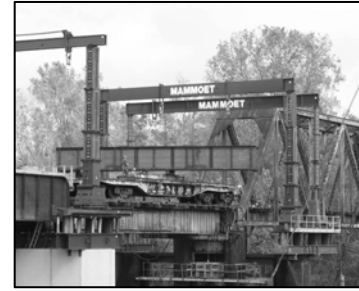
Figure 7

The unpredictability of the Trinity River demonstrated the need for an alternative means (from barge-mounted cranes) of setting the replacement superstructure span. Mammoet, a heavy lift contracting firm, teamed with D.H. Blattner & Sons to develop a unique span erection scheme. In this, high-capacity gantries were placed on the new bridge piers, allowing lifting and swinging of bridge spans without the use of large cranes. Bridgefarmer & Associates carefully reviewed the plans for the gantries and lift procedures, assessing the impact on the newly constructed piers and the loading on the existing structure.

- Shutting down train operations
- Setting the jacking gantry units in place on the bridge and corbels
- Cutting free the existing connections
- Positioning the cross girder via rail, rotating it in place on a railcar turntable, then attaching to gantry
- Lifting the new 245k lb. & old span with the gantry through-plate girder (TPG) onto the railcar
- Transporting, via rail, the TPG and connecting it to a gantry and the existing span
- Skidding the old span onto the railcar
- Cut the tops off the existing piers
- Jack up the existing truss to allow installation of the new cross girder
- Install the new cross girder & the new TPG
- Lower and shim in place the existing truss section
- Place track panels
- Demolish remainder of the existing piers and install pier protection
