## PROPERTY INSPECTION REPORT # Sample

**Concerning:** 258 Sample Drive, Your City, Texas 00000

**By:** Mark Lyle Brown - TREC License # 9762

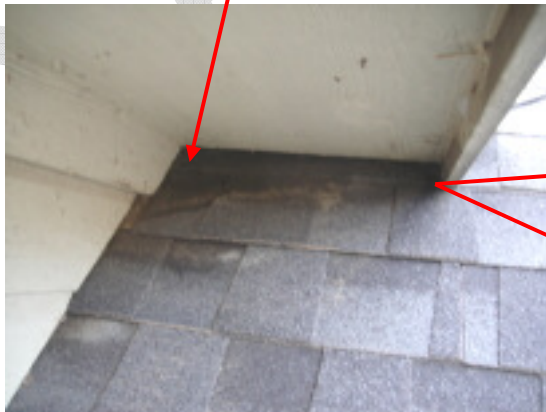
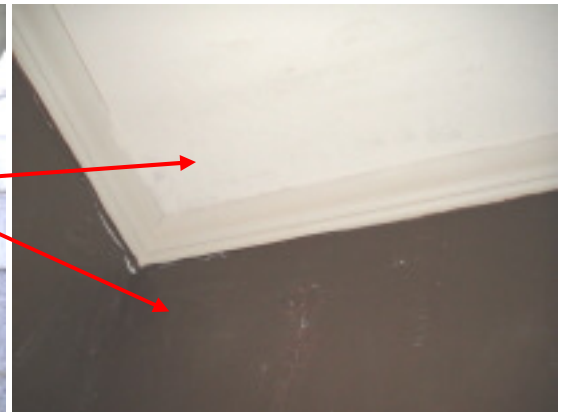
**This torn ridge shingle is allowing water to seep into the structure above the garage-to-home entrance door. The ceiling and walls have water damage. See wall**

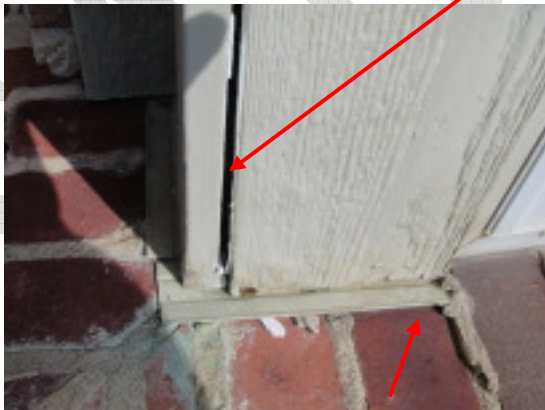
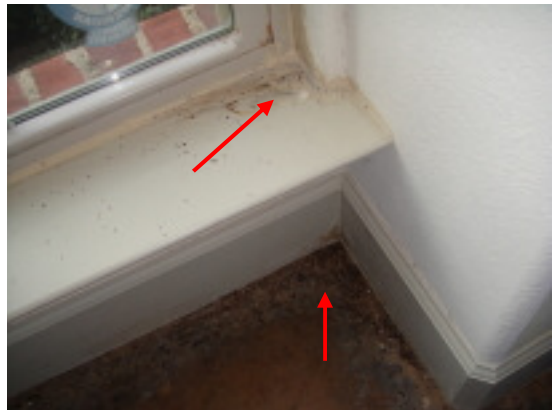
**This flashing above the south breakfast dining window is not sealed properly. Water is entering at this location as well as the outside window trim, and causing water damage on the interior window frame, sill, and baseboard / wall.**

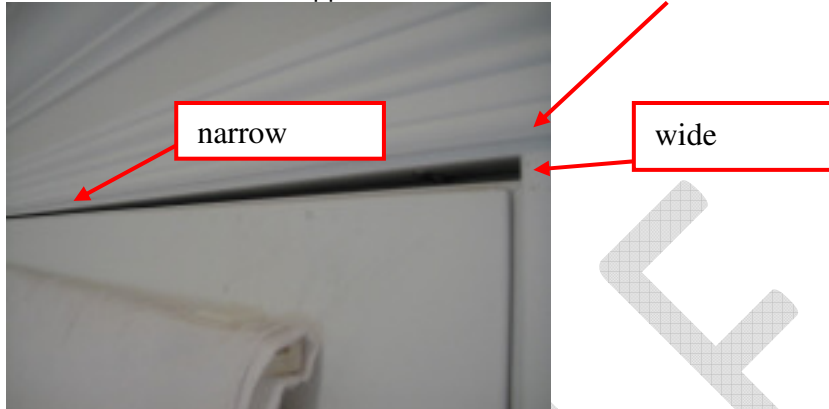
- **The master bedroom rear exit doors deadbolt does not align with the latch plate.** This door is also not square to the doorjamb. There are no indications around the door, inside or outside indicating a structural movement in the amount the door is out of square. Therefore, the issues with this door appear to be an installation issue.

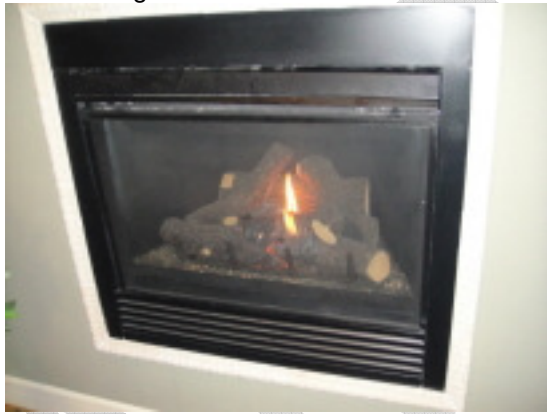
- J. Fireplace/Chimney - Comments:**
- This is a built in self contained gas fired unit that does not require a chimney. The unit has electronic ignition and a blower fan. The unit is working correctly.
