THE INFAMOUS INTERMEDIATE SHAFT(IMS) SAGA

Information compiled from LN Engineering

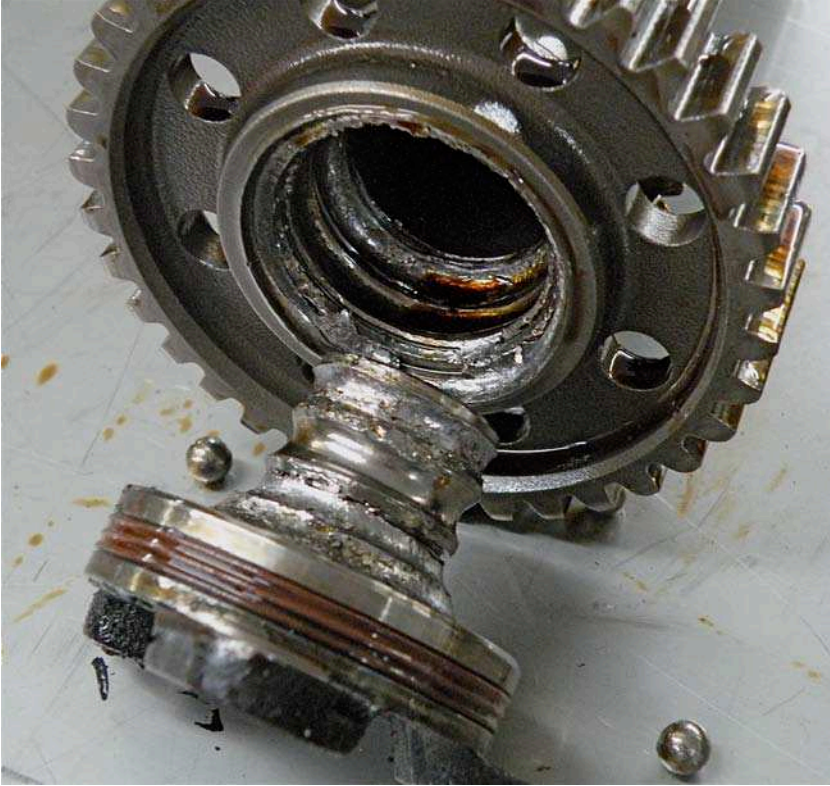
The most common deficiency with the M96 engine and its revisions through 2008 is the failure of the ball-bearing found in the intermediate shaft. The intermediate shaft found in the M96 and later M97 engine was revised three times. The earliest design incorporated a dual-row ball-bearing used through model year 1999 and in some 2000 and 2001 models. Starting in model year 2000, Porsche began phasing out the dual row bearing and went to a smaller single row, with significantly less load capacity. From model year 2002 -2006, all engines used this smaller, lower capacity bearing. Starting with the 2006 model year, the design was again revised to use a much larger single row bearing with the same load capacity of the early dual-row ball-bearings. This bearing increased in diameter, which increased the bearing and ball speed, further improving the bearing. However, starting with the 2006 model year, Porsche in its third revision of the intermediate shaft bearing, changed over to a design that is not serviceable, leaving later model years with no recourse for addressing this issue with preventative maintenance, which failures still frequent. In all revisions, a sealed ball-bearing was used, rather than allowing for engine oil to lubricate and cool the ball-bearing. There is no recommended service interval for these bearings nor provisions for their replacement from the factory. However, with model year 1997 through 2005 engines, the intermediate shaft bearing thankfully is serviceable and with preventative maintenance, costly repairs can be prevented.

By far, the single row ball-bearing used starting in model year 2000 through 2005 are the most problematic. Based off projections calculated by a fellow Porsche enthusiast and retired bearing engineer from Timken, *they figure a 90% survival rate of the single-row 6204 ball-bearing used in the IMS at 90,000 miles* – resulting in a staggering 10% failure rate (called the L10 life)!*

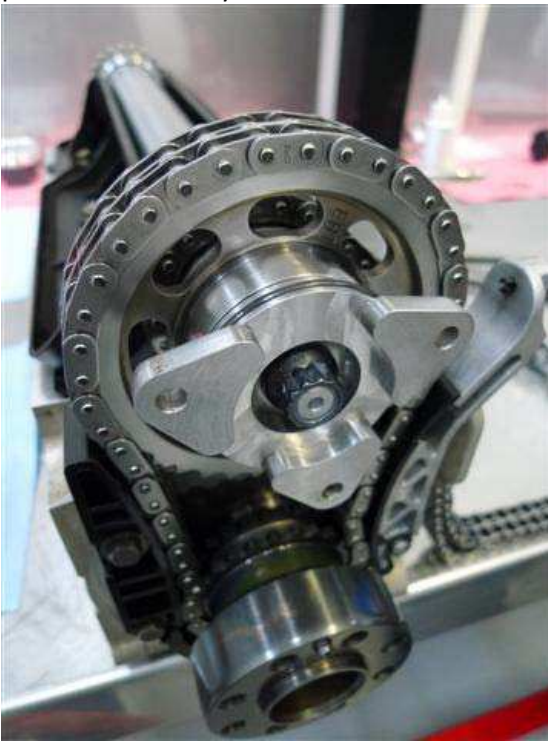
When the M96 engine was developed, for cost savings, one cylinder head casting was made. As such, for interchangeability, the camshafts could no longer be driven off one end of the IMS. This required that the chains be driven off opposite ends of the intermediate shaft. On the rearmost side of the intermediate shaft (closest to the flywheel), you have the main sprocket that drives the intermediate shaft off the crank as well as a smaller sprocket and chain that goes to one of the cylinder heads to drive the cams. Clear on the opposite end of the intermediate shaft there is another sprocket to drive the cams for the opposite cylinder head. This end of the intermediate shaft has a plain bearing surface integrated into the front oil pump console that is pressure fed oil for lubrication directly from the oil pump. As a result, this end of the IMS always performs flawlessly and never shows wear.

Unfortunately, due to how the crankcase was designed, there are no oil passages from which pressurized engine oil can be used to lubricate a plain bearing on the side closest to the flywheel. The IMS in the M96 (and subsequent M97) engine is located directly beneath the crankshaft carrier and is connected to the crankshaft by means of a chain. The IMS has a sealed ball bearing on one end (closest to the flywheel) and a plain bearing on the other end, which resides in the oil pump/coolant console. Additionally, it is this ball-bearing that handles the majority of the load on the intermediate shaft.

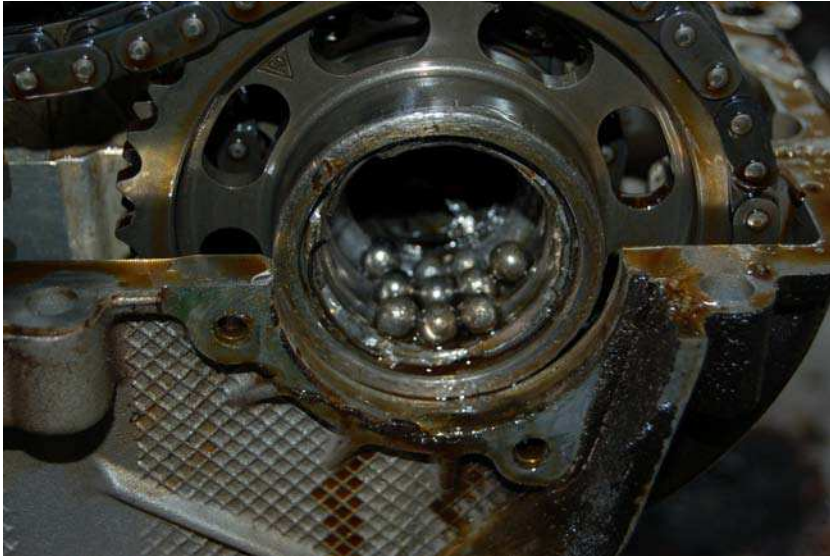
According to information published about the Eisen IMS Class Action Lawsuit, the single row IMS bearing used in 2000 through 2005 model years is reported to have an 8% failure rate, versus less than 1% with the dual row IMS bearing. The 8% failure rate cited by the settlement documents is not far off of the calculated L10 life LN Engineering has been using for the last five

years! With half the load capacity, it is clear to see that the reduced load capacity of the single row IMS bearing is a significant contributing factor to the increased number of failures.

In addition to ball-bearing failures, the intermediate shaft can suffer other failures including but not limited to slippage of drive sprockets which can lead to valve timing related failures. Again, as a cost saving measure, the sprockets were not secured to the intermediate shaft. The center bearing support stud was manufactured with an o-ring groove cut into it, reducing its cross-sectional thickness to less than the diameter of the threads used to secure the IMS bearing assembly. As such, it is common to have the center bearing support stud break during operation, resulting in a large oil leak, and is often an indicator of a failing or failed IMS bearing.

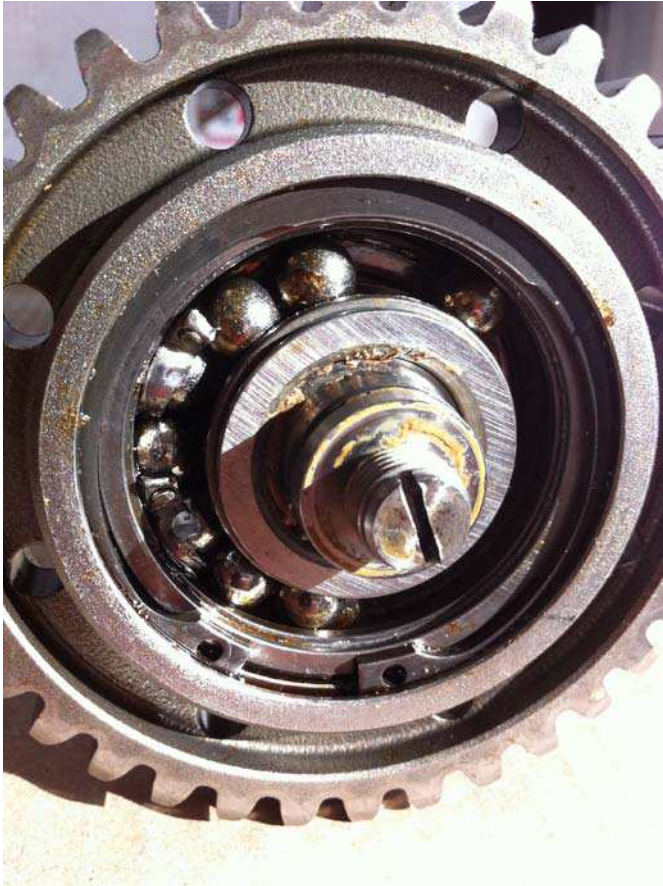
Now for some technical information from our bearing engineering team: "There are many reasons for bearing failure, and usually each failure is due to a combination of causes, not just a single cause. Spalling occurs as a result of normal fatigue where the bearing has reached the end of its normal life span but this is not the most common cause of bearing failure. Spalling

detected in bearings can generally be attributed to other factors. A common cause of bearing failure is due to contamination from tiny metallic particles left over from a previous mechanical failure. These particles are suspended in the oil and if they are allowed to get into the bearing, the result is tiny dents in the hard steel raceway. Often the dent is surrounded by a microscopic raised area (or 'lip'), and when the ball rolls over this lip, the ultra-high point loading exceeds the strength of the steel and it fractures, leaving behind a jagged depression (or 'pit'). Once this cycle begins, wear is greatly accelerated and the bearing will fail prematurely."

One thing is for sure; once you have experienced an IMS bearing failure, there is no turning back. A complete engine disassembly is required to replace the intermediate shaft and in most cases, complete rebuild or engine replacement is your only option.
