## Interim Report on the Status of the Analysis of Electrical Components Installed in Homes with Chinese Drywall<sup>\*</sup>

Mark Gill Andrew Trotta Division of Electrical Engineering Directorate for Engineering Sciences U.S. Consumer Product Safety Commission

#### November 23, 2009

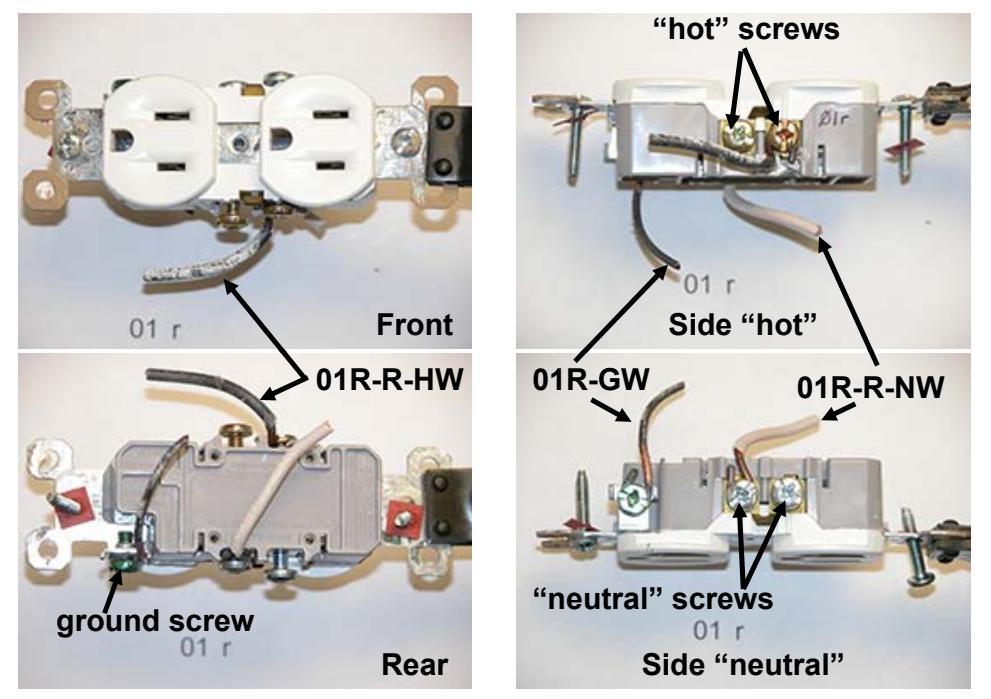
HW = "hot" wire, GW = ground wire, NW = "neutral" wire

Figure 4: Example optical photographs showing four views of a duplex receptacle. The neutral and hot wires have electrical insulation on the part of the wire away from the attachment screws. The ground wire has no electrical insulation, but could appear to due to it being blackened over much of its area.

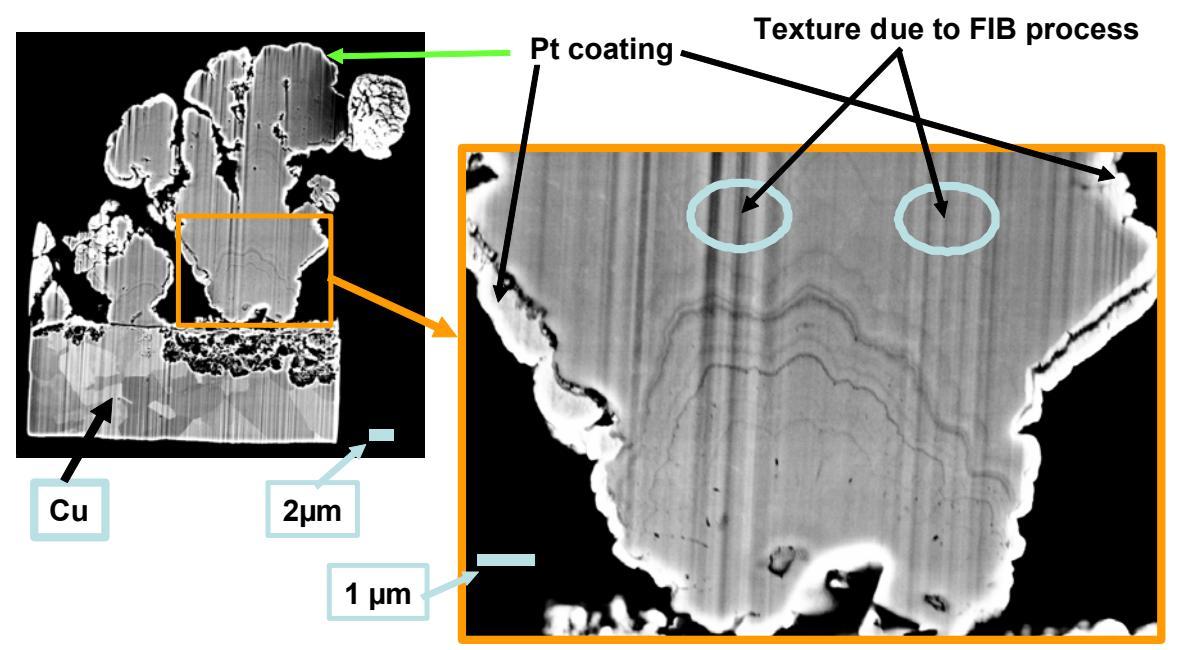
The FIB technique also allows a slice of the corrosion layer and underlying copper to be cut and lifted off the surface. This allowed the slice to be placed horizontally on a sample stub, whereby enhanced imaging and analyses of the cauliflower-like corrosion product and underlying materials could be performed. Regions of the cauliflower like corrosion products show subtle contrast differences (lighter and darker) indicating variations in structure, density or composition. This layer morphology suggests that the growth of the corrosion product layers may have occurred under varying conditions (humidity, temperature, concentration of atmospheric elements, etc.). In additional images of the region shown in Figure 15 it appears that there may be three areas with little or no contrast, separated by what look like darker and lighter bands. The vertical lines in Figure 15 are the result of the FIB process and do not represent variations in the product layer.

The grain (or crystal) structure of the underlying copper can be seen by slight contrast differences (darker or lighter) that are produced by different grain orientations. This kind of contrast is normal and expected for imaging of the copper.

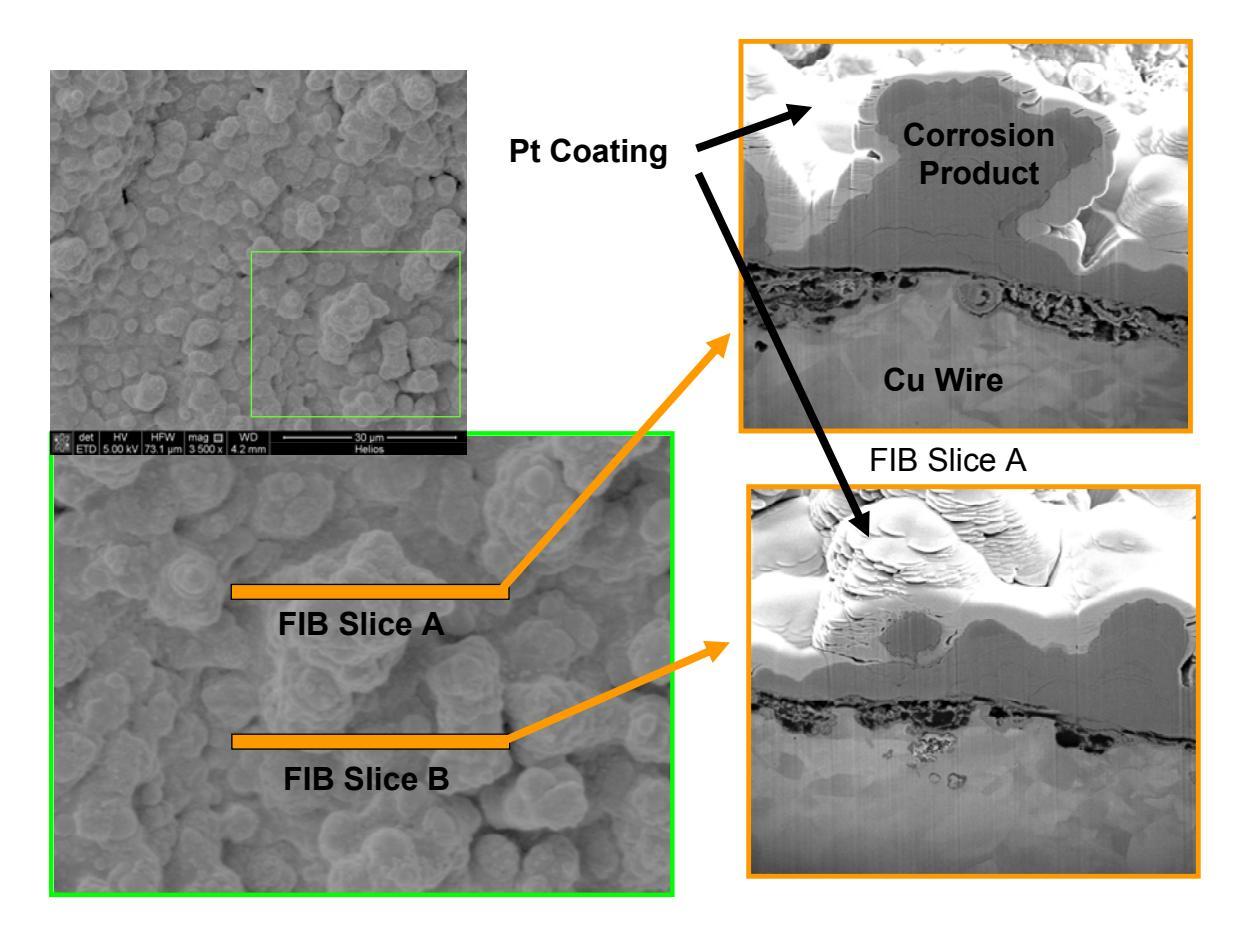
A series of FIB slices were made through the corrosion product on a copper hot wire. Two of the slices are shown on the right in Figure 16 along with the corresponding plan view SEM images (left) showing the region from which they were taken. The bright layers on top of the corrosion product are platinum used to protect the underlying material during the FIB cutting process.
