**ASPHALT CONCRETE  
PATCHING MATERIAL  
EVALUATION**

**Interim Report**

**SR 548**

1. Report No. OR-RD-01-19		2. Government Accession No.		3. Recipient's Catalog No.	
4. Title and Subtitle  Asphalt Concrete Patching Material Evaluation Interim Report				5. Report Date June 2001

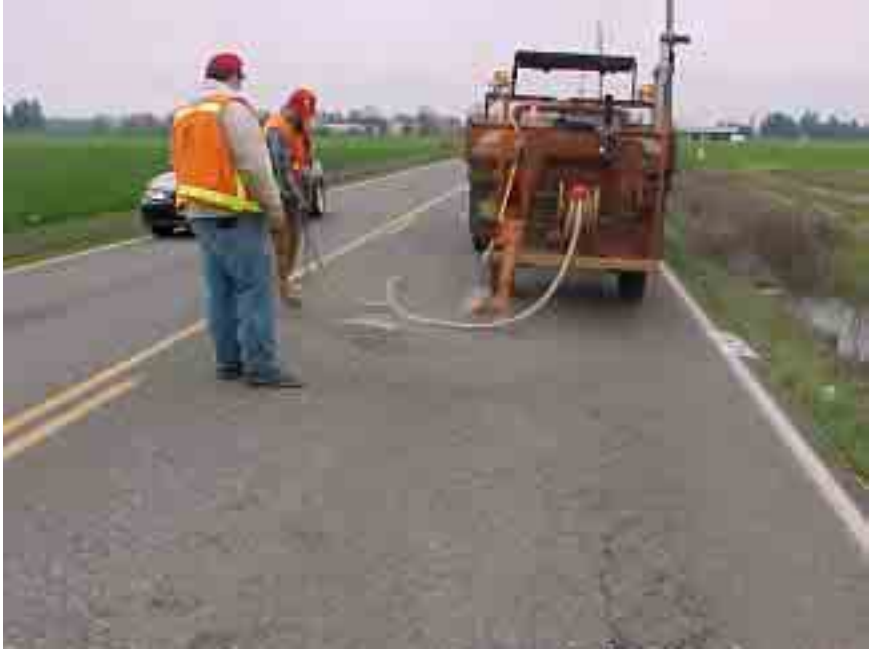
Figure 4.3: Wallace Road pothole manufacturing

Figure 4.3 shows material placement with the general pavement condition. Figure 4.4 shows the completed holes looking south. The materials tested, installation order, depth and final shape are shown in Table 4.2. The cold mix used as the control mix (obtained from the ODOT's Salem Maintenance office) was UPM purchased from Porter Yett Co., Portland, OR.
