Home Inspection Report

**6754 Amber Lake Lane
Alpharetta, Georgia 30022**

**Prepared for Sue Cassidy
February 8, 2012**

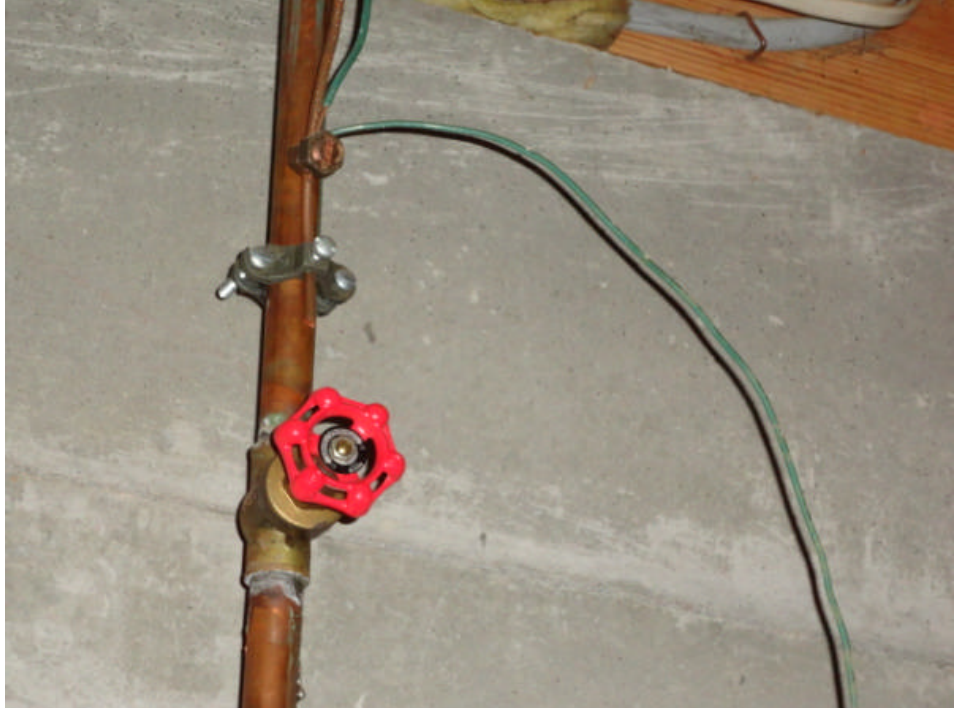
**Main Water Line Cutoff
Location:**

The main water cutoff valve is located on the basement wall where the water line enters the house.

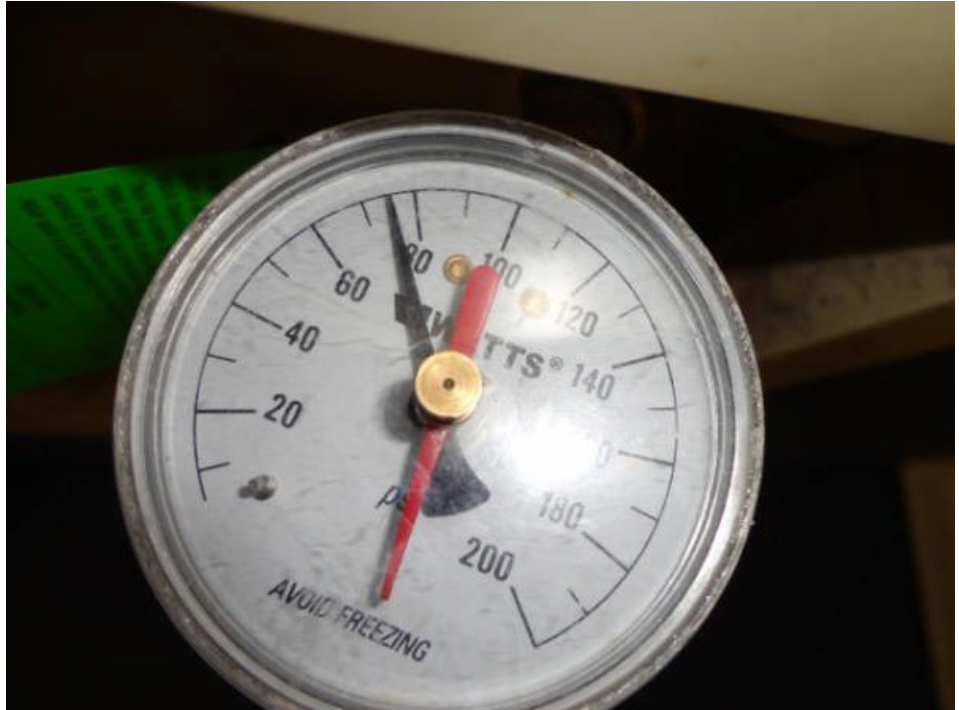
Water Pressure:

The water pressure was tested at the laundry hookups. Water pressure was found to be in the normal and acceptable range at 75 psi.
