The severe Tohoku Sequake in Japan and its impact on the Fukushima Daiichi nuclear power plant

*Bernhard Kuczera, Karlsruhe/Germany,
and Ludger Mohrbach, Essen/Germany*

Volume 56 (2011), Issue 4/5 | April/May

**International
Journal for
Nuclear Power**

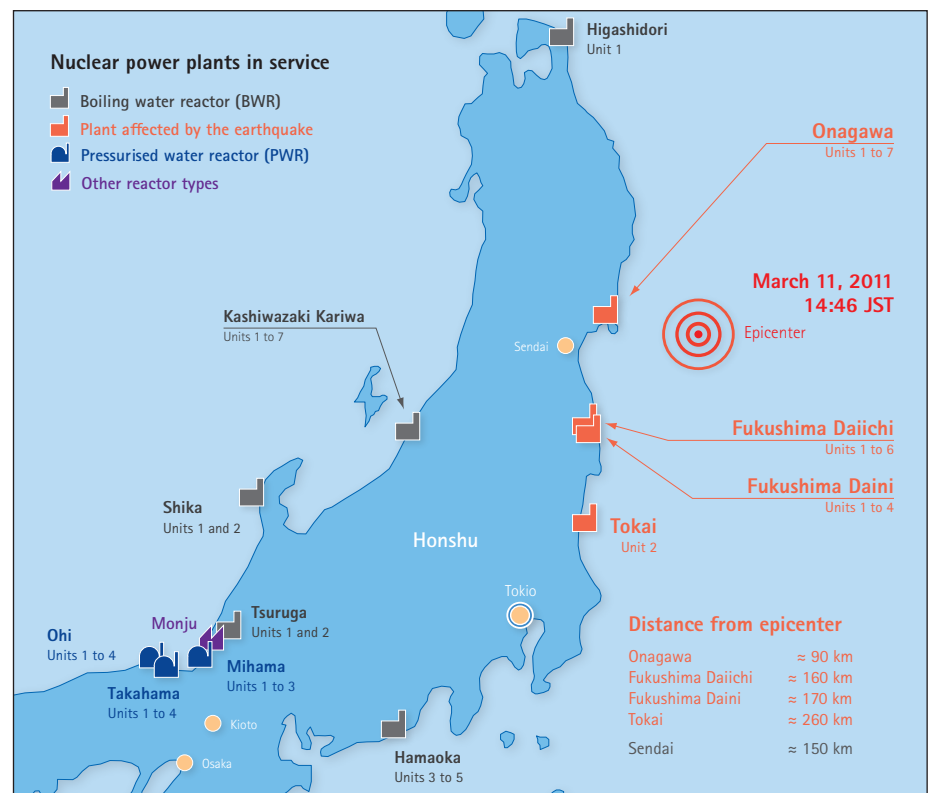
The quake on Friday, 11 March 2011, with a magnitude of 9.0 was a so-called inter-plate rupture, much stronger than the frequent intra-plate earthquakes with typical magnitudes up to around 7 Japan is more or less used to (Figure 1).

Fig. 1. The epicentre of the seaquake off the Japanese Pacific coast.

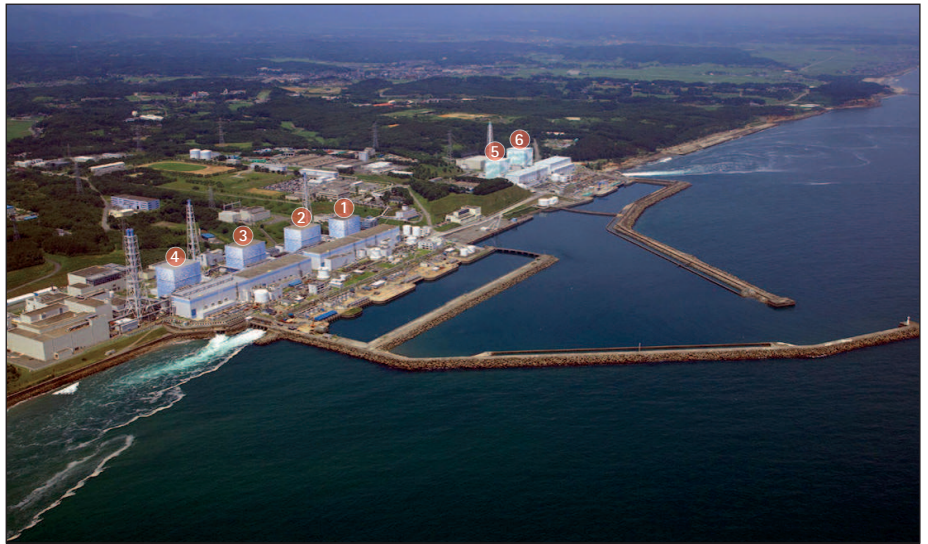
Figure 2 shows a photo of the plant taken before 11 March 2011. The plant comprises six boiling water reactors (BWR) with their turbine and auxiliary buildings located on a low plateau directly on the Pacific coast line. Together, the six units had a total output of 4,696 MWe_{gross} and 4,547 MWe_{net}², thus forming together with the adjacent *Fukushima Daini* site (4 BWRs with a total of 4,400 MW_{gross} and 4,268 MWe_{net}, located about 11 km South of the *Fukushima Daiichi* site) the largest nuclear power plant complex in the world.

Fig. 2. Aerial photo of the Fukushima Daiichi nuclear power plant before March 11, 2011.

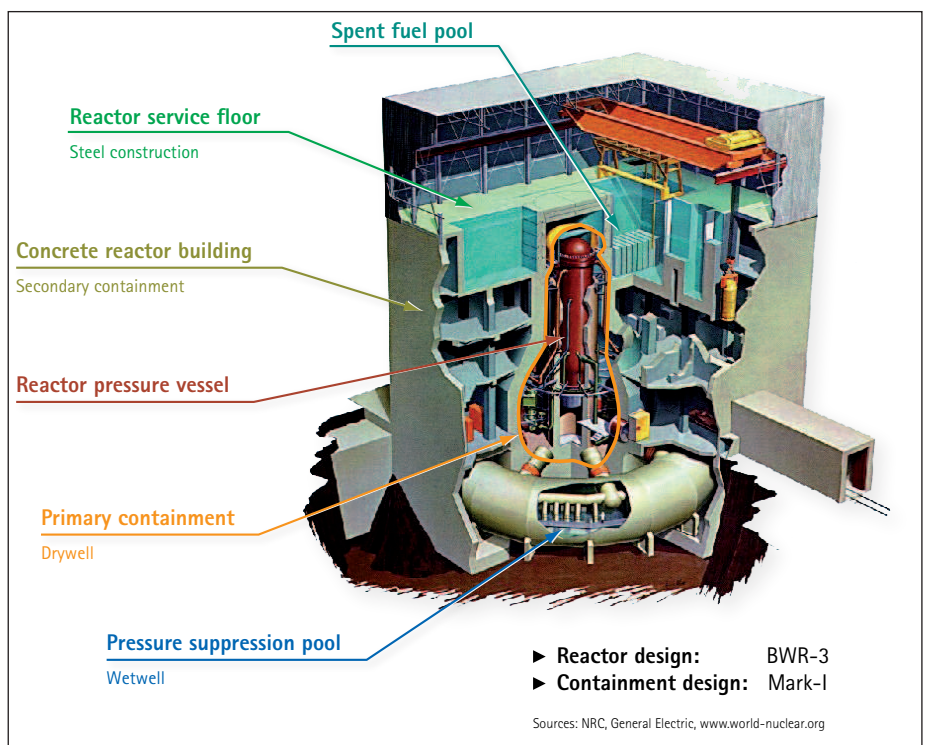
Figure 3 shows unit 1 of *Fukushima Daiichi* with its main safety- and protection devices (e.g. the Mark-I containment of units 1 to 5) as an example for the typical BWR design at the *Fukushima Daiichi* site which corresponds to the BWR-3-design by *General Electric (GE)*. Units 2 to 5 are of the *GE* type BWR-4 and unit 6 of the *GE* type BWR-5. The safety concept for retaining fission products is also depicted: it comprises the barriers – arranged successively – fuel, cladding tubes, (both not shown in the figure), reactor pressure vessel, primary containment (drywell) including condensation chamber (wetwell) and the external reactor building made of reinforced concrete or steel structures (confinement or secondary containment). The pool for storing spent fuel is located in the upper part of the reactor building, however, inside the secondary containment. In this pool, the

Fig. 3. BWR design of the Fukushima Daiichi unit 1; BWR-3 with Mark-I containment. The containment is characterised by the torus-shaped pressure relief system in the lower part of the reactor building.

spent fuel elements (FE) have to be stored intermediately and cooled to remove the decay heat³ that is still being produced. The storage basins for the reactor vessel head, moisture separator and steam dryer are also located in that area. The design basis of the structures for dynamic loads corresponded to an earthquake of magnitude 8.2.
