PROPERTY INSPECTION REPORT

**12345 Main Street
Fairfax, VA 22030**

Prepared by: My EstatePro Inspector

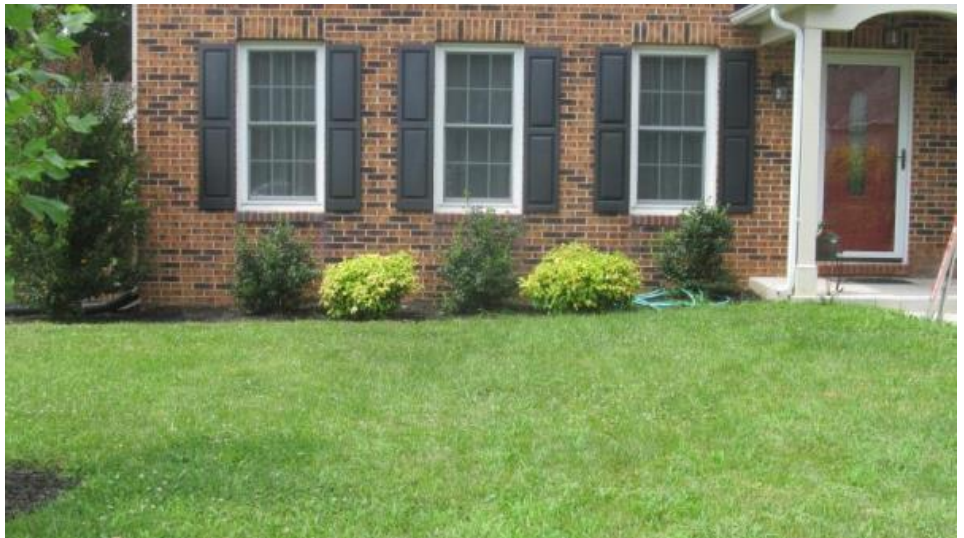
3.4 FOUNDATION DRAINAGE:

Reverse or Marginal grade noted. Grading should be altered or underground drainage installed in order to lead water away from the foundation. Locations include but may not be limited to: rear front and sides.

To aid in keeping moisture away from the foundation, it is recommended that the gutters and downspouts are kept clean and free of debris and that downspouts and a combination of splash blocks, extensions or underground drainage be employed to lead water away from the foundation to avoid water intrusion.

It is important that positive drainage be maintained at least 6' away from the foundation at all locations. Maintain a 6" slope over the first 10' from the foundation.

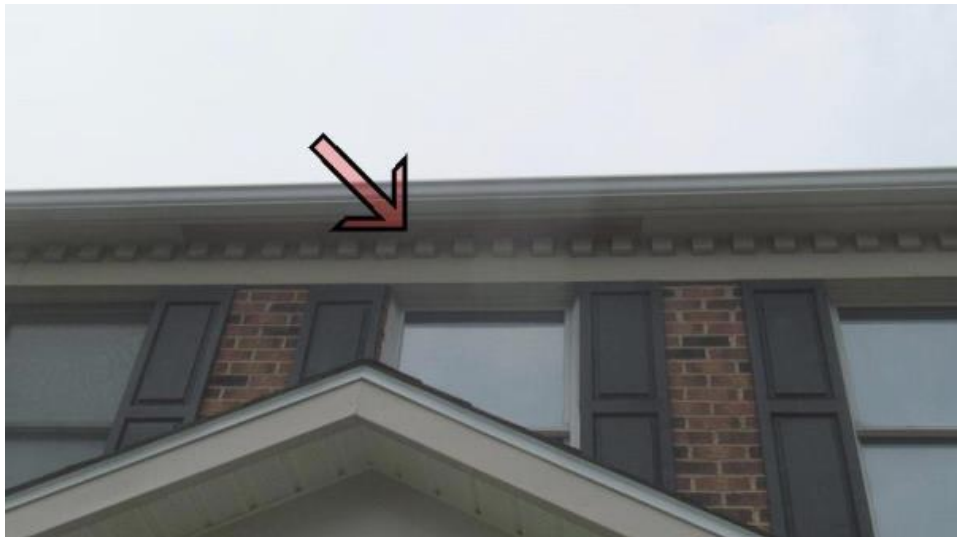
Areas of the trim were found to be unpainted. Recommend painting the soffit at the front and the trim at the garage door opening to preserve the wood and prevent deterioration.

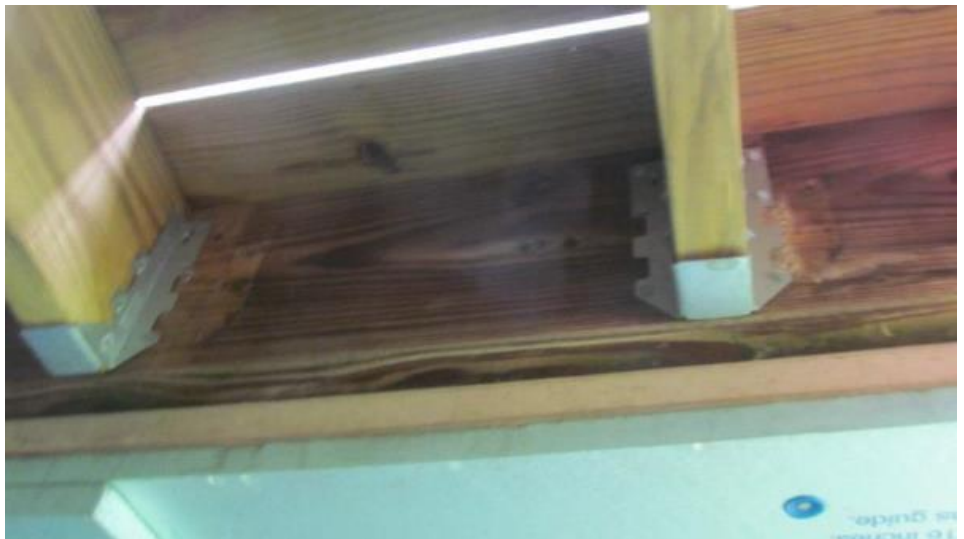
The framing around the bay window or chimney is not in accordance with the standard deck detail calling for a double header frame. Update for increased safety. This portion of the deck is only nailed to the house.

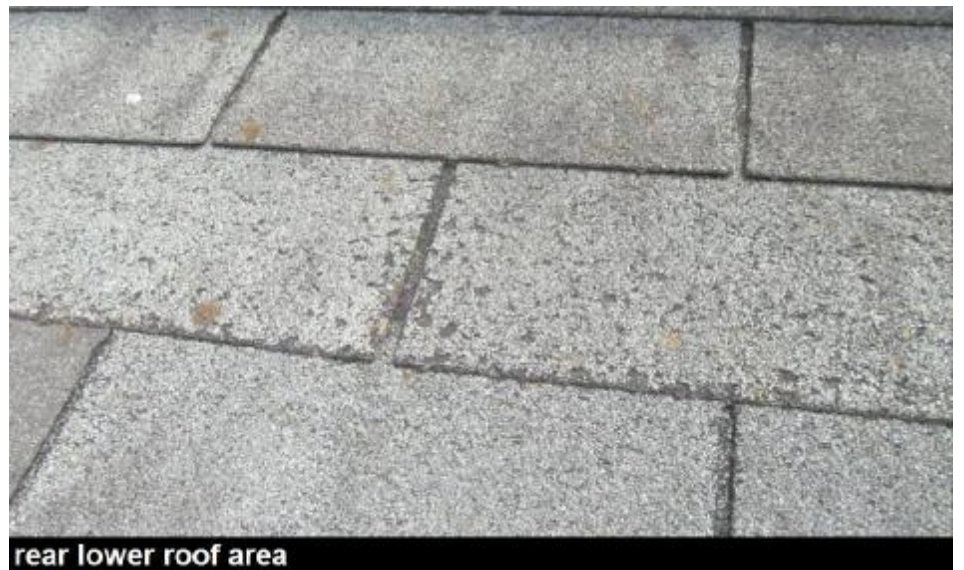
The rear roof areas are weathering faster than the front.

Some minor damage noted.

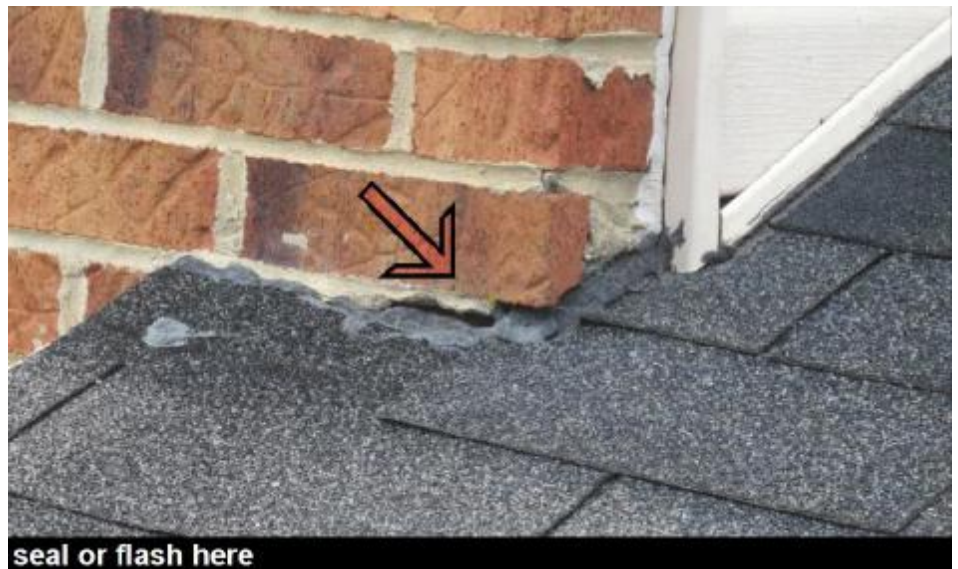
Usually a metal flashing is installed where the garage roof attaches to the brick front. Caulk or add flashing to seal the area.

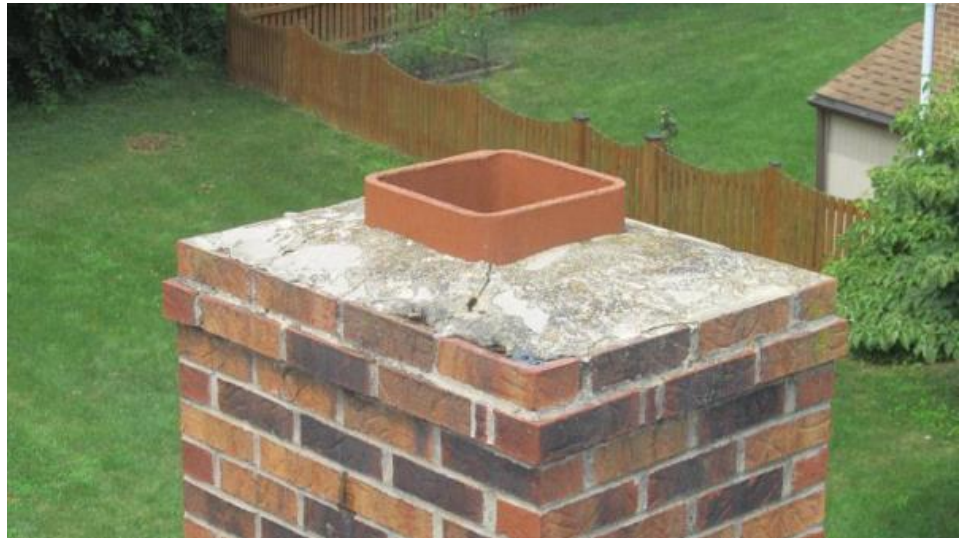
5.20 CHIMNEY CROWN:

A mortar chimney crown is installed. Monitor the crown every few years for cracks which typically appear. These cracks can easily be repaired or caulked. Thin or flat crown noted. They usually start at about 2" thick and wear over time. This crown is thin as viewed from the ground and should be further reviewed by a qualified contractor for repair needs.

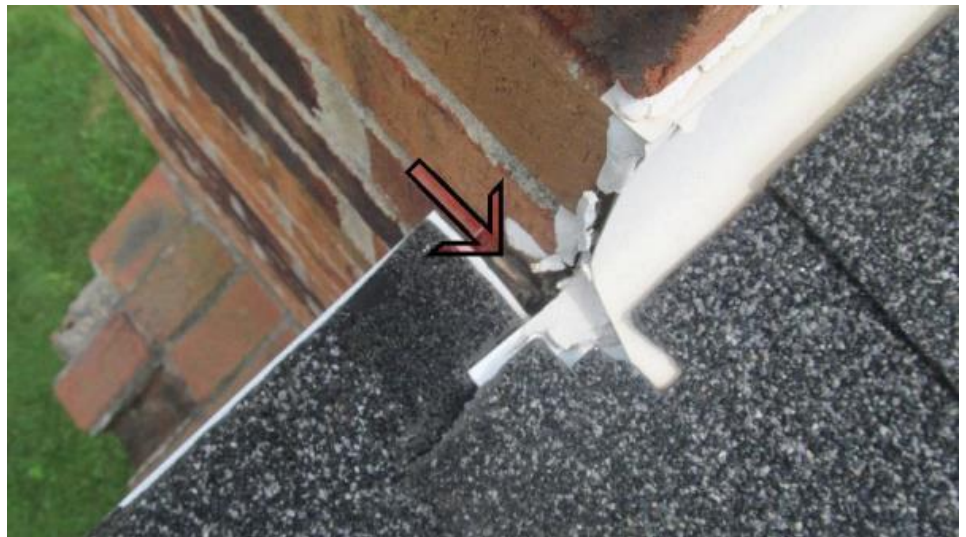
The following conditions were noted: **The chimney/roof joint shows deferred maintenance separation cracks. Recommend sealing with the appropriate sealant.**

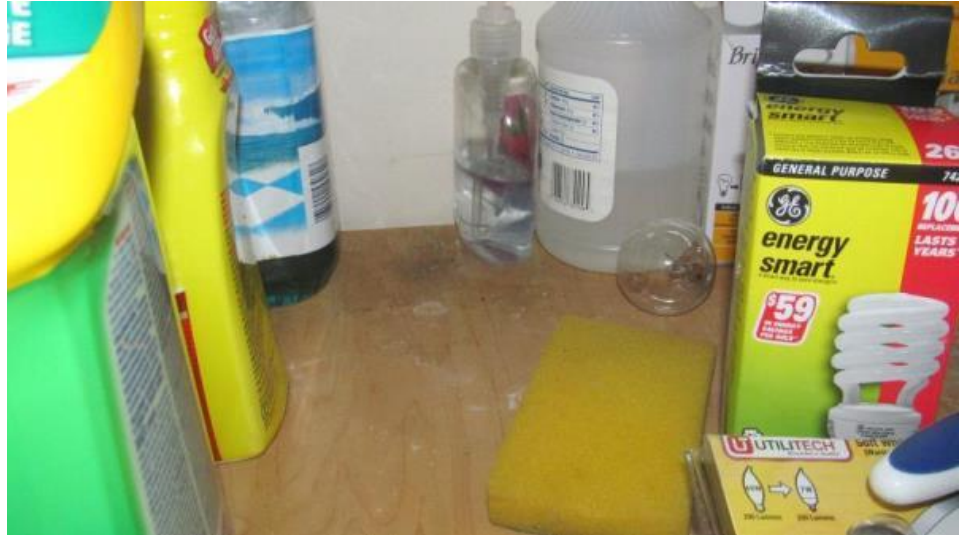
There is evidence of a past leak under the sink. Monitor.

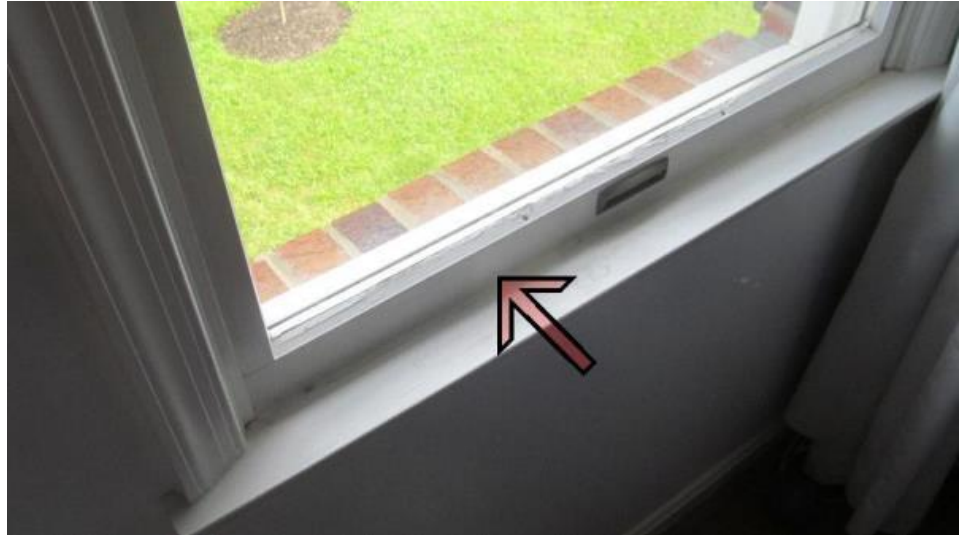
There are cracks or small holes in the window pane(s). Locations include: 2 sashes in the dining room, two in the master bedroom.

Some emergency exit windows are caulked shut in the bedrooms. This is a safety hazard and should be repaired now. Repair and re-test.

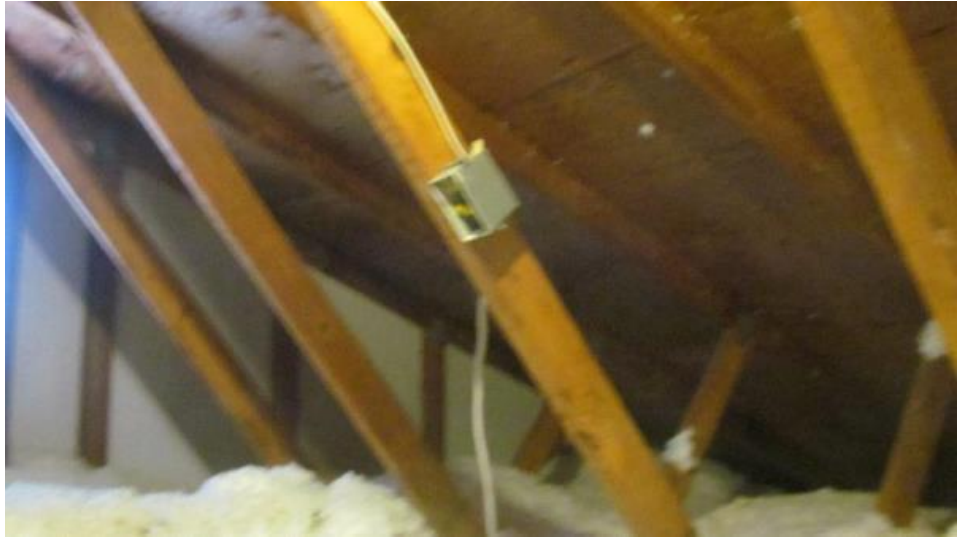
The electrical junction box does not have a cover and the wires are exposed. This condition may be easily corrected with the installation of an inexpensive cover.

Some of the electrical connections are not properly installed in the safety of the electrical boxes as required. Repair at the attic fan and verify the fan thermostat is working and the fan functions as intended.

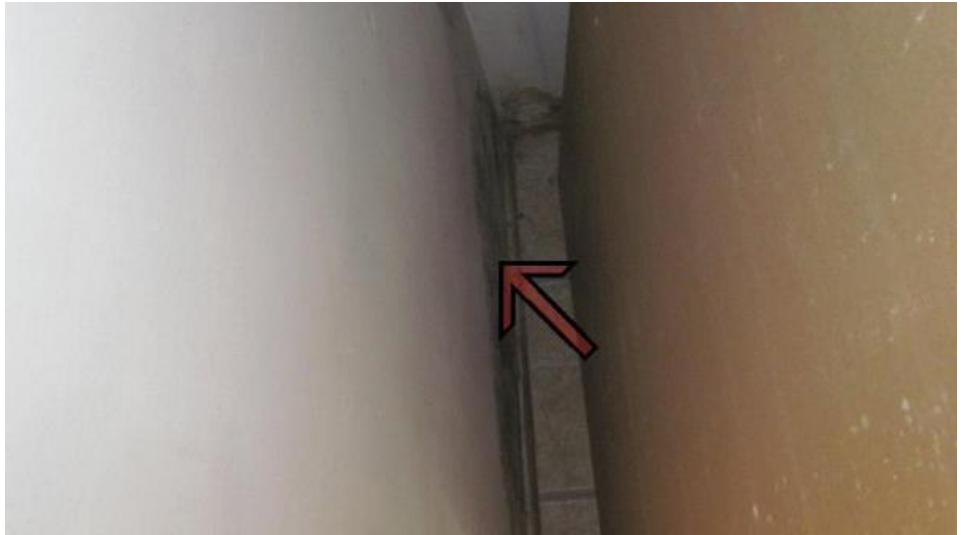
Evidence of supply pipe leaks. Water is leaking from the basement cold water shut off valve for the old washer hook up. Repair the leak and replace the drywall in the cove. it will be moldy on the back side.
