PROPERTY INSPECTION REPORT

**12345 Main Street
Fairfax, VA 22030**

**This Report is the Exclusive Property of:
John & Jane Doe**

Prepared by: My EstatePro Inspector

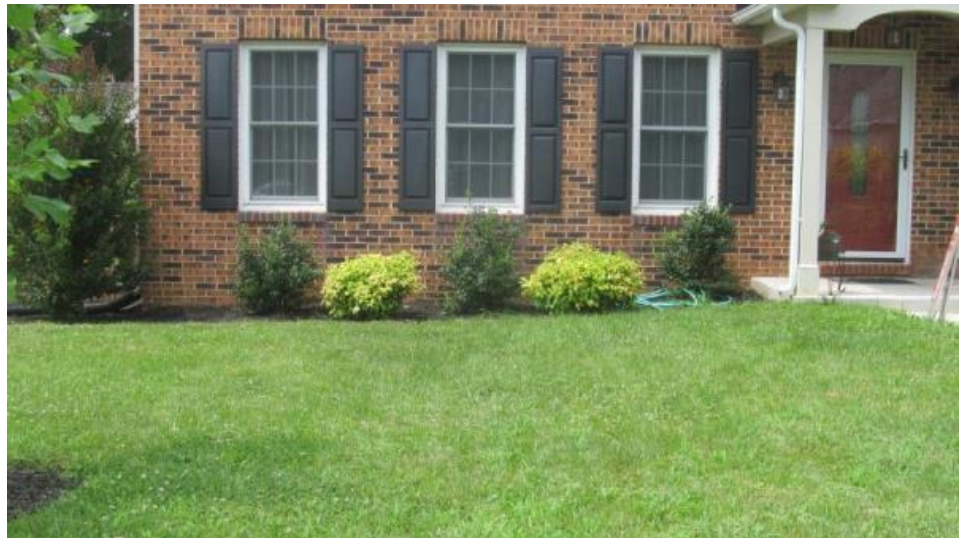
3.4 FOUNDATION DRAINAGE:

Reverse or Marginal grade noted. Grading should be altered or underground drainage installed in order to lead water away from the foundation. Locations include but may not be limited to: rear front and sides.

To aid in keeping moisture away from the foundation, it is recommended that the gutters and downspouts are kept clean and free of debris and that downspouts and a combination of splash blocks, extensions or underground drainage be employed to lead water away from the foundation to avoid water intrusion.

It is important that positive drainage be maintained at least 6' away from the foundation at all locations. Maintain a 6" slope over the first 10' from the foundation.

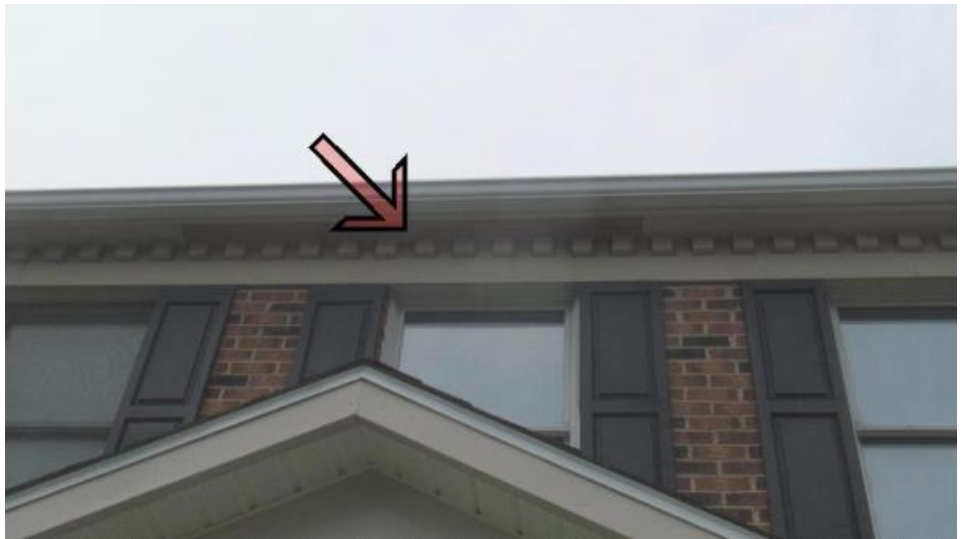
Minor localized peeling/flaking noted. Suggest painting to preserve wood.

Areas of the trim were found to be unpainted. Recommend painting the soffit at the front and the trim at the garage door opening to preserve the wood and prevent deterioration.

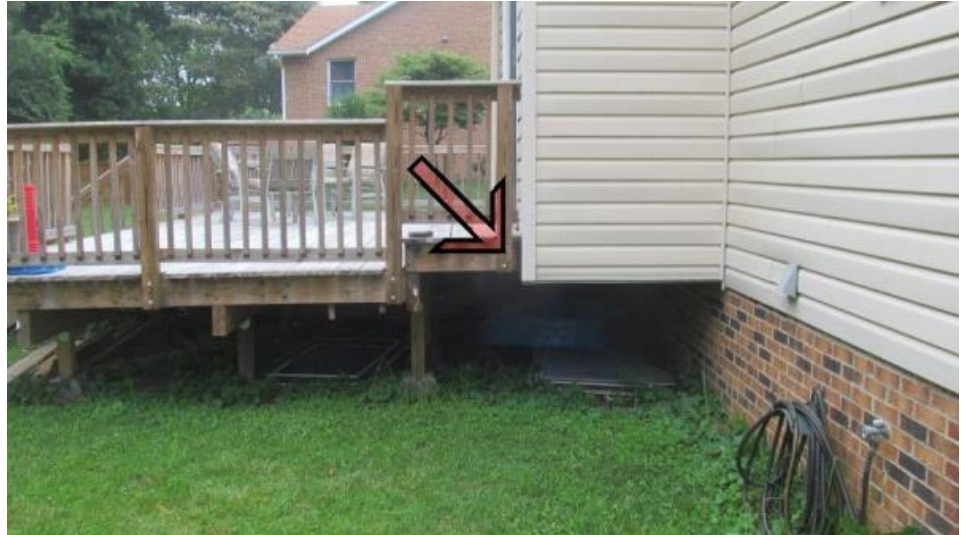
The framing around the bay window or chimney is not in accordance with the standard deck detail calling for a double header frame. Update for increased safety. This portion of the deck is only nailed to the house.

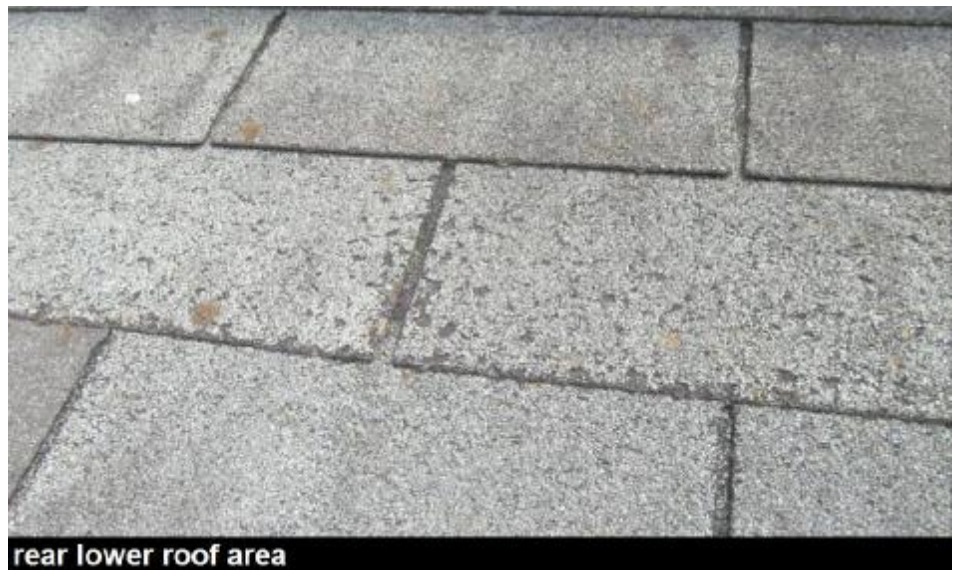
The roof is serviceable and functional. The roof appears to be in fair condition.

The rear roof areas are weathering faster than the front.

Some minor damage noted.

Typical maintenance recommended. This usually consists of a thorough inspection and the repair/replacement of damaged/missing roofing material and sealants. This maintenance will help to insure the weather tightness of the building and should be performed on a regular basis.

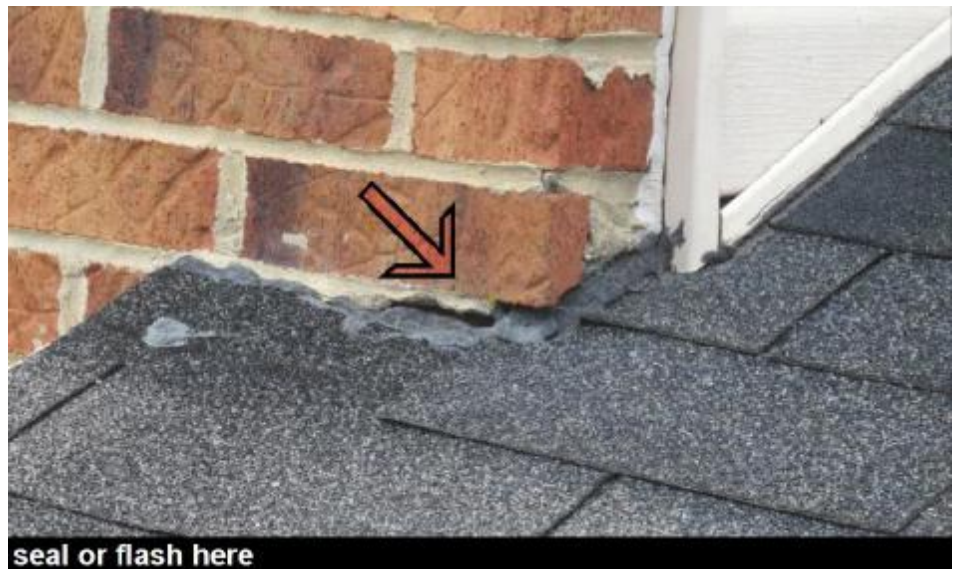
Caulking or sealant is installed along the roof and siding in some areas. If flashed properly you should not need caulk. Inquire with the seller about the need.

Usually a metal flashing is installed where the garage roof attaches to the brick front. Caulk or add flashing to seal the area.

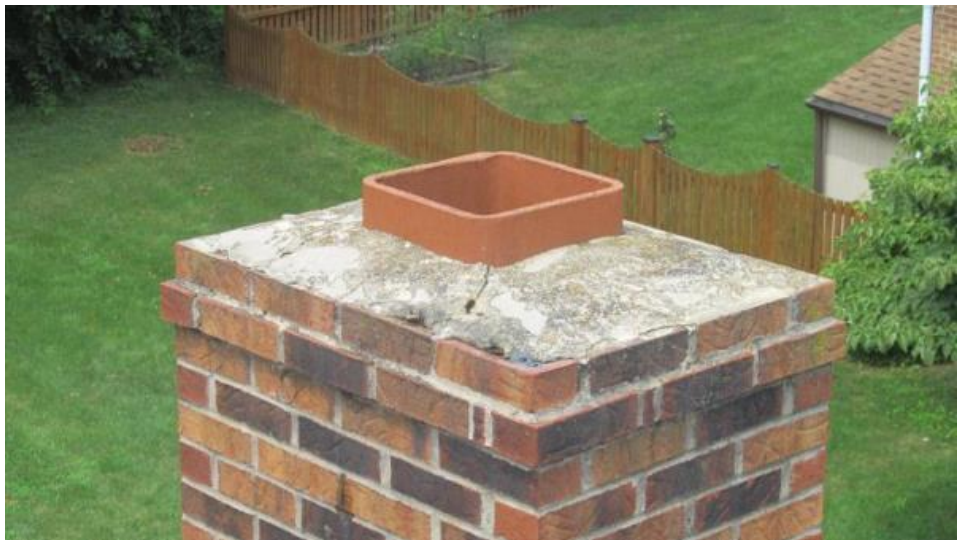
5.20 CHIMNEY CROWN:

A mortar chimney crown is installed. Monitor the crown every few years for cracks which typically appear. These cracks can easily be repaired or caulked. Thin or flat crown noted. They usually start at about 2" thick and wear over time. This crown is thin as viewed from the ground and should be further reviewed by a qualified contractor for repair needs.

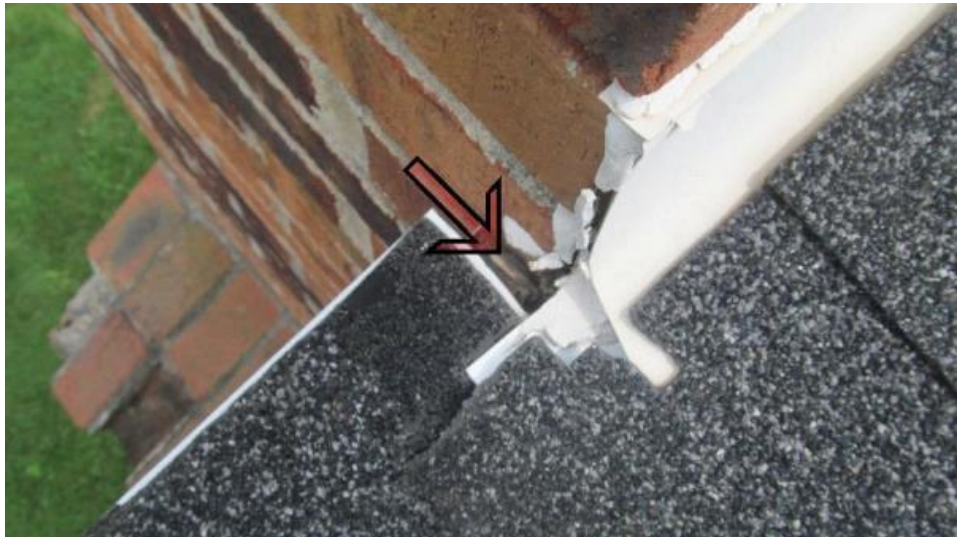
The following conditions were noted: **The chimney/roof joint shows deferred maintenance separation cracks. Recommend sealing with the appropriate sealant.**

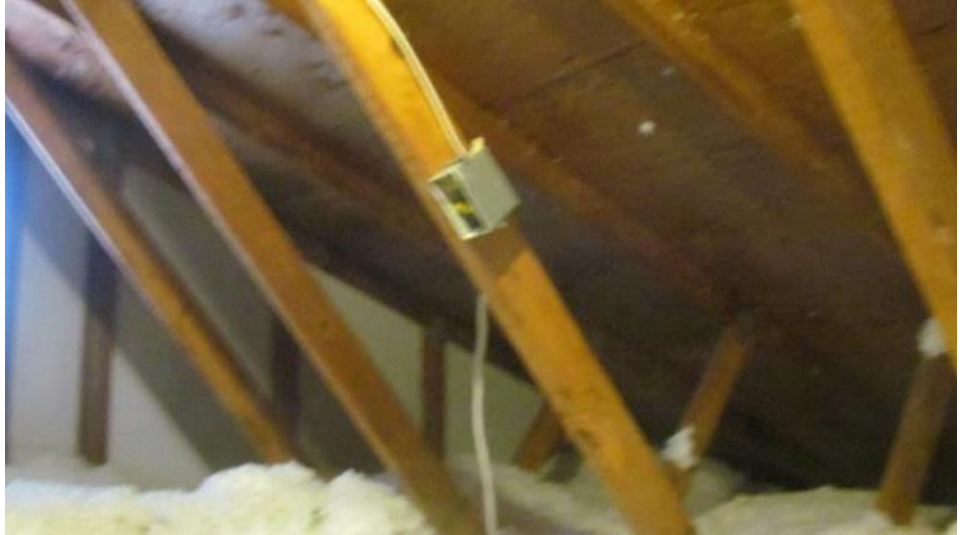
The electrical junction box does not have a cover and the wires are exposed. This condition may be easily corrected with the installation of an inexpensive cover.

Some of the electrical connections are not properly installed in the safety of the electrical boxes as required. Repair at the attic fan and verify the fan thermostat is working and the fan functions as intended.
