-- PRINDLE LAKE DAM --

PHASE I

INSPECTION / EVALUATION REPORT

Date of Inspection: JUNE 6, 2008

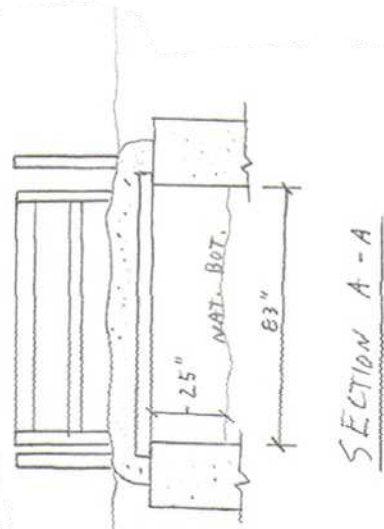
FIGURE 2. SITE SKETCH

CUT TIMBER PLACED @ APPARENT OLD SPILLWAY OUTLET

- a = SEEPAGE, ROUST
- b = SEEPAGE, 1/2 GPM FLOW
- c = SEEPAGE, CLEAR

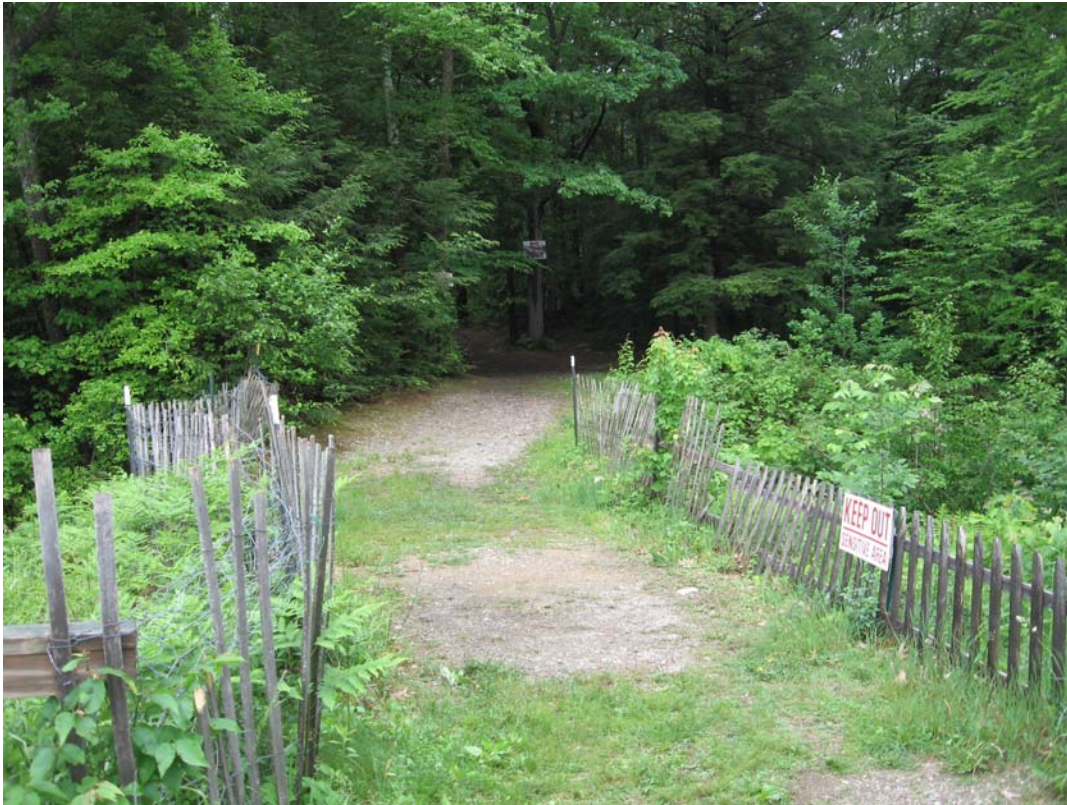
Photo 001. Standing on spillway looking at left abutment

Some trees and shrubs were present within 25 feet of the abutments (Photos 001 and 008).

The crest exhibits minor erosion near the abutments and the spillway (Photo 001) apparently due to recreational foot traffic.
