PROPERTY INSPECTION REPORT

Concerning: 1234 Street Dallas, TX 75219
(Address or Other Identification of Inspected Property)

By: Michael Craycraft TREC License #21088 09/21/2014
(Name and License Number of Inspector) (Date)

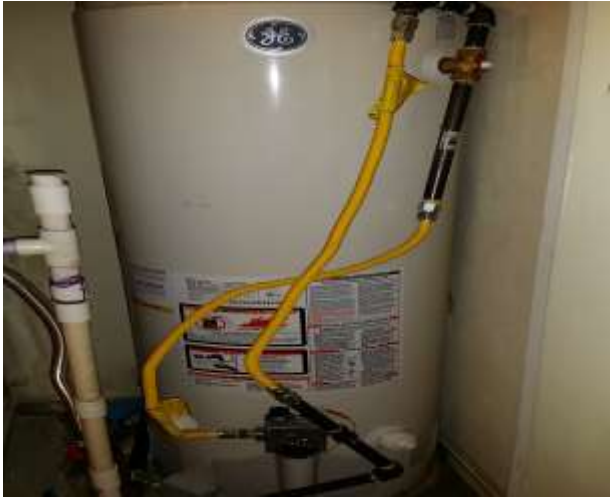
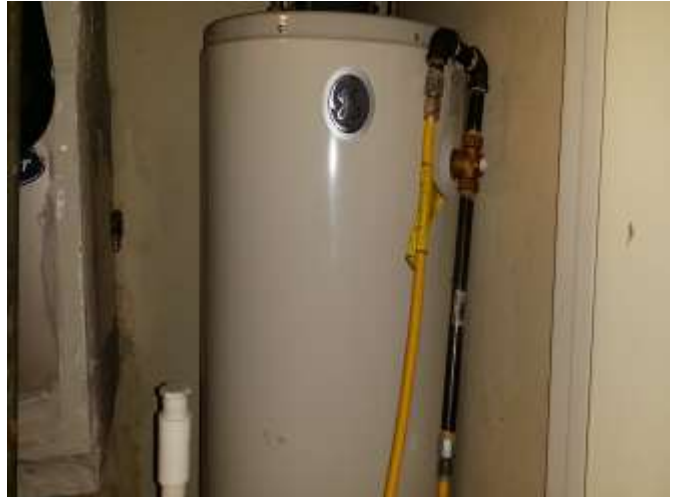
this into consideration when noting the manufacture date listed above for the unit at this property.

It is highly recommended that a licensed plumber further evaluate the water heating equipment and make all necessary repairs/replacements.
