MARINE ACCIDENT REPORT

SS EDMUND FITZGERALD

SINKING IN LAKE SUPERIOR

REPORT NUMBER: NTSB-MAR-78-3

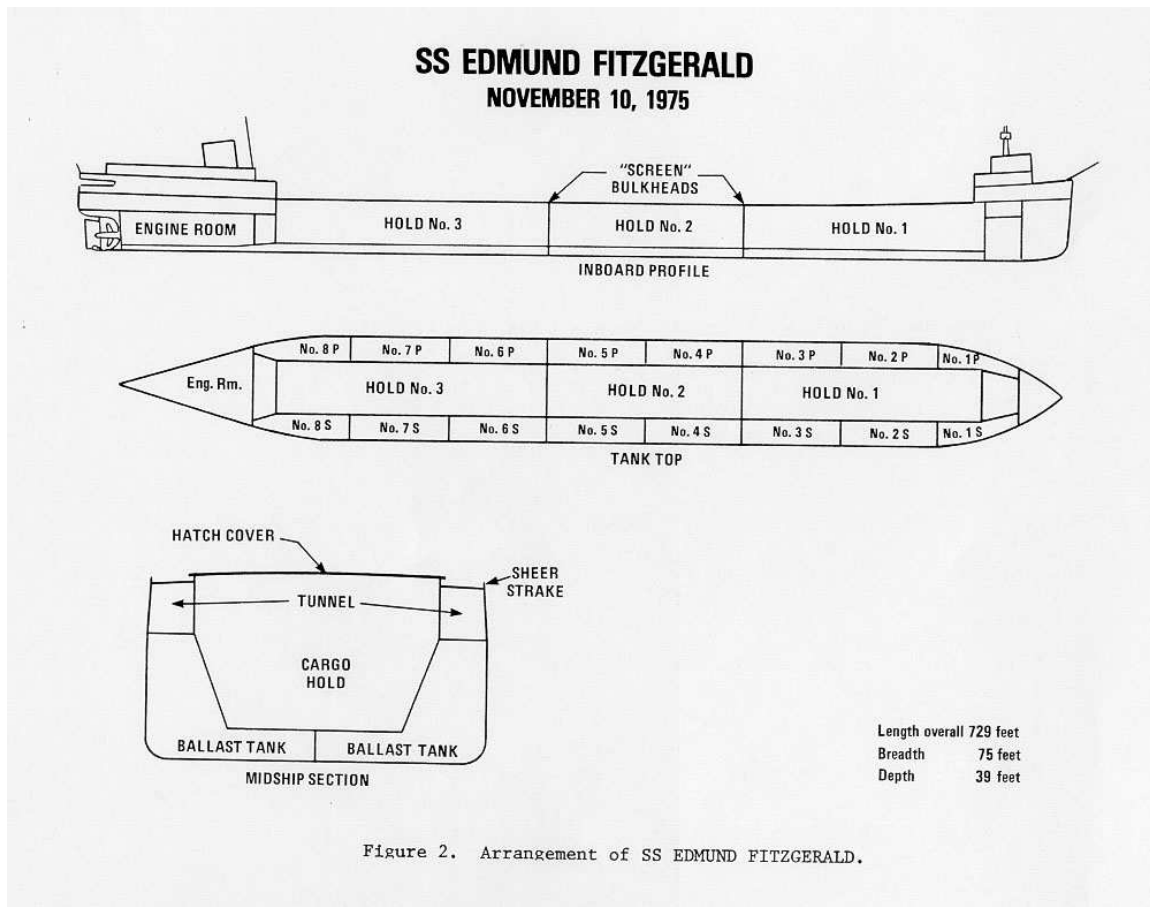
Figure 2: Arrangement

The FITZGERALD was a conventional "straightdecker" Great Lakes bulk cargo vessel. (See figure 2.) It was 729 feet long, 75 feet in breadth, 39 feet in depth, 13,632 gross tons, and 8,686 net tons. It was propelled by a 7,500-hp, steam turbine and was built as Hull 301 at Great Lakes Engineering Works, River Rouge, Michigan, in 1958. The vessel was owned by Northeastern Mutual Life Insurance Company and operated by the Columbia Transportation Division of the Oglebay Norton Company.

The vessel had a 860,950-cubic-foot cargo hold divided by two nonwatertight transverse "screen" bulkheads. Outboard and below the cargo hold were eight ballast tanks divided at the centerline into port and starboard tanks. (See figure 2.) The forward deckhouse contained the pilot house and accommodations for the deck crew. The engine room was located aft, above which were the rest of the accommodations and the crew's messing facilities. Below the weather deck and above the ballast tanks were two tunnels, one port and one starboard, used for access between the accommodation areas during adverse weather. The sheer strake extended 15 3/8 inches above the weather deck at side and was connected to the stringer plate by a riveted gunwale bar.

Figure 2. Arrangement of SS EDMUND FITZGERALD.

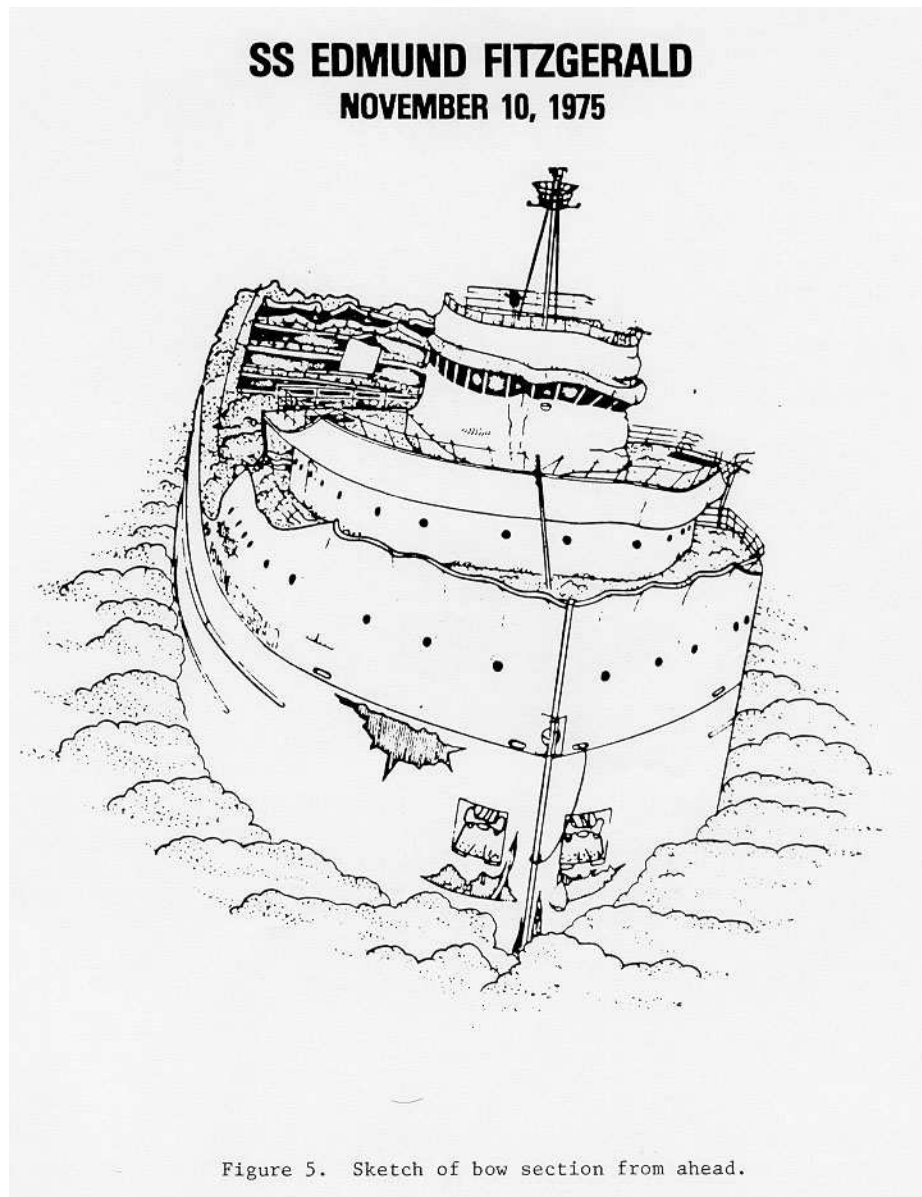
Figure 5: Sketch of bow section from ahead

The results of the CURV III visual survey and three earlier side—scan sonar surveys were assembled and reviewed by Seaward, Inc., which prepared a sketch of the wreckage (see figure 3), and artists' conceptions of the wreckage from several viewpoints. (See figures 4 to 8.)
