Insight Property Inspections

Property Inspection Report

10101 Common Avenue, Las Vegas, NV 89178
Inspection prepared for: All Sampled
Real Estate Agent: Tony Dacloser - Real Estate Agent of Las Vegas

Date of Inspection: 10/22/2014 Time: 9 am
Age of Home: 10 Years Size: 2,020 square feet
Weather: Mostly Sunny 80 degrees
Inspection fee \$275 paid by credit card

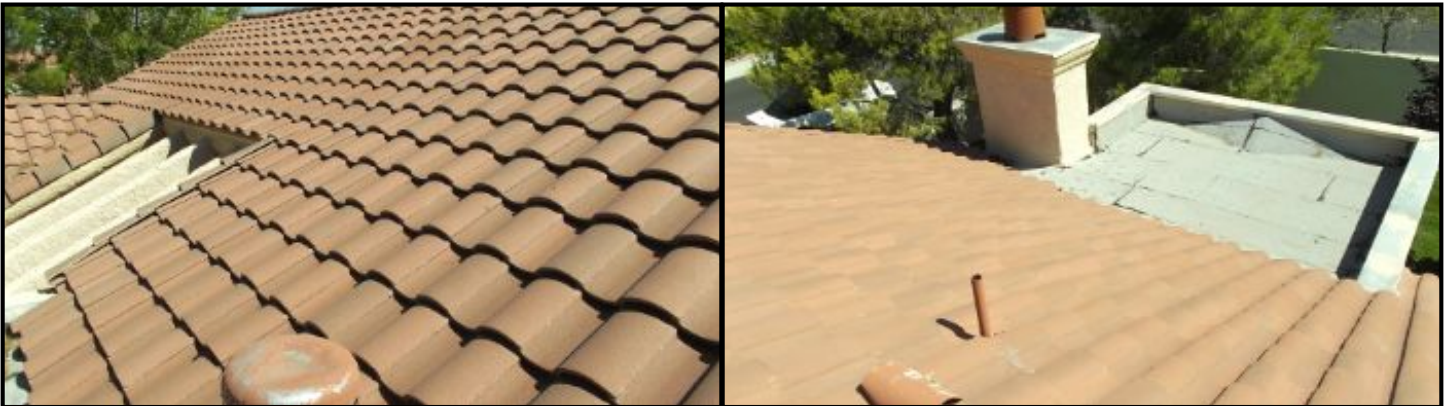
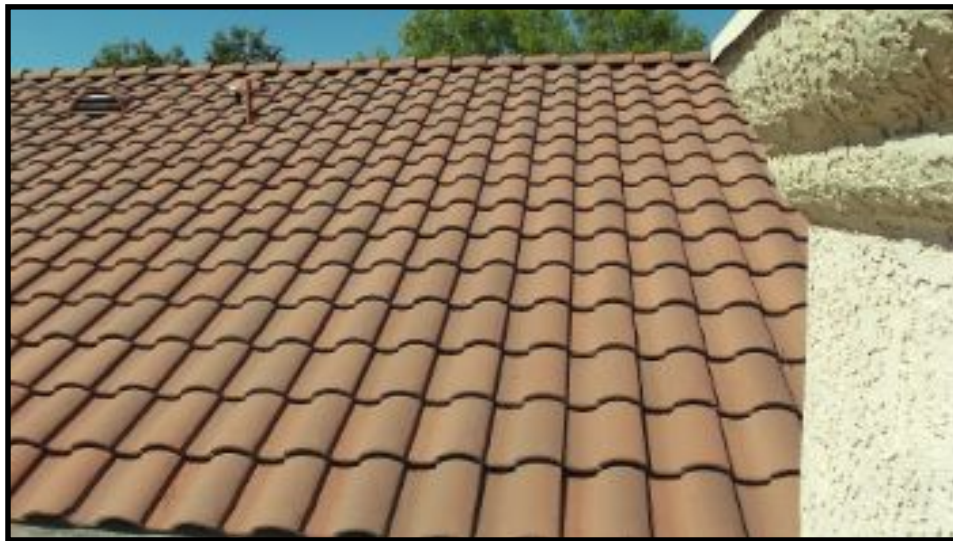
1. Roof Condition

- Normal wear for age of roof. No major structural roofing issues observed during this inspection.

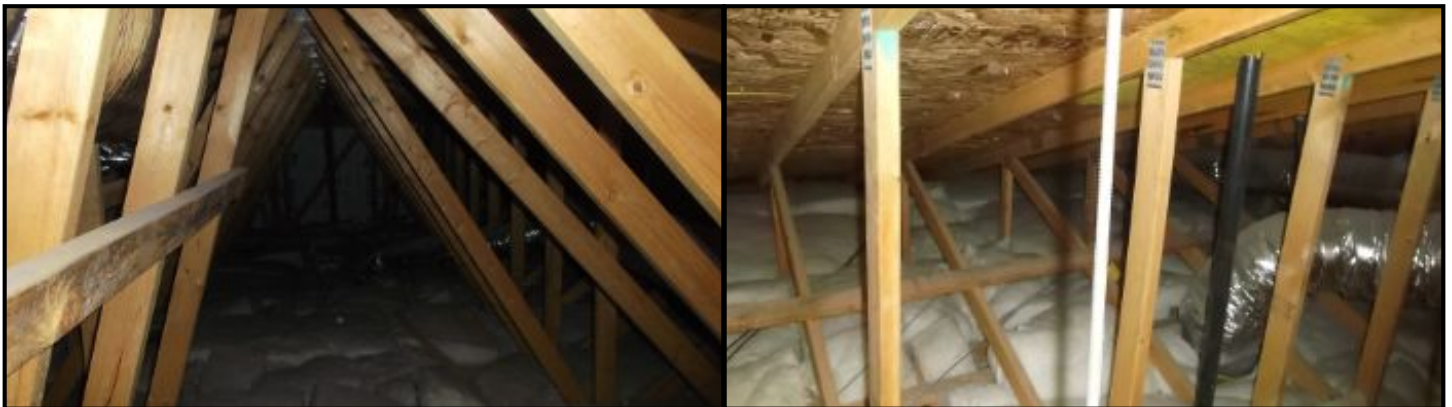
- Manufactured truss work and other accessible framing components observed. The accessible areas of the attic area were reviewed. No structural anomalies observed during this inspection. Refer to photographs. These are representative photos and are provided for informational purposes.

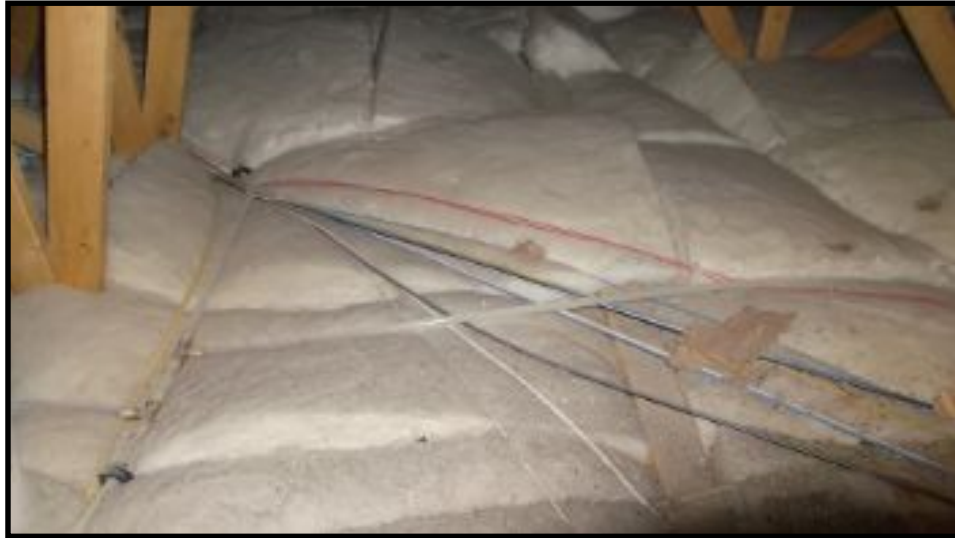
3. Insulation Condition

• Insulation thickness and coverage observed. The accessible areas of the attic were reviewed for adequate and proper insulation coverage. The insulation appears intact and in good condition. The photograph depicted is a representative photo of this finding. This is a positive finding.

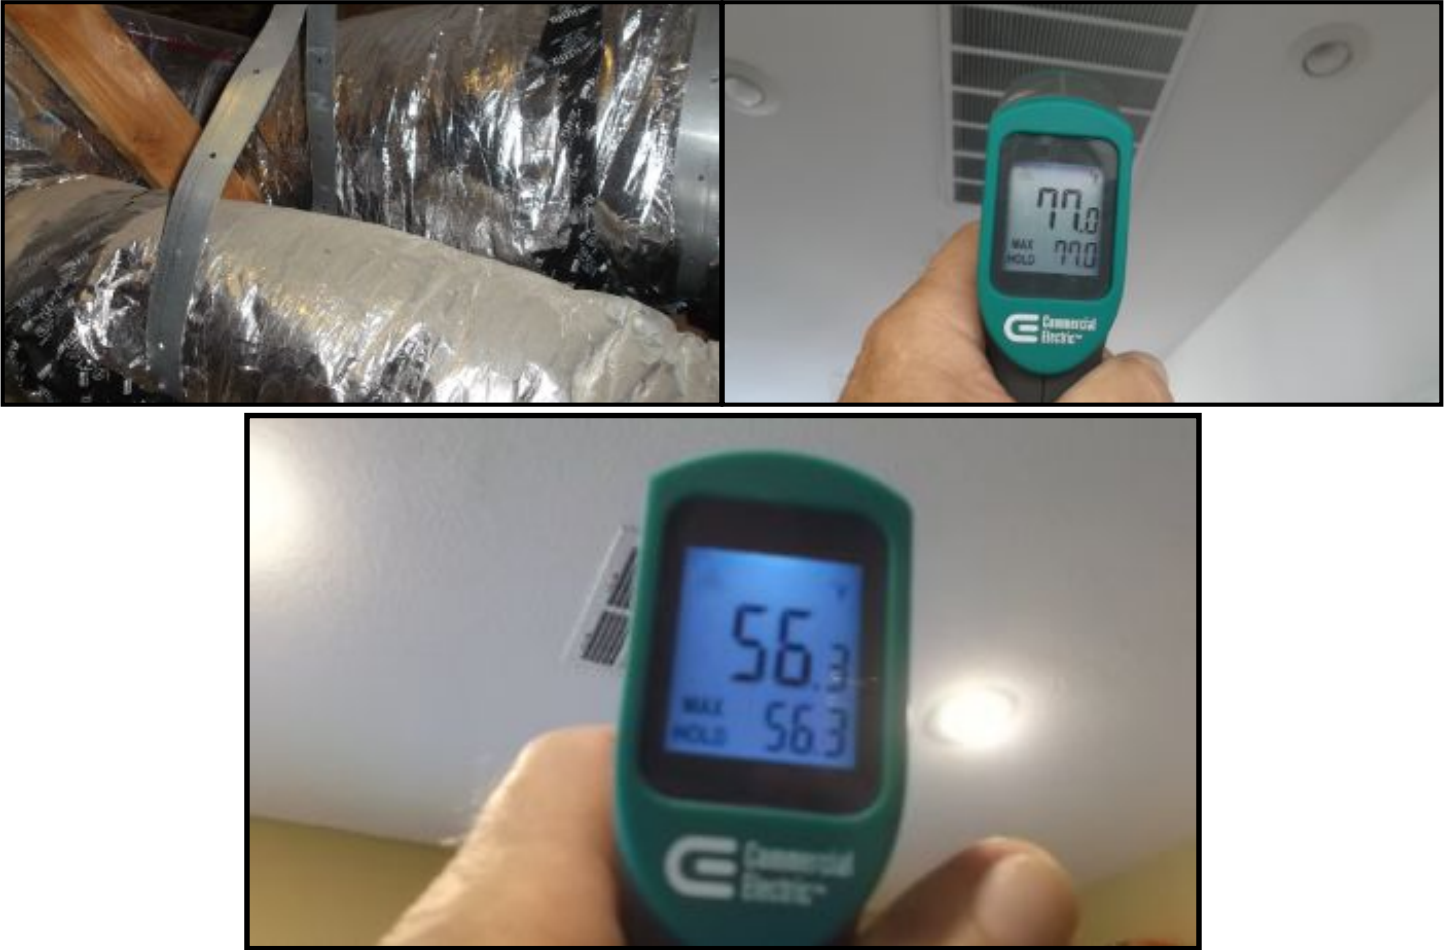
2. Air Supply

- The return air supply system appears to be in good condition. The accessible portions of the HVAC ducting system were reviewed for proper installation and integrity and no anomalies were observed.
- Refer to the photograph for detailed view.
- The temperature inside the home was lowered by 4 degrees during this inspection. Operation of HVAC system appears normal. Air conditioning differential testing satisfactory. The temperature of the air at the HVAC return (filter) was compared to the temperature of the closest outflow register. Refer to the photographs for sample temperature readings. Manufacturers recommend between 15 and 21 degrees difference between the readings. The indications observed on the inspectors laser thermometer show the differential observed on this unit to be 21 degrees and well within allotted parameters.

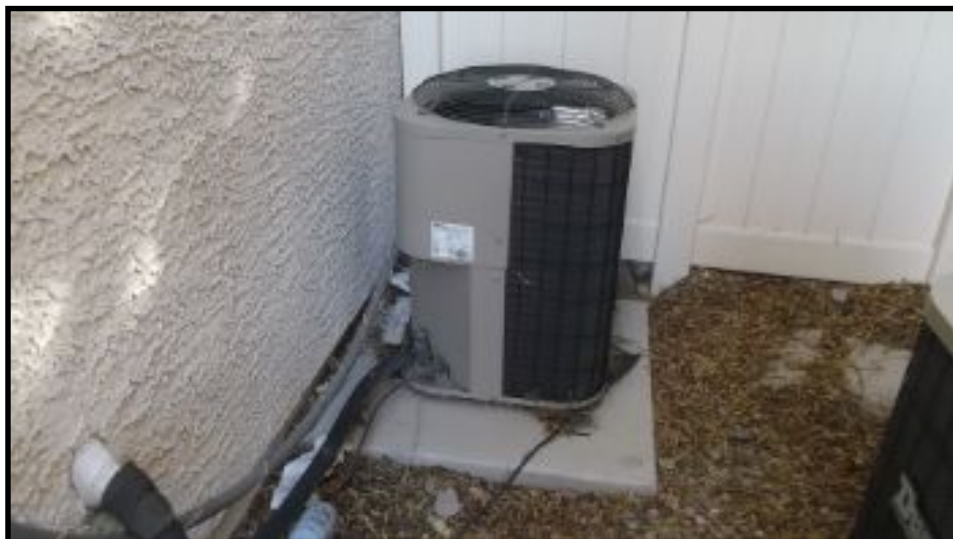
6. Refrigerant Lines

- Deteriorated insulation noted at refrigerant line on air conditioning condenser/compressor unit at the side of the home. Refer to photograph. The proper installation of this tubular foam insulation can have a significant impact on the efficiency of the unit and reduce annual cooling costs. This insulation is readily available at most home improvement stores. Wrapping the insulation with 20 mil electrical tape will help reduce deterioration of the insulation. Corrections are recommended.
- Corrective maintenance should be performed to restore the component to its proper condition.

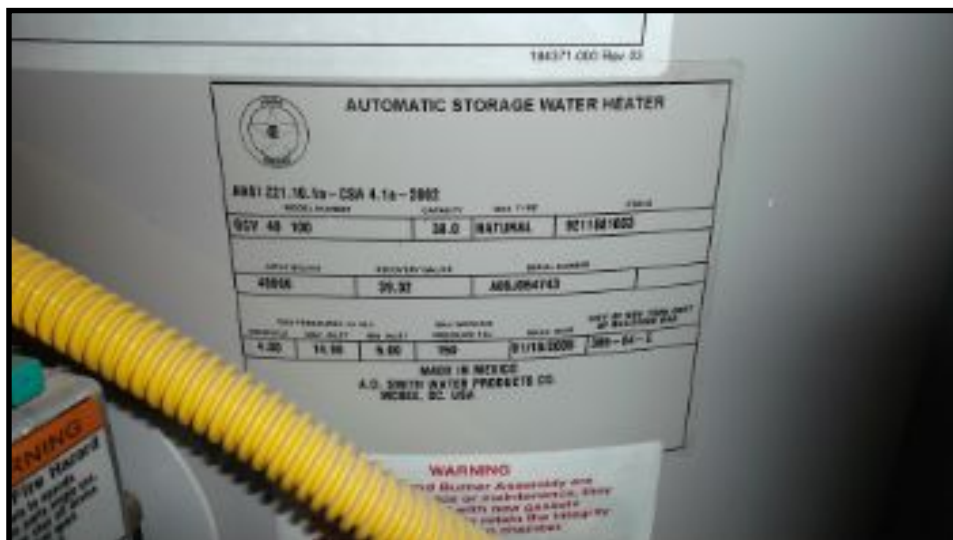
2. Water Heater Condition

- Water heater age verified. The installed water heater was manufactured January of 2006. This is the manufacture date meaning the unit was installed at a later date.
- Water temperature observed to be: 112 degree F. Recommended temp should be set at 105-120 degrees F to prevent scalding, extend water heater life, and improve energy efficiency and conservation.
- The water heater was functional. No active leaking observed at the water heater during this inspection.

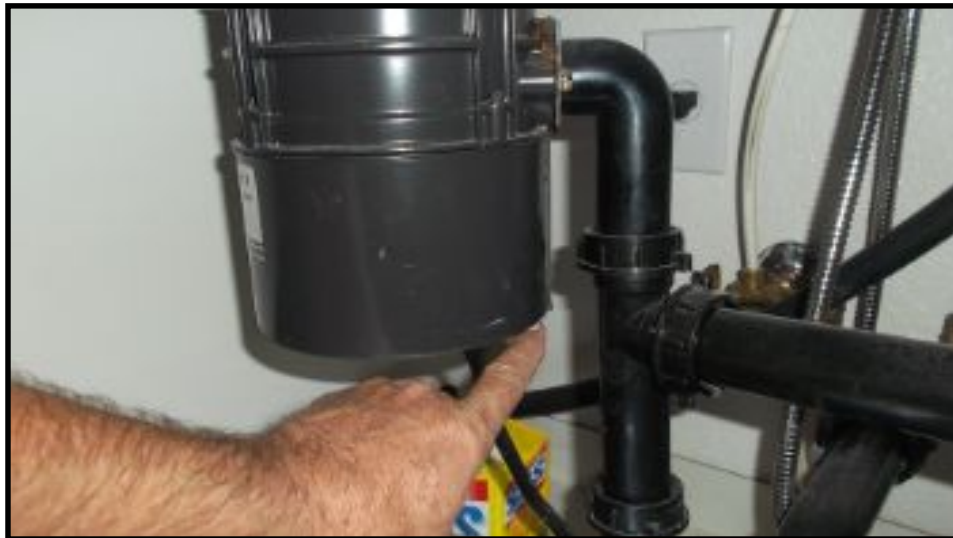
- Leakage observed at garbage disposal. The disposal is leaking at the casing. The disposal may need to be replaced.
- It is recommended that a licensed and qualified plumbing contractor review this condition and repair or replace the disposal.

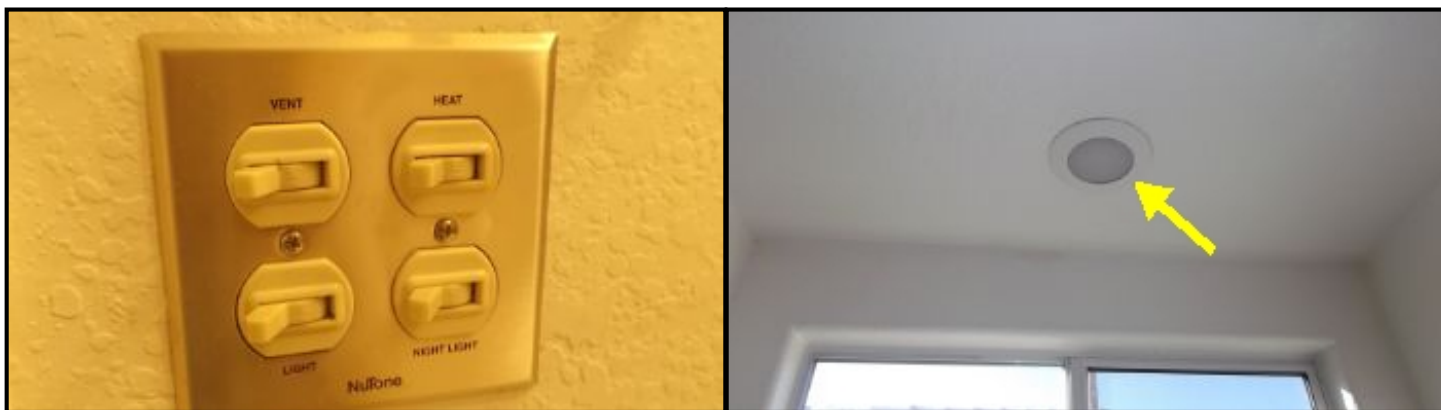
- Electrical outlets and switches functioned properly during this inspection.
- Bathroom lighting is functional.
- No major system safety or function concerns noted at time of inspection.
- Burned out bulb observed in master shower area. The inspector uses an electrical detector to help verify electricity at all accessible fixtures. There is power to the light fixture above the master shower. The bulb needs replacement. 60 watt bulb is recommended. It is recommended all lighting be verified prior to taking title to the property.

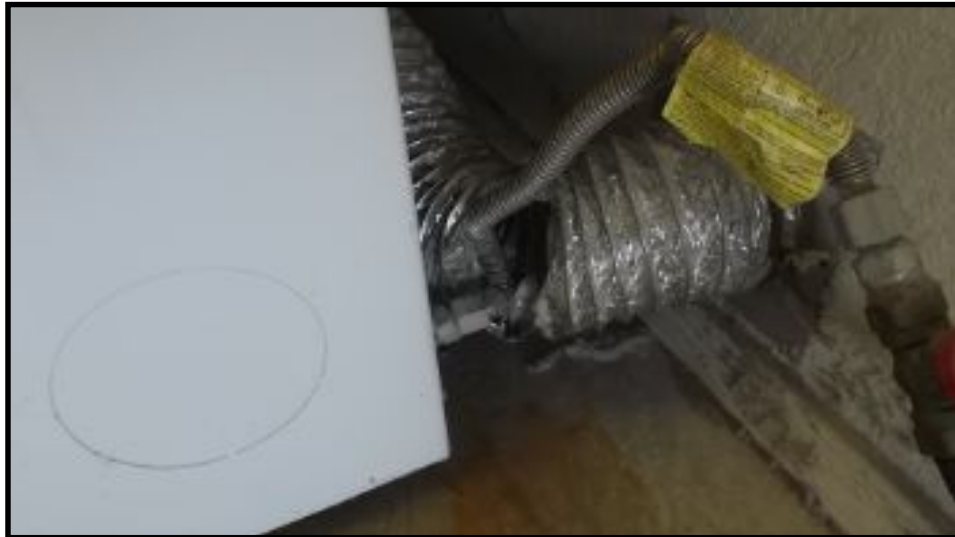
- The flex dryer vent tube is damaged and needs replacement. This condition will discharge moist air and lint into the laundry room and cause lint build up behind the dryer, which is a fire hazard. The area needs to be cleaned of excessive lint and the damaged vent replaced.
- Refer to the photograph for detailed view.
- These products are readily available at most home improvement stores.

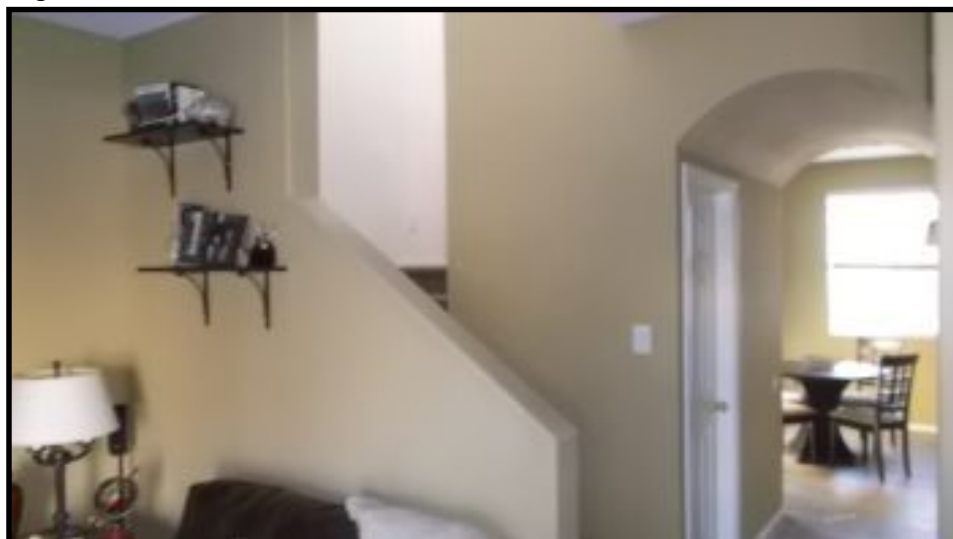
4. Wall Condition

- The walls are in good condition.

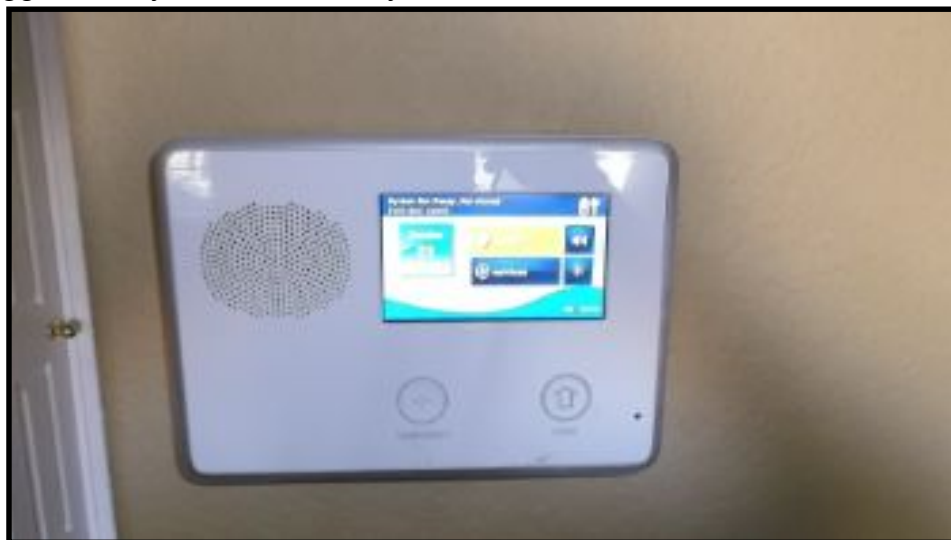
5. Electrical

- Electrical light fixtures, outlets and switches functioned properly during this inspection.
- Alarm system observed. This is a positive finding. The client is advised to research potential alarm system providers through the yellow pages or internet. Many alarm companies provide review and activation of these systems. This particular system can be accessed and controlled with a " Smart Phone ". We suggest that you review this system with the seller.

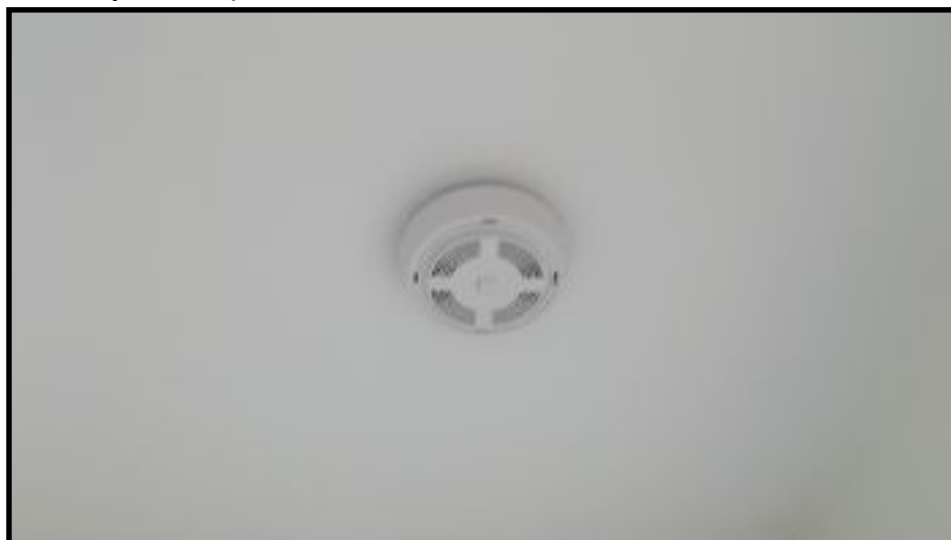
6. Smoke Detectors

- Operated when tested.
- Hard wired with battery back up.

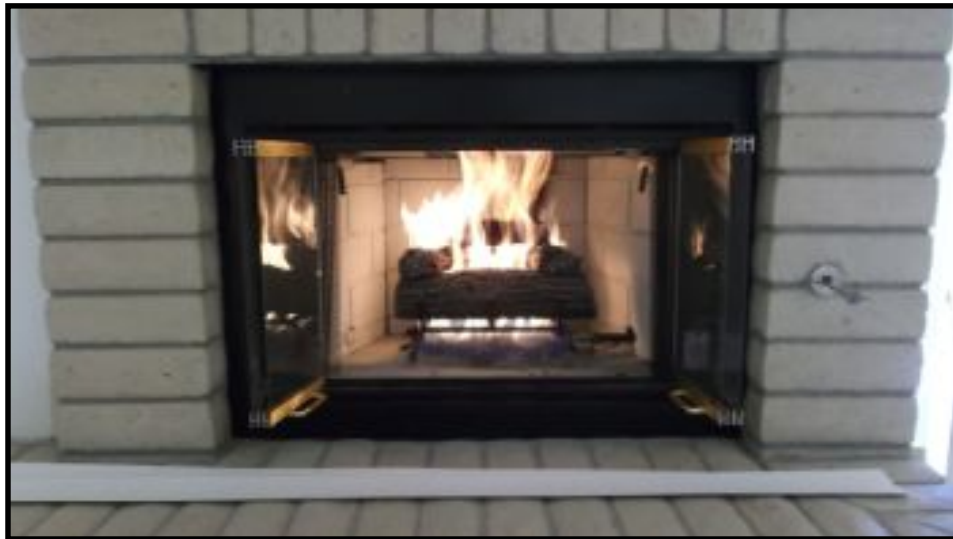
- The gas fireplace is properly installed. The damper is functioning properly and the flue piping is not obstructed. The rooftop vent cap is in place and functional. This is a positive finding.
- Manual light fireplace observed. This type of burner must be lit with a match.

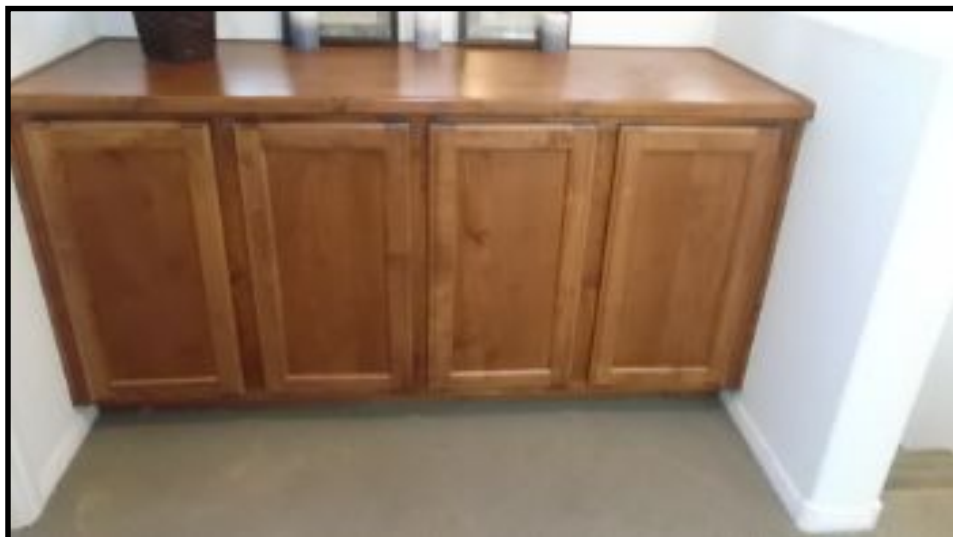
10. Cabinets

- The interior cabinetry is functional and in good condition.

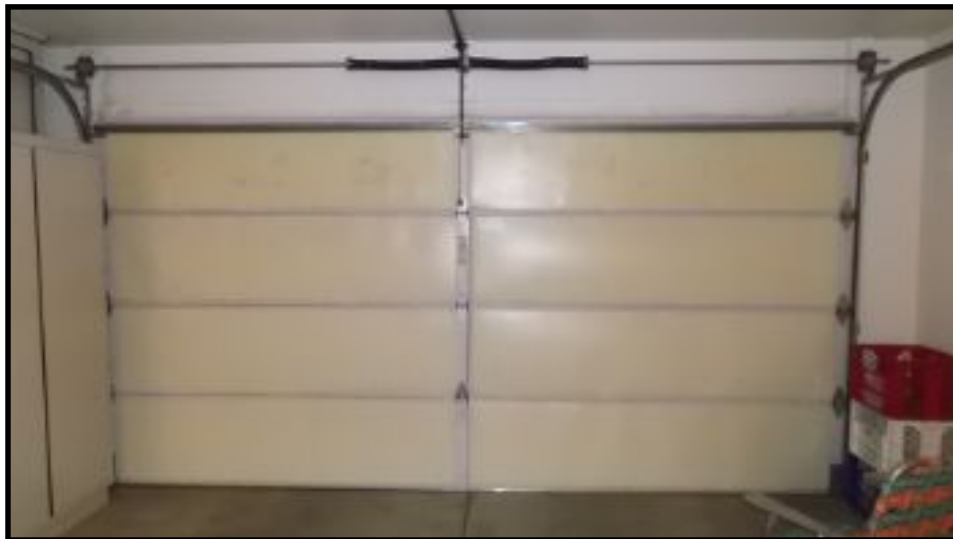
1. Garage Door Condition

- No deficiencies observed.
- Garage doors are the most frequently used door in most homes. Monitor the condition and proper operation of garage doors on a regular basis as part of an appropriate home maintenance plan.

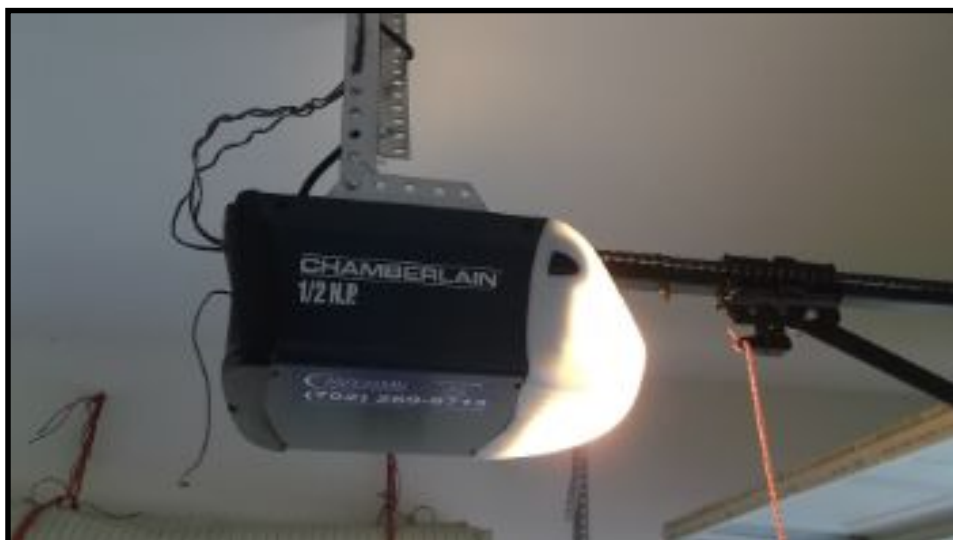
2. Garage Opener Status

- Chain drive opener noted.
- The garage door automatic opener functioned during this inspection.
- The vehicle door reversed with moderate resistance. The garage door has a pressure/tension reversing mechanism that was tested and found to be operating correctly. This deemed a positive finding.

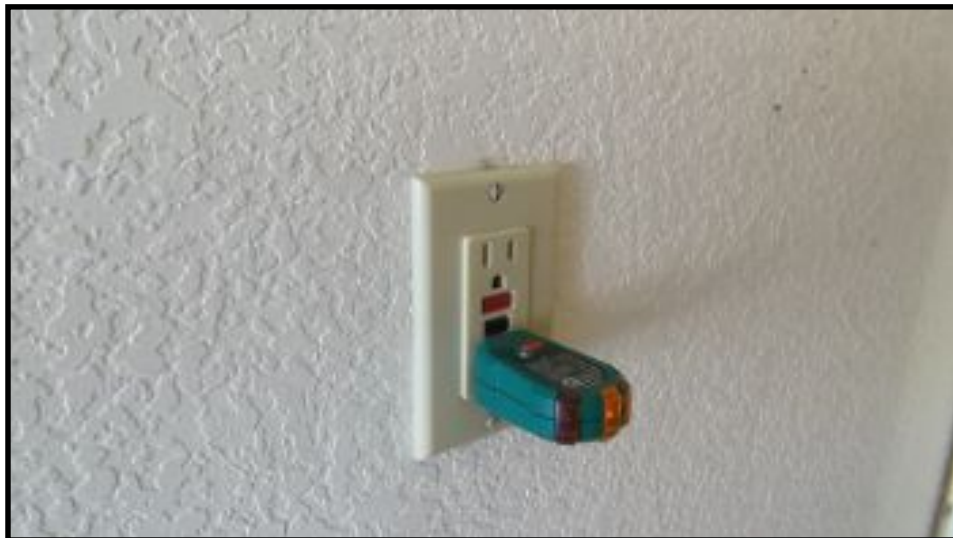
- GFCI properly located and tested. All of the non dedicated garage receptacles were verified to have GFCI protection. The reset for the receptacles is located on the front wall of the garage. This is a positive finding.

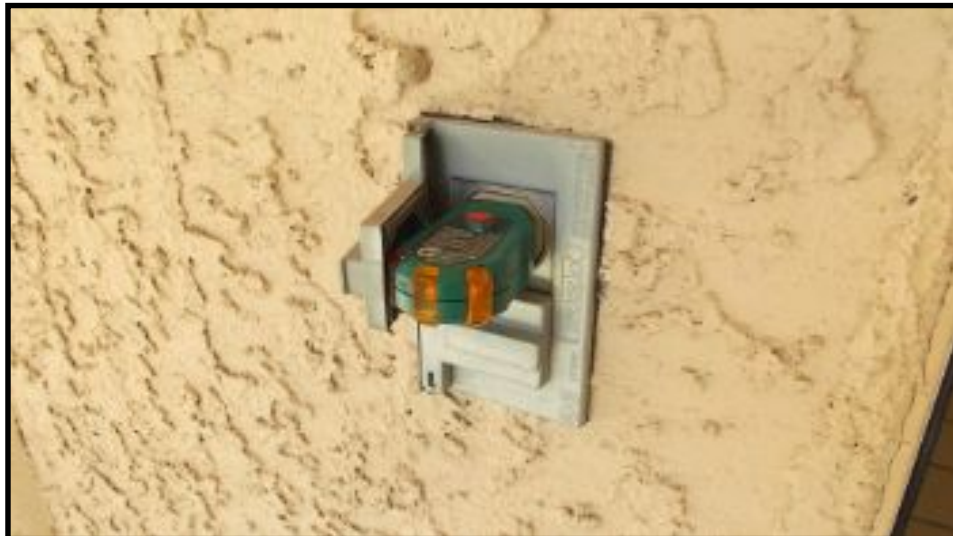
- All exterior outlets were tested and found to have GFCI protection.
- Reset for all of the exterior outlets is in the garage.

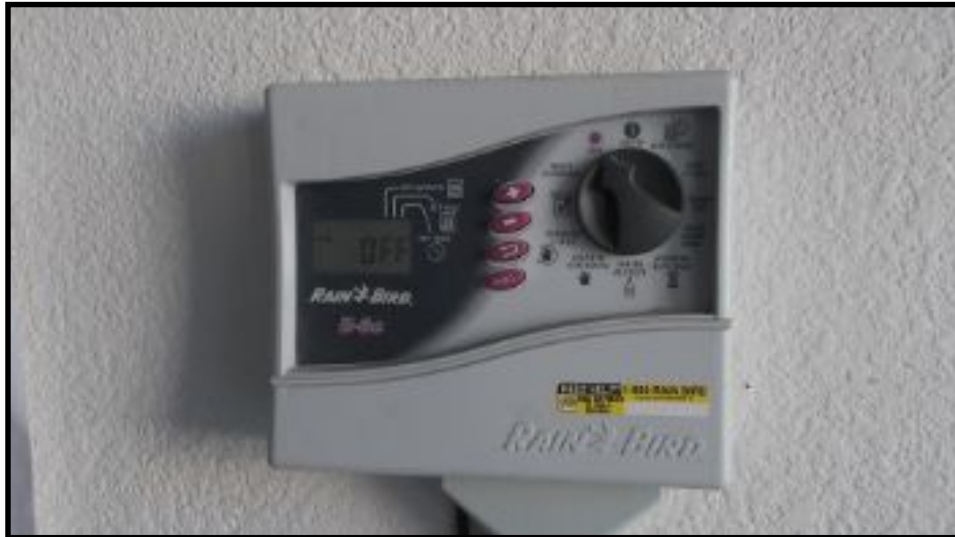
6. Sprinklers

- The sprinkler system operates with a control panel located in the garage.
- The irrigation system was functioning properly during this inspection.

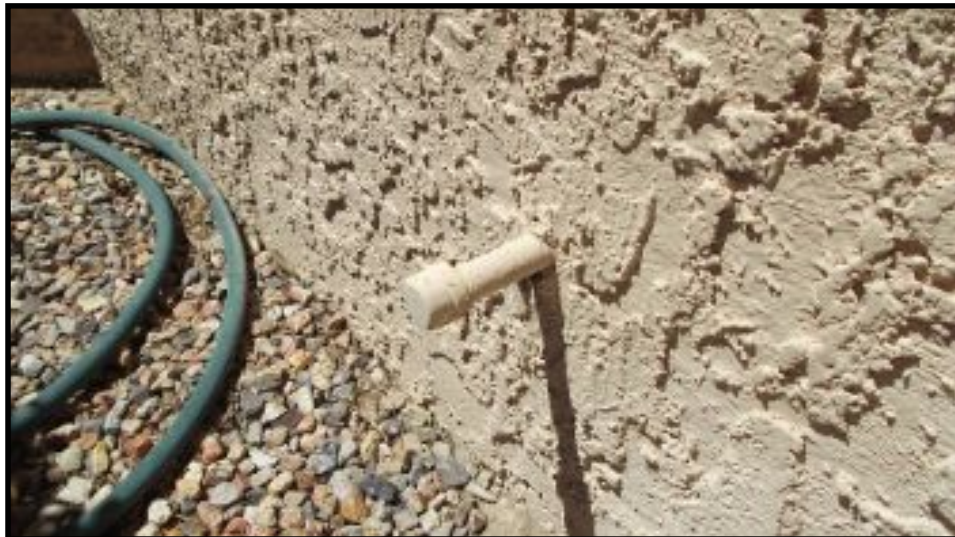
8. BBQ & Fountains

Materials: Gas stub observed at rear patio area. This considered a positive finding.
