Home Inspection Report

1000 Main St.
AnyTown, Cape Cod, MA

Prepared By: Ken Amelin

03/16/2015.

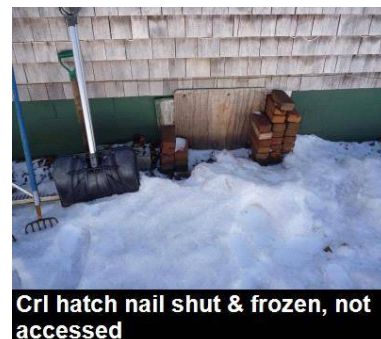
Analysis: Conditions within the crawl space are undetermined. Hidden problems could exist.

Recommendation: With the owner's permission, the sealed hatch should be opened and the entire crawl space inspected prior to commitment.

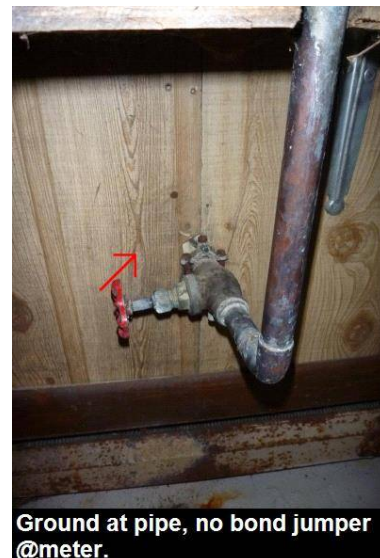
Analysis: The ground connection appears functional for the age of the home and no repairs are required; nevertheless, I recommend that you have a jumper cable installed.

Recommendation: Hire an electrician to install a jumper ground cable at the water meter for greater safety and to conform with modern ground/bond requirements.

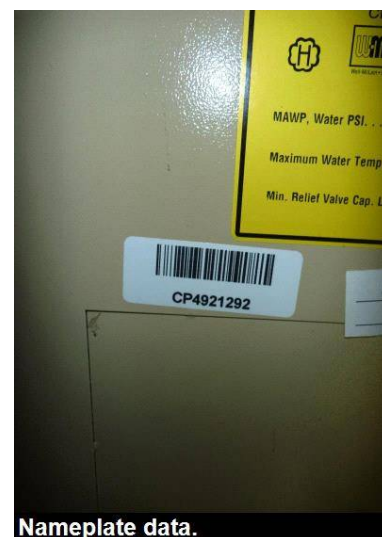
** **FUNCTIONAL with EXCEPTIONS:** Repair or Replacement Required.

Analysis: The lack of maintenance tags may indicate postponed annual maintenance cleanings, tune-ups, parts replacement and safety inspection.

Recommendation: You should have the heating system serviced now, prior to occupancy and annually there after to establish a regular service schedule.

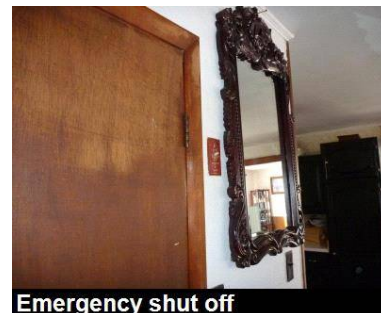
Emergency shut off

The emergency shut-off switch is located in the hallway.

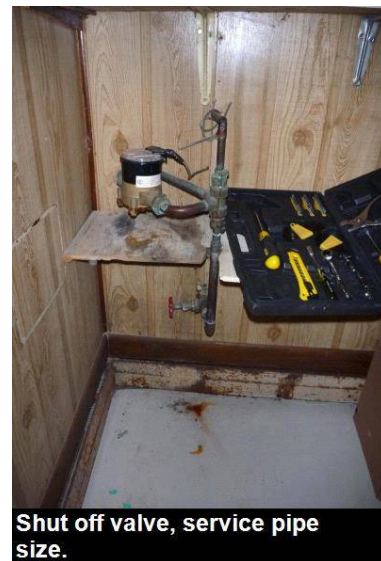
Analysis: Such corrosion is typically caused by the acidic nature of the water supply and flux residue at fittings and valves.

Recommendation: Monitor the piping for corrosion repair and leaks. Repair as required.

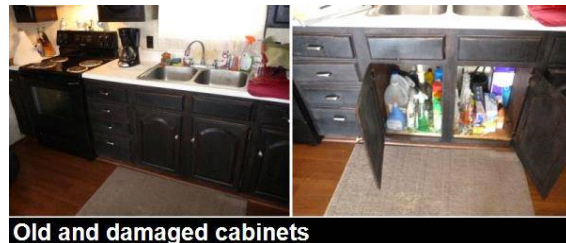
Analysis: In my opinion, the kitchen is a candidate for optional total remodeling.

Recommendation: I advise that you visit a kitchen cabinet contractor and review options for remodeling the room.

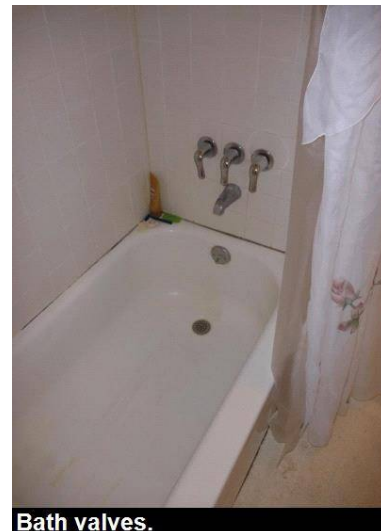
Analysis: Gaps could allow leakage & interior water damage.

Recommendation: Caulk tub / floor joint, tub / wall joint and faucet spout & handle as general maintenance.

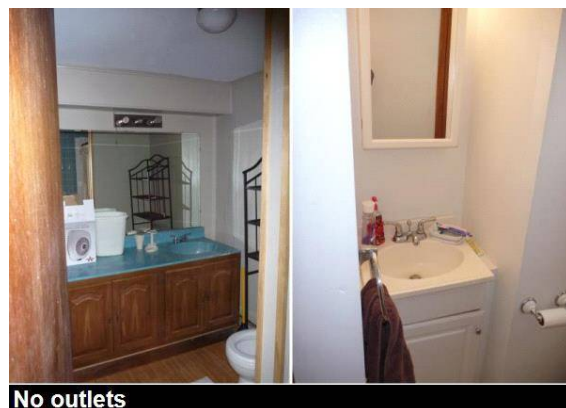
Analysis: The lack of an outlet will be inconvenient by modern standards.

Recommendation: A GFCI protected outlet installation is recommended for modern shock protection. Consult an electrician at your option.
