Blue Palmetto Home Inspection

Property Inspection Report

123 Dream Home Lane, Summerville SC, 29483
Inspection prepared for: Julia Sample & Julia Sample
Inspection Date: 1/4/2011 Time: 3:45 pm
Age: 8 years Size: 1500 sf + -
Weather: Partly Sunny 60 degrees
This is just a test report.

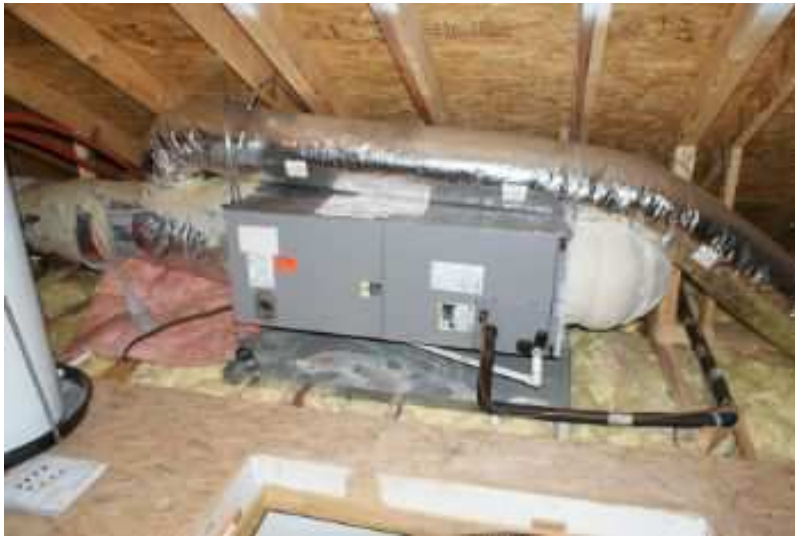
Materials: This house has a forced air heat pump.
Materials: The air handler is in the attic.

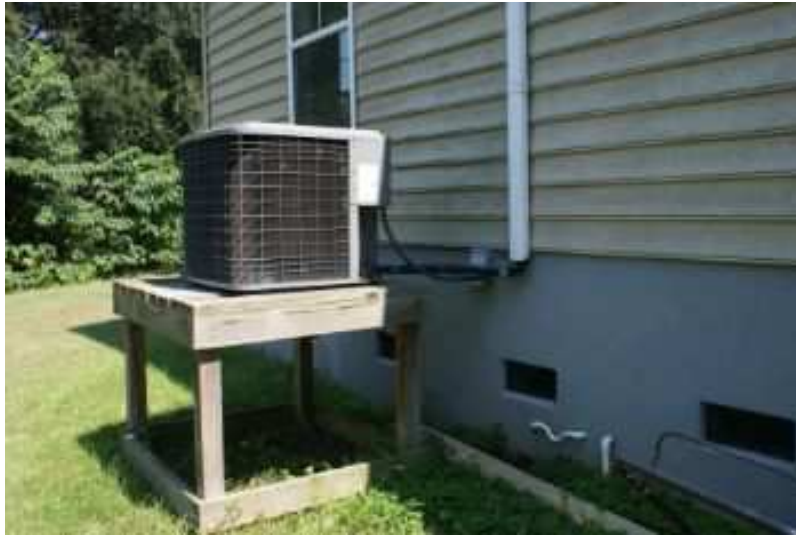
located left side of house

Compressor Type: electric
Location: The compressor is located on the left side of the house.
