# Home Inspection Report

2214 Gardner Road  
Hamilton, Ohio 45013

01:48 May 22, 2008

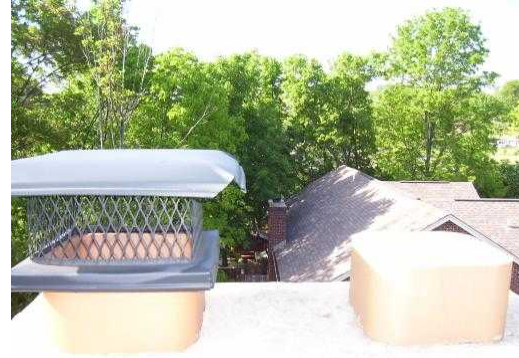
16. ☐ ☐ ☐ ☒ ☐ Chimney Flashing: Galvanized, tern metal Loose  
counter flashing- repair

4. **Flashing:** Galvanized, tern metal Prone to possible leaks
5. **Plumbing Vents:** PVC Plumbing vent flashing has failed. Replace vent flashing.
6. **South Chimney Chimney Flashing:** Galvanized, tern metal Loose counter flashing- repair

Chimney Flashing: replace flashing into joint and re-caulk
