Nuclear Ship SAVANNAH

Radiological and Non-Radiological Spaces Characterization Survey Report

CONTRACT No.: DTMA1C05013

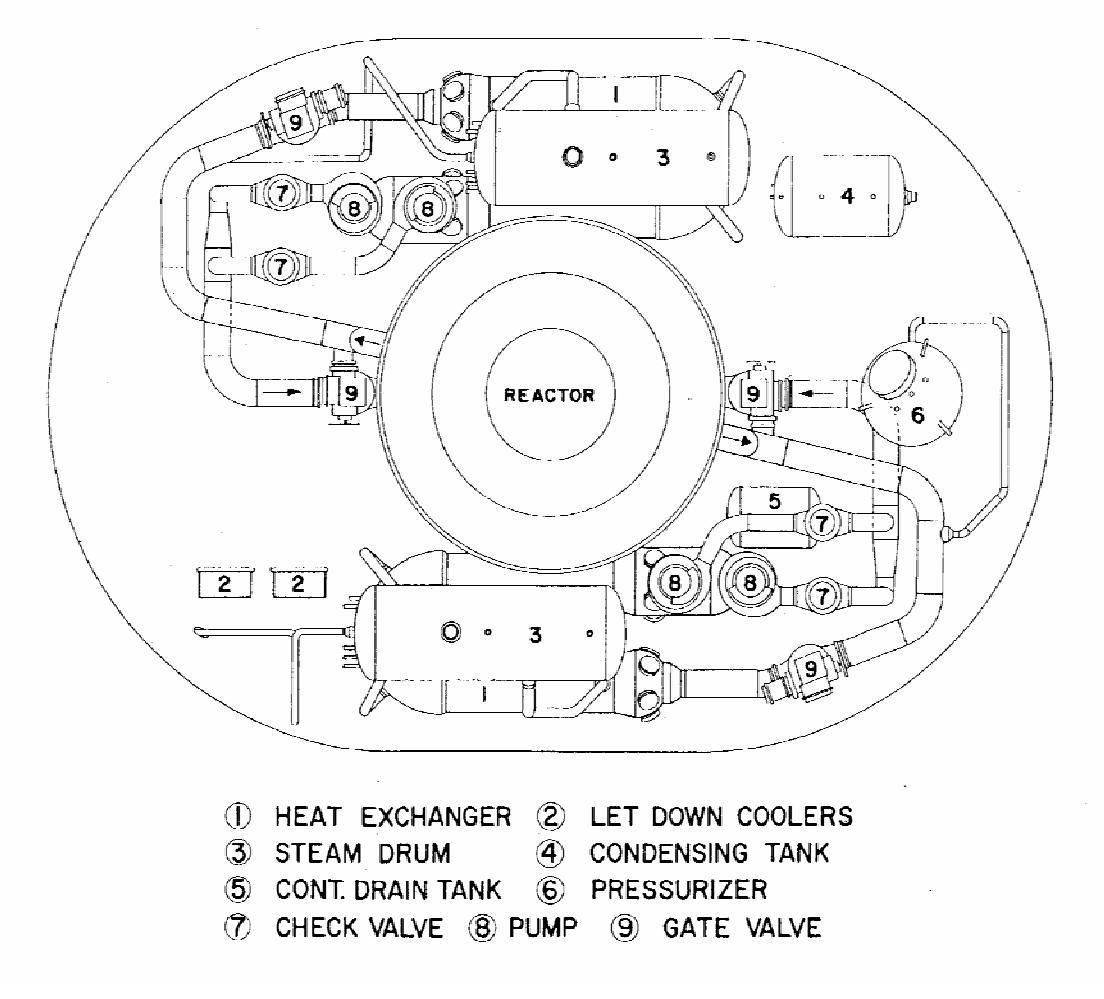
Figure 5A.6-1 Primary Containment Equipment Layout

Table 5A.6-1 provides a summary of radiological condition found during the evaluation of Primary Containment. The values listed are maximums. Consult the write-ups below the table and survey sheets for details. Figures 5A.6-1 through 5A.6-5 provide a layout of the primary containment by elevations and plan views.
