# *Torre Inspection Service*

## Property Inspection Report

12345 Me Ave, Some Where, NY 12345  
Inspection prepared for: IR EIFS  
Date of Inspection: 1/25/2012 Time: 9:00 am  
Weather: Clear Outside Temperature 40 Degr'e's

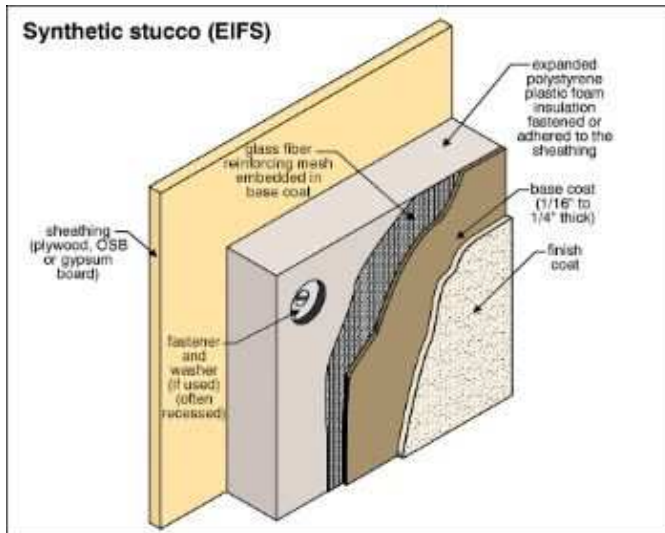
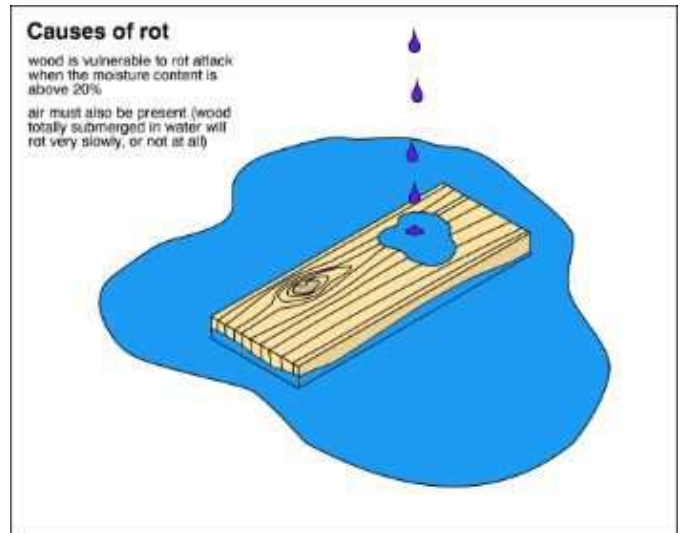
The substrate resistance tester(SRT) measure less then 5 pounds of resistance when popping through the wood substrate on a small area in the front elevation.

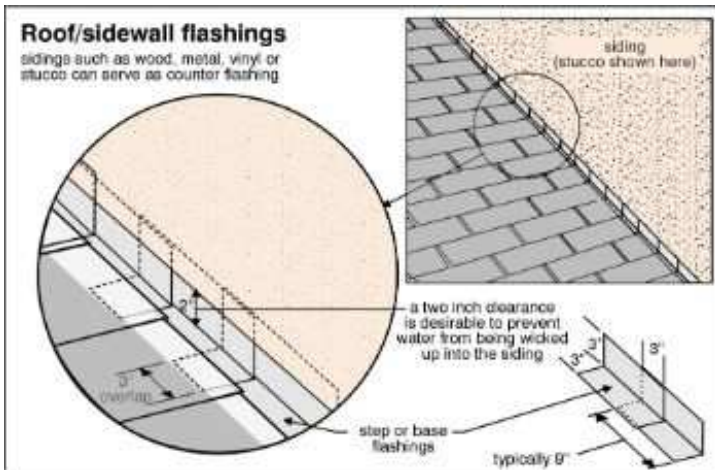
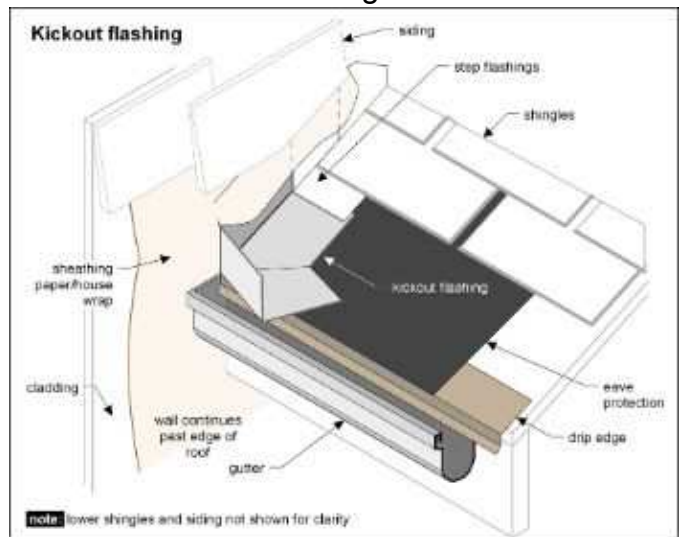
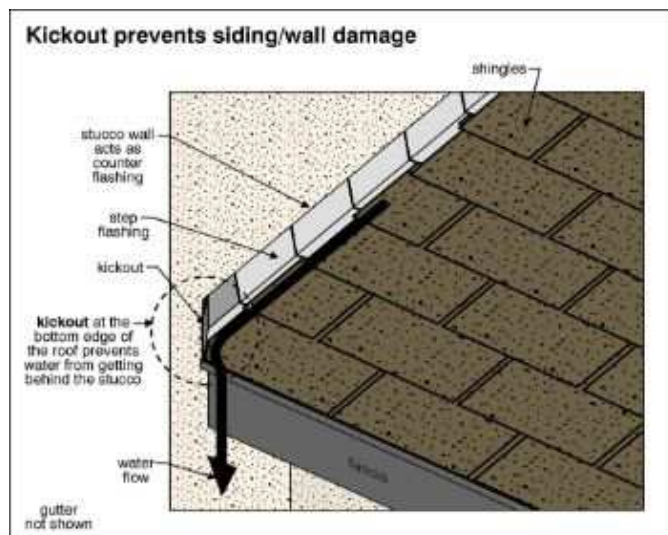
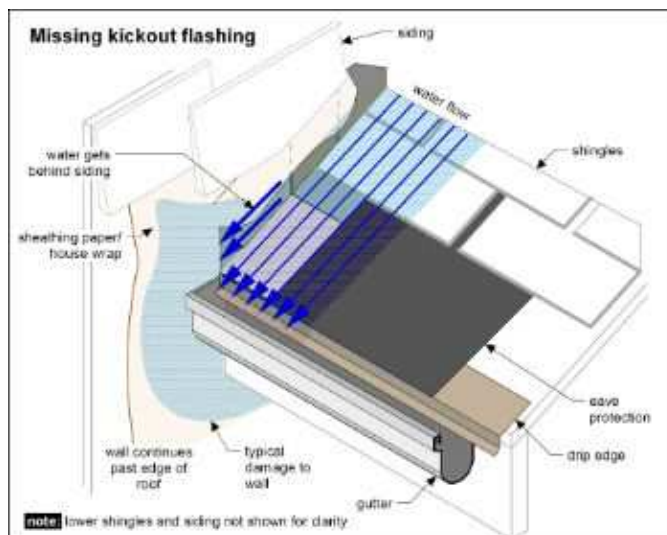
No kick-out flashings were installed where walls extended past roof edges. This may allow moisture intrusion of the exterior wall covering. Moisture intrusion can damage materials and encourage the growth of microbes such as mold. Roof termination clearance and diverter flashing or kick out flashing. Recommend a licensed roofing contractor repair or install all missing diverter flashing and then have then have a certified EIFS contractor repair the EIFS around the new diverter flashing to prevent future water damage.

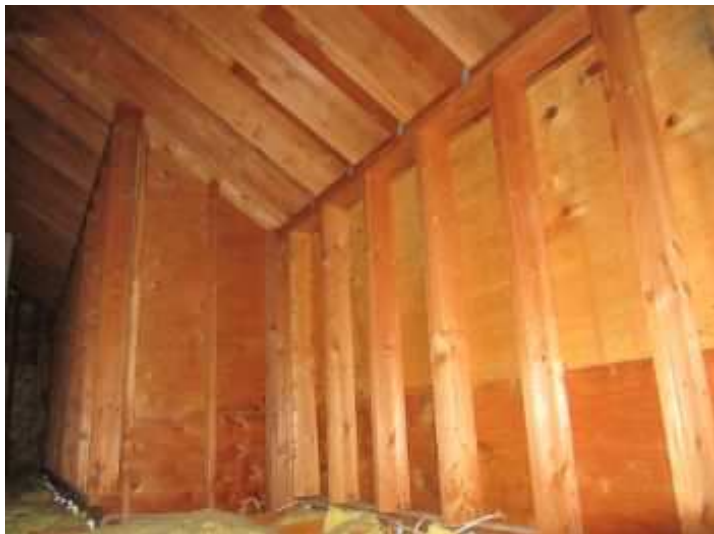
I inspected the attic by entering it. But there is no flooring, and the insulation is covering the joists. I am unable to safely move all around the attic space completely. Inspection restrictions.
