PROPERTY INSPECTION REPORT
PROVIDED BY
**A CLOSER LOOK
HOME INSPECTIONS INC.**

PREPARED EXCLUSIVELY FOR
**1517 KATIE CT
NEW LONDON WI 4961**

A CLOSER LOOK HOME INSPECTION REPORT

CLIENT NAME: Craig Baumgartner.
INSPECTION SITE ADDRESS: 1517 Katie Ct.
INSPECTION SITE CITY/STATE/ZIP: New London, WI 54961.
DATE OF INSPECTION: June 17, 2010.
TIME OF INSPECTION: 12:00 PM.
INSPECTION #: 1517 Katie Ct New London.
REAL ESTATE AGENT: Erica Smedema.
CLIENT MAILING ADDRESS: 1517 Katie Ct.
CLIENT CITY/STATE/ZIP: New London, WI 54961.
CLIENT PHONE #: 920 982 7970.
CLIENT FAX #:

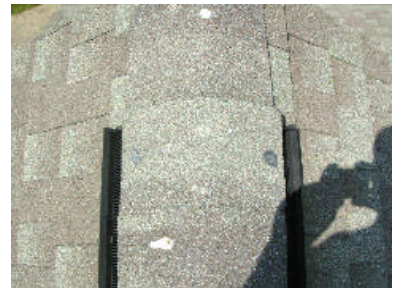
STYLE: Gable.
 PITCH: Medium.
 TYPE: Composition shingles.
 APPROXIMATE AGE: 10 - 15 years.
 ROOF COVERING CONDITION: General condition appears satisfactory with normal signs of weathering/curling and aging. Regular maintenance and inspections are advised. Moss buildup is present. Exposed nail heads present on roof recommend tarring.
