A+ HOME INSPECTIONS

HOME INSPECTION REPORT

Evaluation of property located at: **123 Easy Street, Nashville, TN**
Inspection is performed for: **Mr. and Mrs. Buyer**
Time of the inspection is: **February 26, 2010 9:30 AM to 12:40 PM**

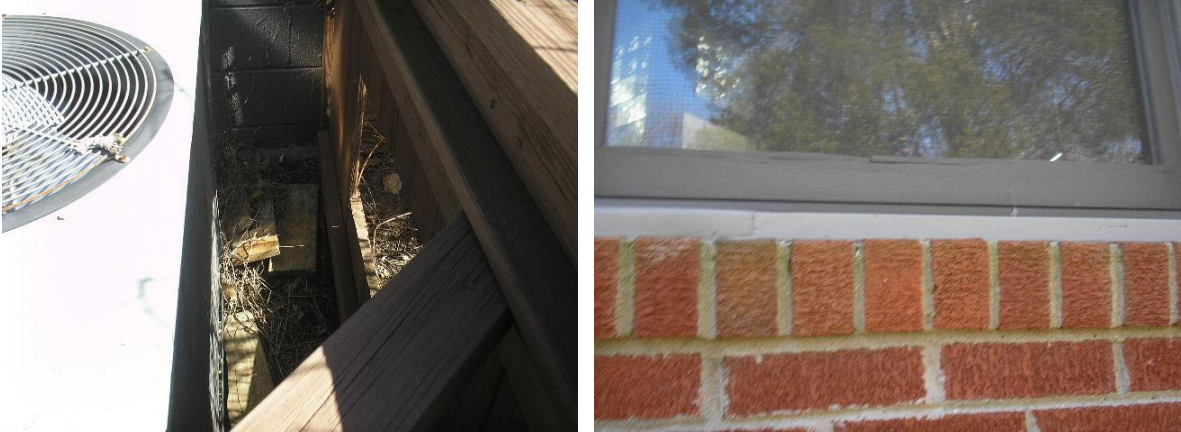
- 9.
10. Rear left master window wood sash is rotted at bottom of its lower glass pane. This is the window above the crawl space door. Wood mullion and nosing between the windows has been cut off and patched.
11. There has been some rot, and there is some bare wood showing on the fascia board under the front left soffit. Gutters may have overflowed from clogged downspouts.
