# The Uniform Building Inspection Report™

**Single Family Residence:**  
1234 Your Street, Your City, CA 94596

**Inspection Date:**  
8/4/2009, 9:00:00 AM

**Report Number:**  
90804a

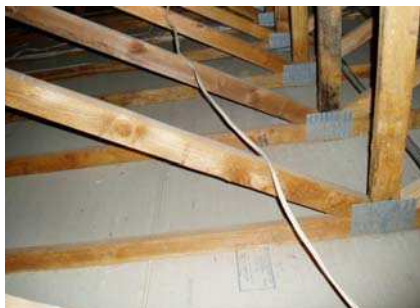
Photo: 5470 (1)

[N] 5470: Electrical additions/modifications noted. Added wires noted in the sub-area and attic which are not properly secured in place. Check for permits and municipal inspection records. See Photo(s) 5470.

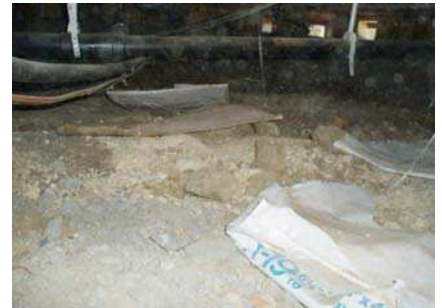
Photo: 9430 (1)

[E] 9430: Sub-area crawl-hole partially blocked. Ducting and communication wires are in the access area. It is recommended to keep this area clear for easy access.  
See Photo(s) 9430.
