DOT/FAA/TC-12/48

Aircraft Skin-Penetrating Nozzle Testing of a Freighter Aircraft Cargo Liner

December 2012

Final Report

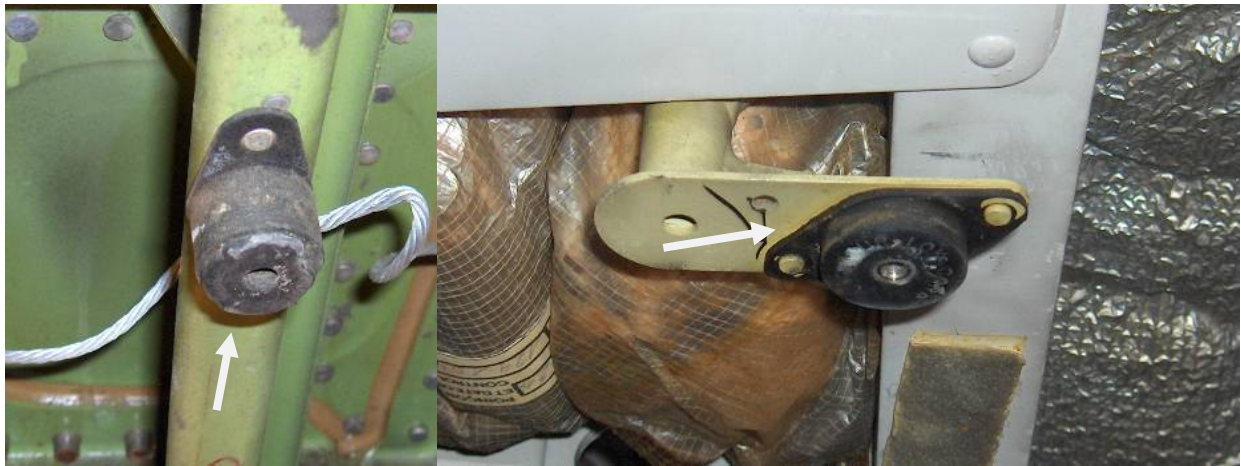
The cargo liner in freighter aircraft mounts to a lightweight frame [10] that holds the cargo liner in place while adding minimum weight to the aircraft. This nonstructural frame attaches to the aircraft frame through various brackets and fasteners. Some are solid brackets held in place with rivets, and others fasten to vibration isolation nuts held in rubber mounts riveted to the frame. Other fasteners, such as Hi-Lok® fasteners or Cherrymax® blind rivets, are sometimes used, but these are mainly for repairs and locations where it would be difficult to use solid rivets. The cargo liner framework is not a main, load-bearing, stressed structure, so the lightest weight hardware that can handle normal wear and tear is usually used. The full-scale tests described in this report used standard, aircraft supply, aluminum, solid-flush rivets, as well as steel nutclips, screws, and fender washers. This test did not include vibration-isolation hardware, which is discussed briefly in section 4.2 and shown in figure 2.

Figure 2. Rubber Vibration-Isolation Hardware

Although not used in this test, note that the cargo liner is sometimes fastened to the airframe with rubber anti-vibration or anti-noise mounts, as shown in figure 2. However, the stress resistance of an elastomer mount (figure 2) would be equal to or less than that of aluminum fasteners, and the heat resistance could be considerably less. The failure of mounting hardware observed under the stronger conditions of all-aluminum construction would happen faster with elastomer mounts. Furthermore, elastomer hardware attaches to the airframe with aluminum fasteners, which become the point of failure even if the rubber does not deteriorate from heat or if the hardware was designed to maintain integrity with rubber failure.

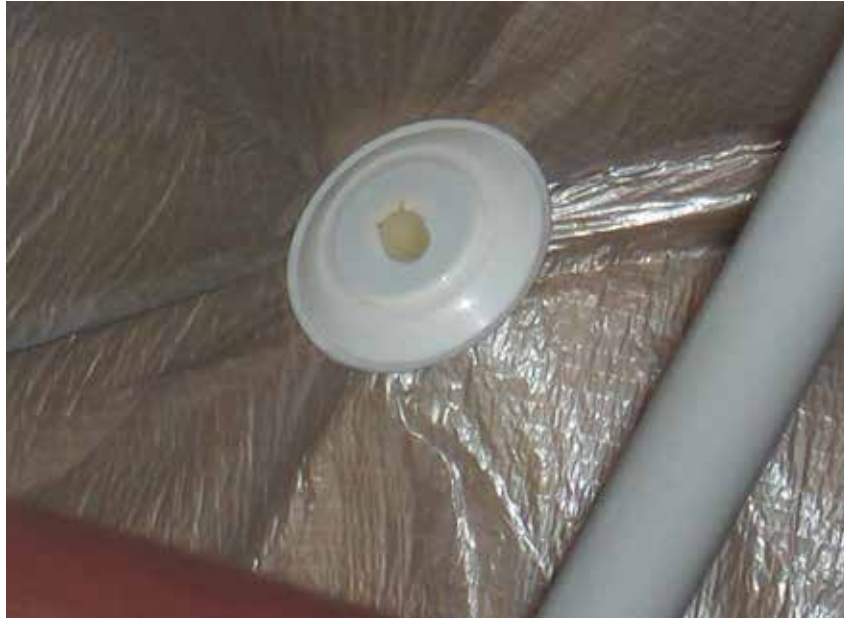
AN-4C polymer moisture barrier forms an insulation blanket assembly. Plastic pins attached to the stringers or frame, shown in figure 3, hold the insulation blanket in place in production aircraft. These protrude through the insulation blanket, then metal or plastic clips slide over the pins to keep the insulation blanket in place. The test used plastic zip ties to hold the insulation blankets instead of plastic pins because of ease of installation and similar plastic material properties used for the clips and zip ties.

Figure 3. Plastic Insulation Retention Pin and Clip

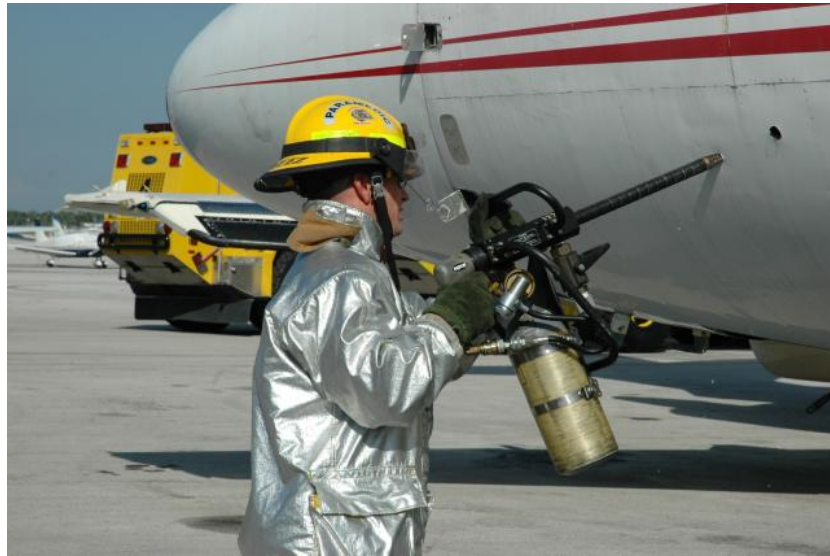
The SPAAT pneumatic rotary tool, shown in figure 6, can flow about 100 to 150 GPM of firefighting agent. A hollow-bit pneumatic drill dispenses firefighting agent through the body of the drill. Pneumatic power is provided either by an on-site air compressor or by a portable compressed gas bottle. Bits are changeable to provide a different pattern of holes for use with each type of agent.

Figure 6. Firefighter Training Using a SPAAT [11]

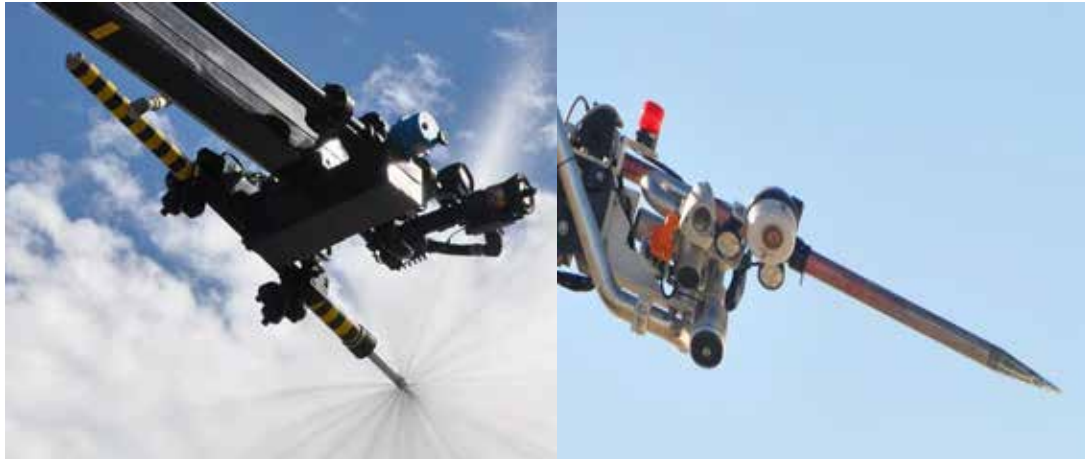
The ASPN is a firefighting nozzle mounted on the HRET of a fire apparatus. The HRET allows the fire apparatus operator to extend nozzles, cameras, and other equipment out to and above different parts of the aircraft. The ASPN penetrates the aircraft skin to deliver firefighting agent to the aircraft interior. It consists of a conical nozzle attached to the HRET and is equipped with a solid-steel, sharpened ASPN tip. Figure 7 shows two basic ASPN models: the Stinger[®] (left)

and Snozzle[®] (right). Both models are capable of flowing 250 GPM of water or foam agent through the piercing nozzle. The main difference between the two models is the method of aircraft penetration. The Stinger[®] hydraulically thrusts the ASPN in quick succession through the aircraft skin, and the Snozzle[®] uses the force provided from the boom to penetrate the skin of the aircraft slowly.

Figure 7. The ASPN System Models: Stinger[®] (left) and Snozzle[®] (right)

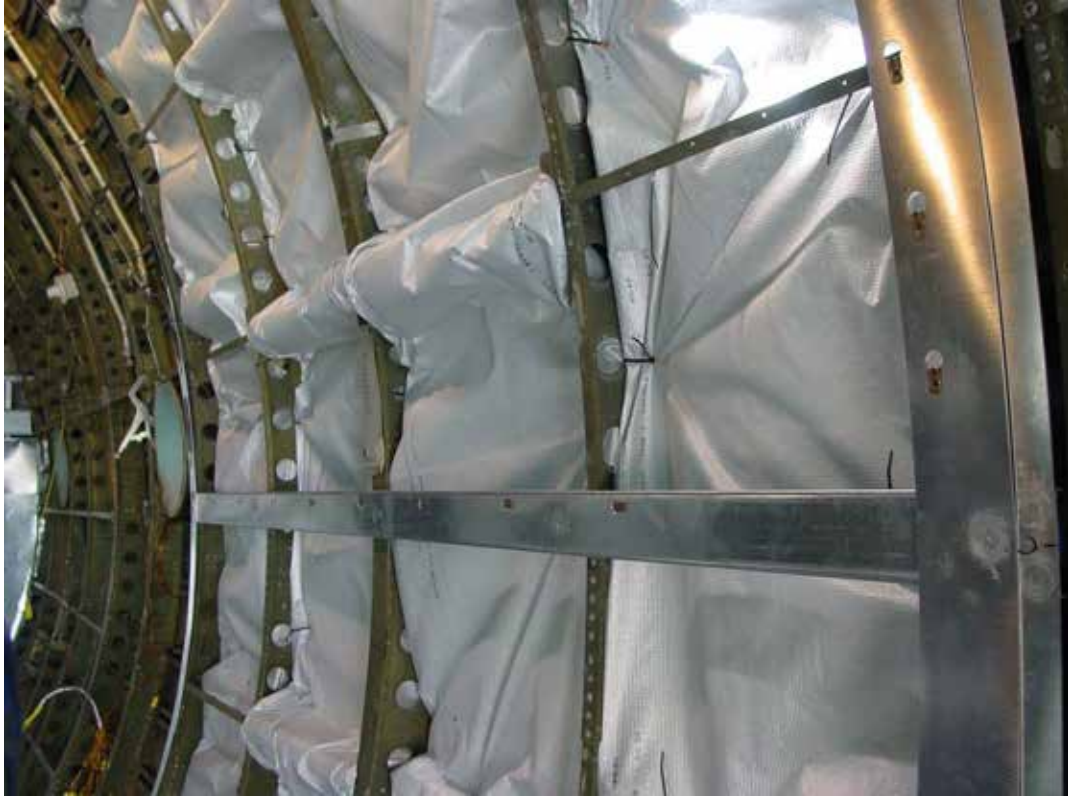
The test section was four frames wide to reduce edge effects that could occur from the discontinuous nature of only partially lining the test fuselage, rather than fully lining the fuselage as is done with normal aircraft. The installed assembly was complete including thermal insulation, cargo liner, and hardware in accordance to current aircraft, as shown in figure 13.

Figure 13. Test Section With Insulation Blankets and Framing Installed

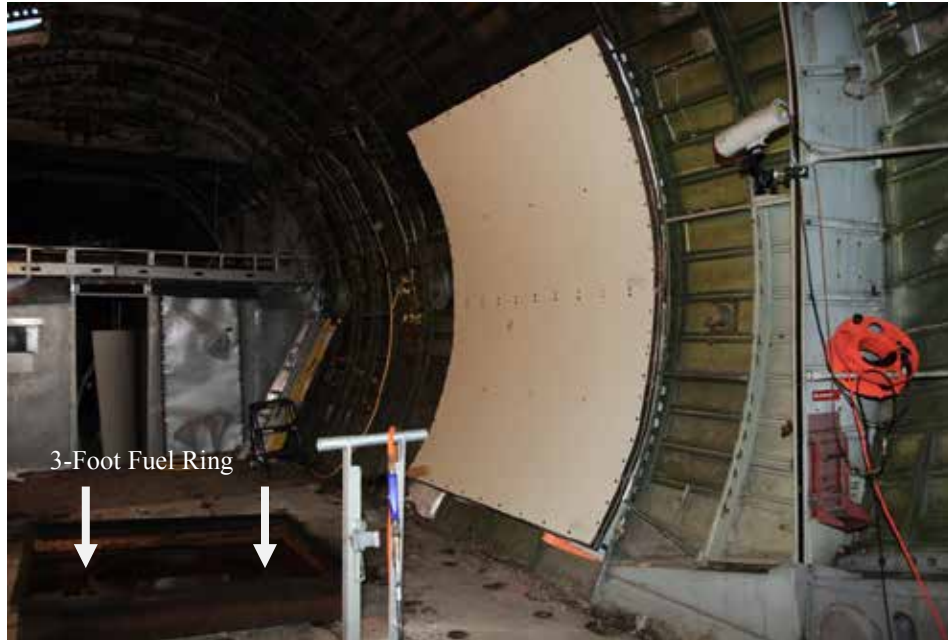
The fire tests used a pan fire within a 3-foot ring located 32 inches away from the cargo liner, with Exxon Mobile Corporation's Tekflame[®] used as the test fuel. This setup is shown in figure 16. Figure 17 shows the warm-up portion of the test. Penetration started once the cargo liner's backside reached the same temperatures of the small-scale tests.

Figure 16. Full-Scale Test Section Ready for Fire Heating

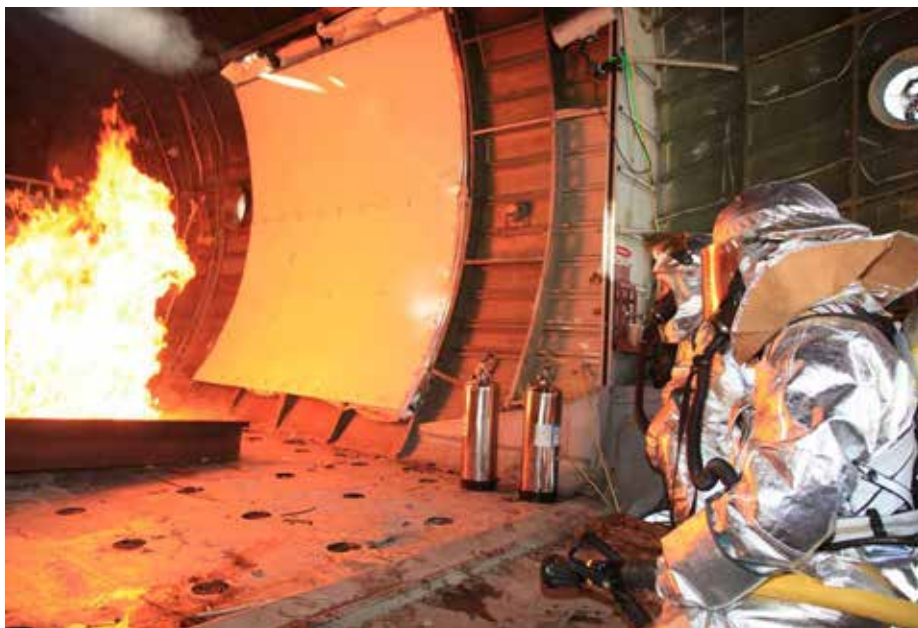
Figure 17. Fire Test

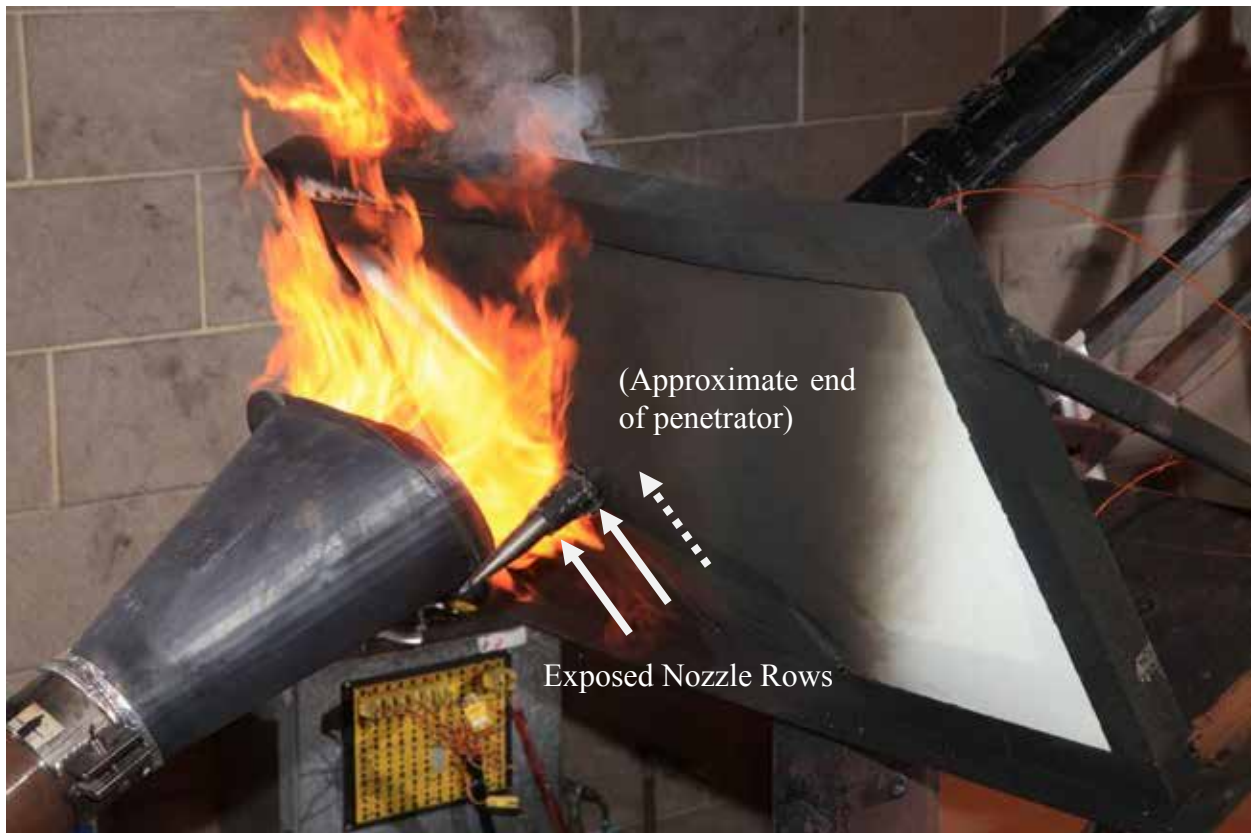
The tabulated results for the small-scale tests are listed in table 1. Ambient tests showed that unheated cargo liner provided little stretch or deflection, and once the cargo liner was initially penetrated, 67% of the nozzle holes were unobstructed by the cargo liner. Heated tests showed that, in some instances, the added softening and deflection caused enough flex in the cargo liner to obstruct between 56%-78% of the nozzle holes and have them remain on the backside of the cargo liner. This is evident in the small amount of penetration that occurred in the offset test shown in figure 18. The dashed arrow in figure 18 indicates the approximate end of the ASPN. The solid arrows indicate the nozzle holes that protrude through the cargo liner.

Figure 18. Incomplete Penetration During Heated Test

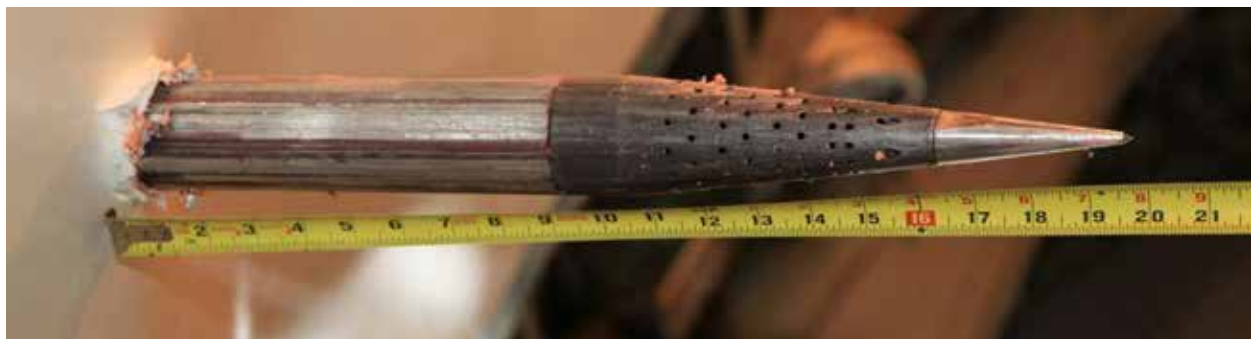
The ambient tests showed that intact and unheated cargo liner provided little resistance to penetration. The cargo liner did not bow or stretch significantly. The mounting hardware remained intact and kept the cargo liner close to the hull even after repeated penetrations. Figure 21 shows that the nozzle fully penetrated into the interior of the fuselage without any problem.

Figure 21. Complete Penetration During Ambient Test

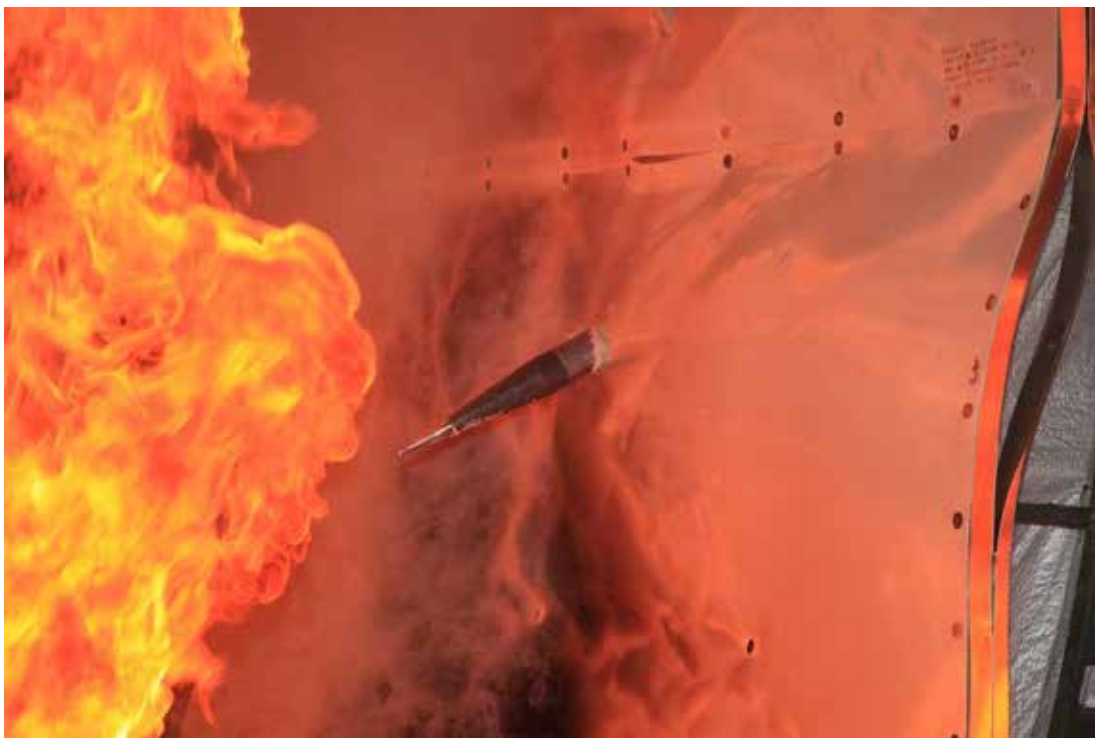
Figure 23. Complete Penetration During Full-Scale Test

The increased damage in the flame-heated tests did not interfere with penetration, as shown in figure 23. The increased heat resulted in delamination of the cargo liner, visible in the bubbled appearance of the backside in figure 24. It also came in the form of the obvious lamina separation reaching to the edge of the cargo liner as in figure 25.

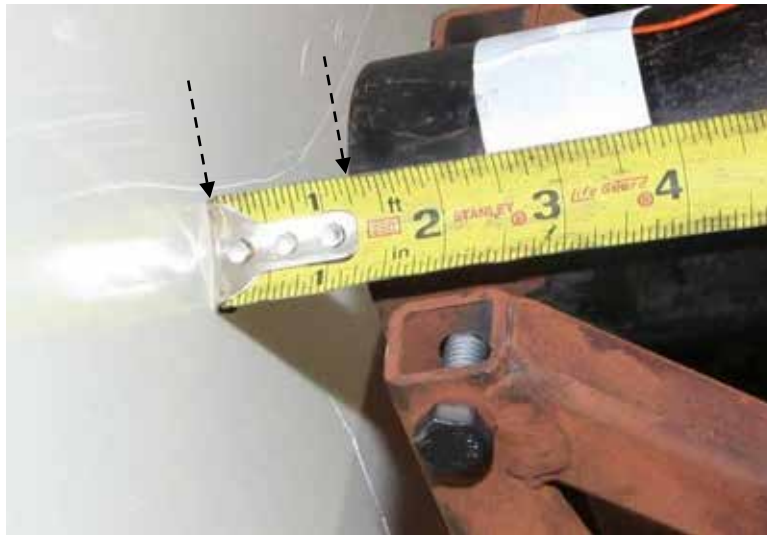
Figure 28. Deflection Offset

The small-scale tests showed that the cargo liner could stretch, although stretching was minimal when close to room temperature and much greater under heat. Figure 28 shows the offset present in the small-scale tests, and figures 29 and 30 show the amount of stretch or deflection during respective heated and unheated penetration.

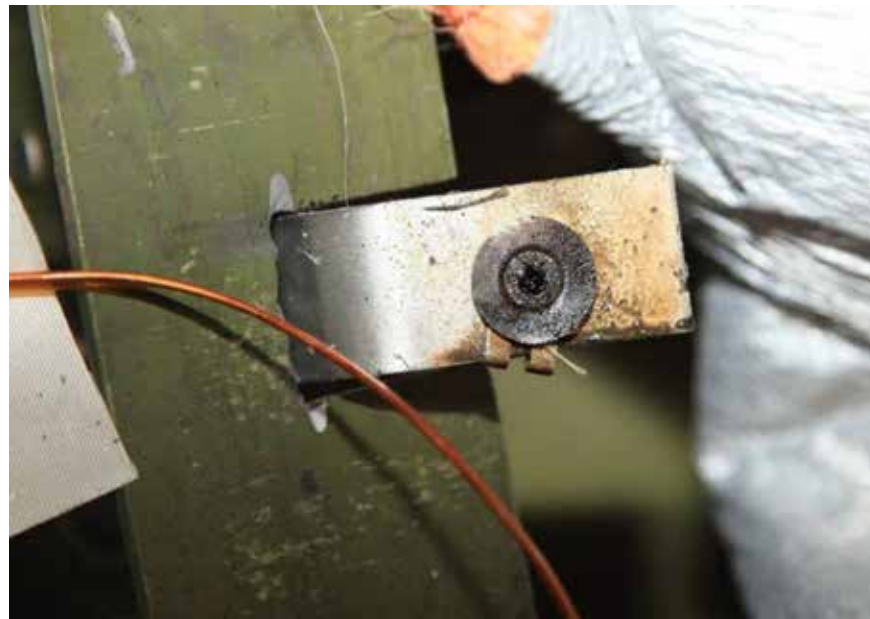
Figure 31. Screw and Washer Still Attached to Bracket

In the flame-heated scenario, if the cargo liner completely lost the resin surrounding the hardware fasteners or became hot enough to become completely pliable, the cargo liner stretched around and popped off the fender washers and screws that held it in place. In testing, this happened with the mid-field fasteners attached to single brackets, as shown in figure 31. However, when the cargo liner popped free from the mid-field mounting hardware, the ASPN was able to penetrate the cargo liner in most tests. In only 1 of the 45 fire-heated penetration tests, the ASPN was obstructed enough to possibly prevent firefighting agent from being applied. Given sufficient length, the ASPN is capable of penetrating into the interior of freighter aircraft without problem.

The flame-heated tests showed that once the cargo liner loses its resin, it becomes more susceptible to certain kinds of damage. This is evident by the screws and washers pulling through the fiberglass and remaining attached to the mounting brackets during penetration. The flame-heated tests also showed that there are instances where the mounting hardware can provide protection to the resin, thus allowing the stress applied to the cargo liner to transfer to the cargo liner frame instead of tearing the cargo liner. This protection is evident in figure 33.

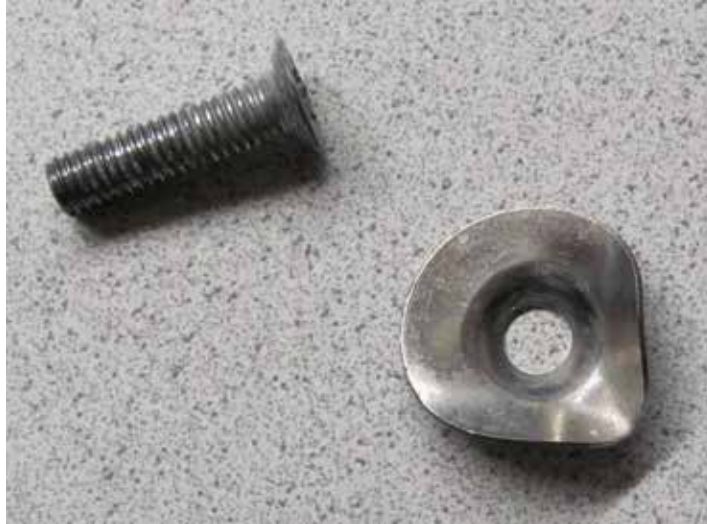
Figure 32. Washer Bent From Penetration Force

In some instances, the cargo liner pulled on the mounting hardware hard enough to bend and partially fold the fender washers surrounding the screws, as in figure 32, allowing the cargo liner to pop free from the bracket. At that point, the only hardware holding the cargo liner panels in place were the edge fasteners attached to the cargo liner frame. These fasteners typically remained secure due to their closer spacing and stress sharing between fasteners.

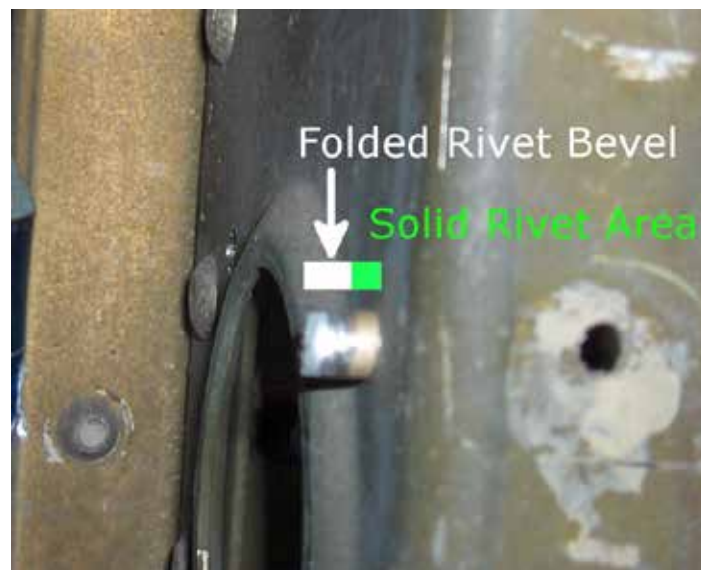
Figure 34. Rivet With Bracket Pulled off Beveled End

In general, the amount and type of stress anticipated drives the specification of aircraft hardware. Normal solid aluminum rivets are designed to hold against shear (pulling across) stresses rather than normal (pulling out/apart) stresses. Unheated cargo liner is sufficiently rigid to act as a taut membrane that transfers force to the hardware as shear stresses rather than normal tensile stresses. When the ASPN impinged on the heated and softened cargo liner, the cargo liner slackened enough to pull on the hardware differently than when rigid. It pulled at an angle that combined shear and normal stresses in such a direction as to warrant pulling out the rivets. It is then congruent that the mounting hardware would fail in this situation. In this case, the normally beveled head of the rivet folded and pulled through the fastener hole, as shown in figure 34. The addition of heat to the rivets further exacerbates the problem by softening the rivet, further reducing the strength of an otherwise already relatively low resistance to the types of forces encountered. Most aluminum alloys have typical melting points between 900°-1200°F [1], and this is within the range of aircraft fuel fires.
