Subject: "NHTSA's Approach to Motorcoach Safety"

# NHTSA's Approach to Motorcoach Safety

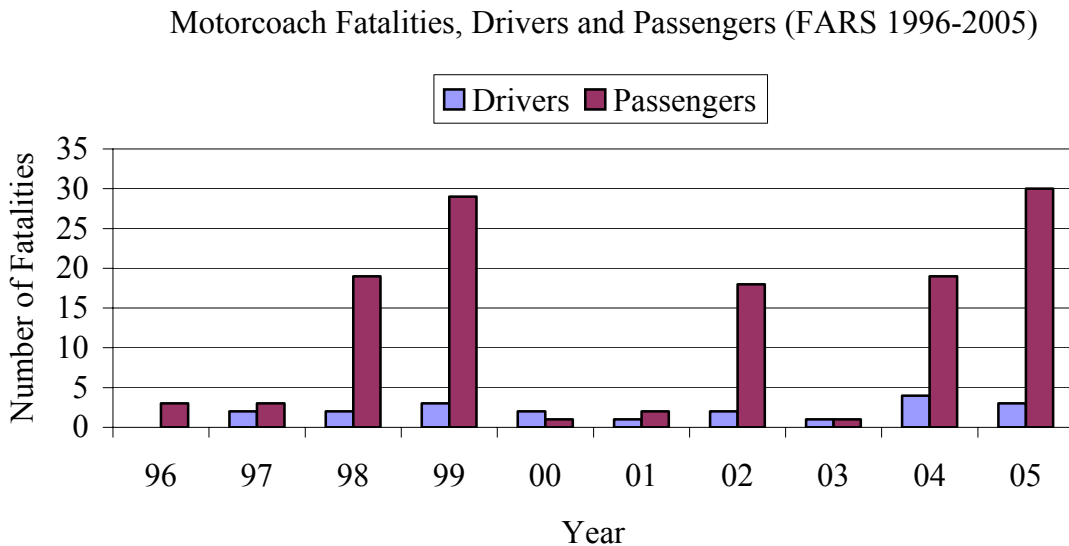
**Figure 1:** Motorcoach fatalities.

Figure 1 shows motorcoach fatalities from 1996-2005. The increased fatalities for the years 1999, 2004, and 2005 each resulted from a single event with a large number of fatalities. The majority of fatalities in 1999 resulted from a crash in Louisiana in which the motorcoach struck a guardrail, jumped a ravine, and struck the embankment at a high speed. There was no rollover involved in this event. This crash resulted in 22 fatalities, all of which were passengers. The majority of fatalities in 2004 resulted from a crash in Arkansas, which involved the motorcoach hitting a highway signpost and subsequently rolling over. This crash resulted in 15 fatalities, including the driver. All 14 passengers who died in this crash were ejected; the driver was not ejected. The majority of fatalities in 2005 resulted from a motorcoach fire in Wilmer, Texas. This bus was carrying evacuees from a nursing home during the Hurricane Rita evacuation. The 23 fatalities, all of which were passengers, were caused by a tire fire that subsequently carried into the passenger compartment of the bus. These events show that while motorcoach crashes may be relatively rare, they can cause a significant number of fatal or serious injuries for a single event.

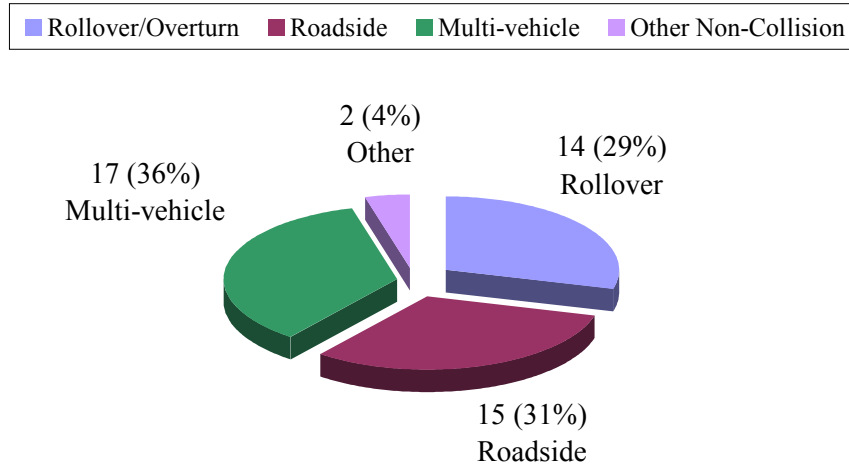
Most Harmful Event, Motorcoach Crashes (FARS 1996-2005)  
48 Events, 146 Fatalities

**Figure 2:** Motorcoach crashes by most harmful event.

Figure 2 shows motorcoach crashes by most harmful event over the years 1996-2005. Multi-vehicle crashes, roadside objects, and rollover/overturn are all within 7% of each other for percentage of fatal crashes where these are the most harmful events.

<sup>4</sup> In one rollover crash, impact with a tree was the most harmful event. That event has been included in Figure 4 even though it was included in the “Other” category in Figure 2.

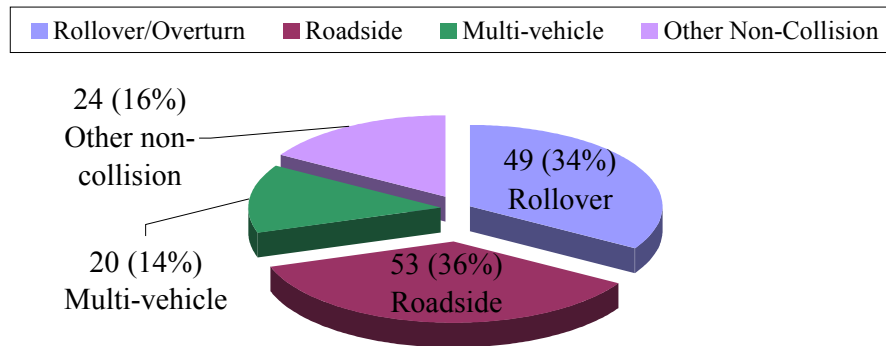
Fatalities by Most Harmful Event, Motorcoach Crashes (FARS 1996-2005)  
48 Crashes, 146 Fatalities

**Figure 3:** Motorcoach fatalities by most harmful event.

Figure 3 shows the motorcoach fatalities by most harmful event. Running off the road and striking a roadside object was the most common most harmful event, leading to 36% of the fatalities. Rollover/overturn was the most harmful event for 34% of the fatalities. The trends for first harmful event were similar, with striking a roadside object being the first harmful event for 40% of the fatalities, and rollover/overturn being the first harmful event leading to 30% of the fatalities.

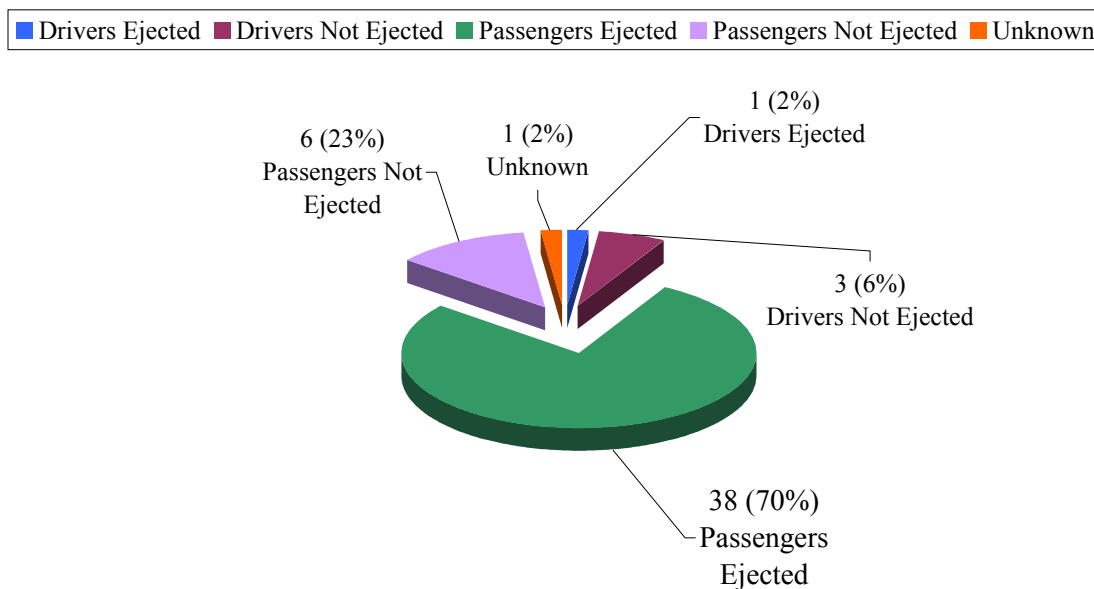
Rollovers, Motorcoach Crashes (FARS 1996-2005)  
15 Events, 49 Fatalities

**Figure 4:** Ejection fatalities in rollover crashes.

Figure 4 shows fatalities in motorcoach rollover crashes<sup>4</sup>. In rollover events, 70% of passenger fatalities were ejections. One driver involved in a rollover crash was ejected.

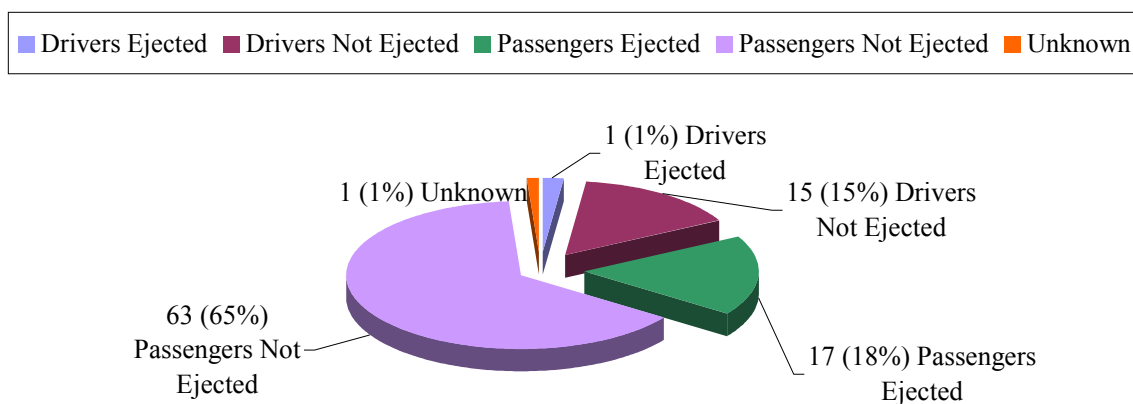
Non-Rollovers, Motorcoach Crashes (FARS 1996-2005)  
33 Events, 97 Fatalities

**Figure 5:** Ejection fatalities in non-rollover crashes.

Figure 5 shows fatalities in non-rollover crashes. Unlike in rollovers, only a small percentage of the passengers and driver fatalities are ejected. There were two cases of ejected driver fatalities in non-rollover crashes.

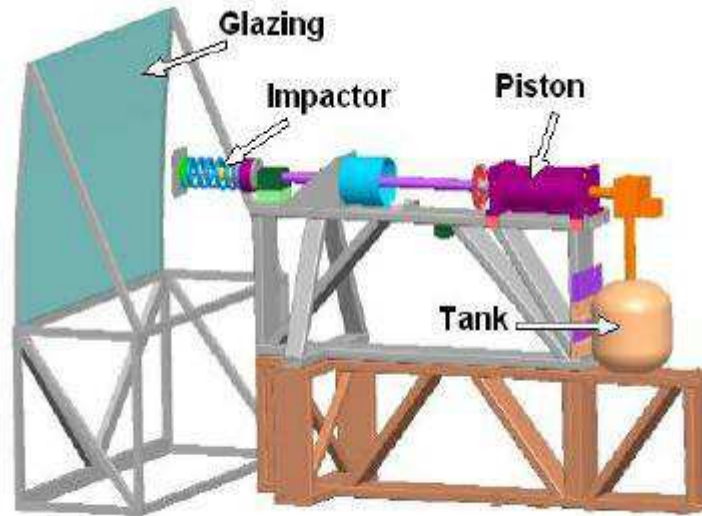
**Figure 6:** Impact Test Device for Window Retention (Transport Canada Study).

Rather than using the CMVSS/FMVSS<sup>16</sup> No. 217 quasi-static head form test of glazing retention strength, a dynamic impact test device was built that represents the torso of the US\_SID test dummy because it more closely replicated the loadings predicted by the numerical simulations. Several drop tests with the US\_SID test dummy were performed and compared with a newly built impact test device to validate that the test device suitably represented the force loading predicted by the numerical simulations. The new impact test device consisted of a guided piston and a platform structure that held a piston with guides along with an accumulator tank used for powering the guided piston, Figure 1. A test procedure using the new dynamic impact test device was developed for testing side windows on a motorcoach for retention strength. Subsequently, only one test was performed in a test fixture that represented the side window structure of a motorcoach with glazing material that was bonded at the top and the bottom. No testing was done to determine the variability of the test procedure.
