Subject: Additional Information for the Review of the License Renewal Applications  
for Dresden Nuclear Power Station, Units 2 and 3 and Quad Cities  
Nuclear Power Station, Units 1 and 2

**Attachment**

**Response to Request for Additional Information**

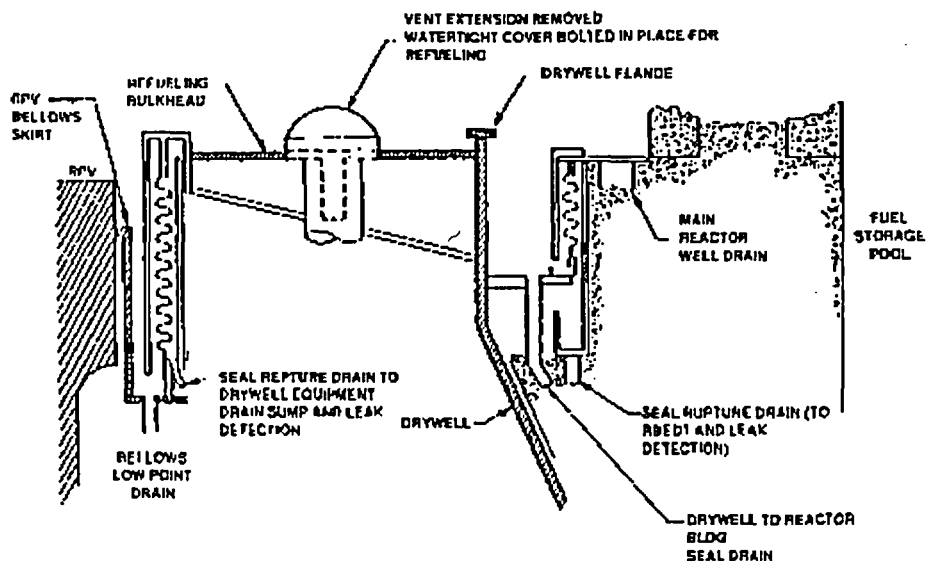
Leakage past the RPV-to-drywell refueling seal is collected and directly piped by design to the drywell equipment drain sump. Refer to the following drawing.

A high flow switch in the drain line to the equipment drain sump provides an alarm in the control room if flow  $>1$  gpm is detected (there is an additional high level alarm on the sump itself). The annunciator response procedure directs actions to quantify/mitigate the leakage, since excessive flow through the drain line could eventually result in leakage into the drywell.
