#### CONSERVATION OF ASSYRIAN RELIEFS AT THE BROOKLYN MUSEUM

Tina March, Lisa Bruno, Hiroko Kariya, Won Ng, Ellen Pearlstein, and Helen Stockman

Conservation of six monumental alabaster reliefs, four broken and two intact, weighing up to 3500 lbs. each, was carried out at the Brooklyn Museum after previous repairs and installation methods failed while they were being moved. The surfaces of all six reliefs were steam cleaned, followed by drying with acetone and ethanol. Cement from a former repair was removed mechanically from the surface with scalpels. The four broken reliefs were disassembled, cleaned of plaster repairs, and reassembled using epoxy. To stabilize the four broken reliefs during movement and reinstallation, a steel mount was attached to the back using bolts. The reliefs were installed in the galleries using a wall cleat with bolts or a turnbuckle system. Small chips of stone were reattached using B-72 in acetone. Ghosting from fill materials remaining on the surface and disfiguring scratches were toned with Liquitex acrylic emulsion paints. The joins were left unfilled.

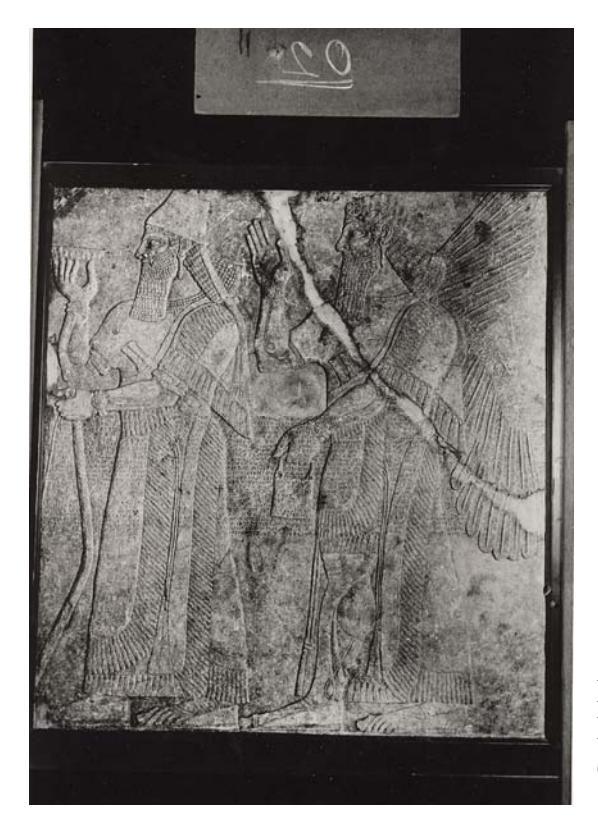
Figure 1. Archive image from the New York Historical Society showing frames overlapping the edges.

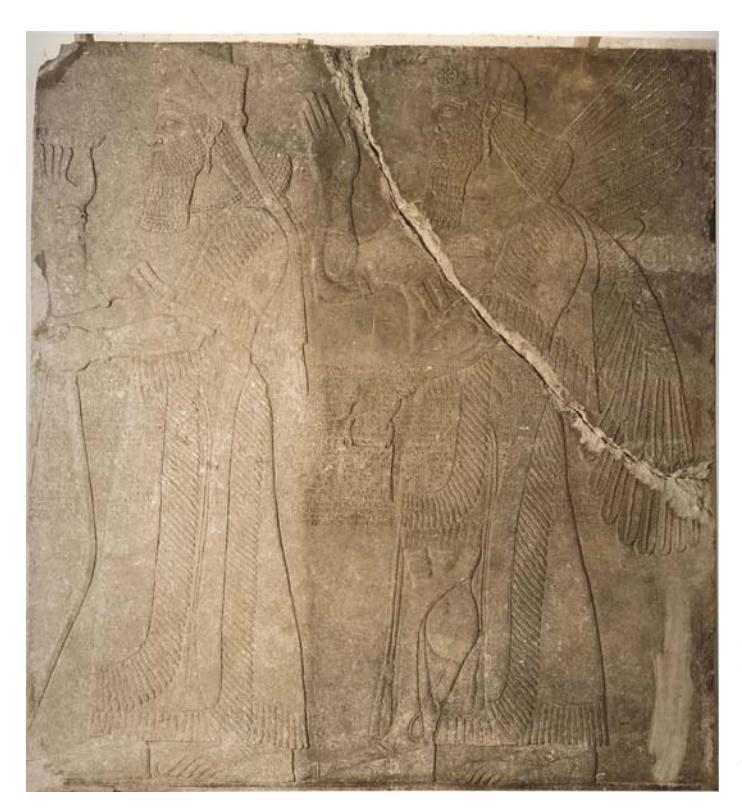
Figure 3. During treatment photograph at the Brooklyn Museum, around 1937. The left side has been washed with water.

used" (Cooney 1937/1938; Fig. 3). The reliefs remained on view until 1949, when due to a changing mission in the gallery, the reliefs were boarded up in situ. The gallery was to become a space used for public lectures, and the Museum could not afford to hire a guard to be stationed in the space to protect the reliefs. Cooney's 1949 report to the NYHS discussed the possibility of mounting the reliefs onto movable steel frames for display in another gallery space, however this was not done. They remained covered from 1949-54 until 1955, when the BM was able to purchase the reliefs, due to the generosity of Hagop Kevorkian (Nagel 1955). In 1956, the reliefs were installed in a gallery dedicated to Mr. Kevorkian, where they remained until 1990. It is noteworthy that photos of the installed reliefs published in 1957 (Fig. 4) show them without any fills in the losses, indicating plaster fills present prior to the recent treatment were applied some time after that date. These images also show residual material, likely cement, surrounding loss edges on the relief surface, which appears to relate to even earlier undocumented fills. Letters from 1858 in the NYHS Archives indicate that there was discussion of restoration and it is possible that this material relates to this time period (Stevens, B.F. 1858).

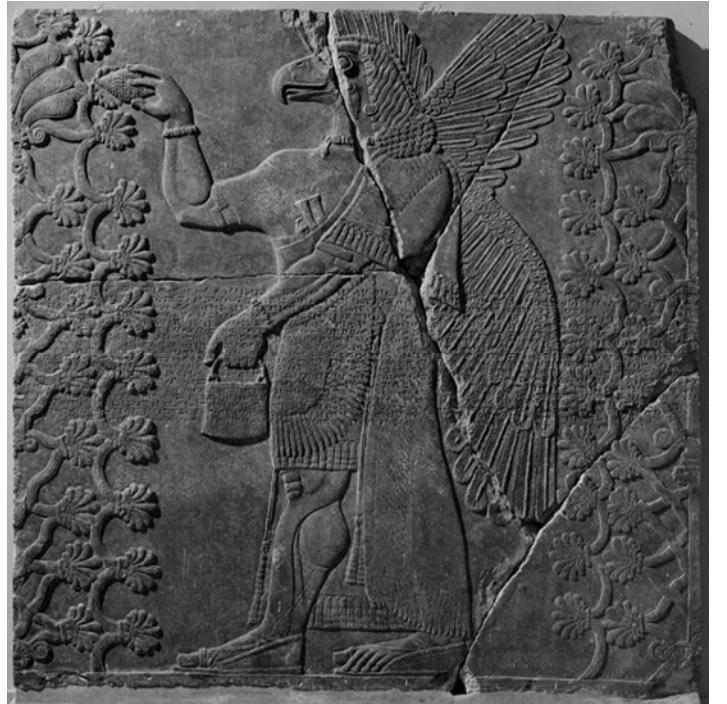
Figure 4. Installation at the Brooklyn Museum around 1957. There are no fills in the break edges.

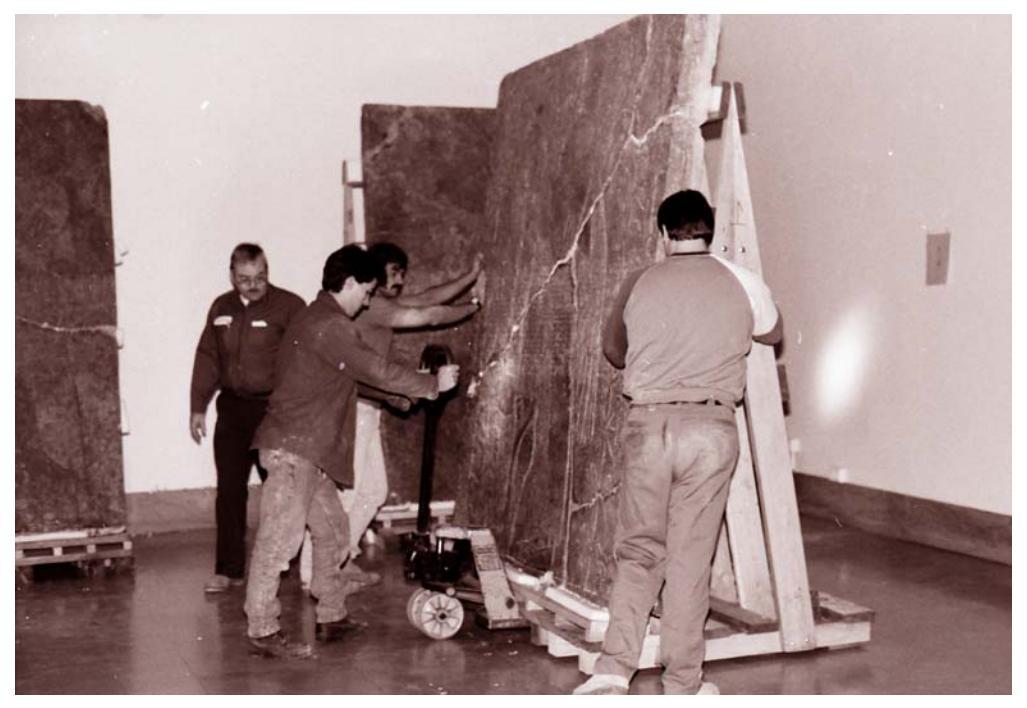
Figure 5. Deinstalled reliefs resting on A-frames, 1990.

In 1990-91, Museum construction necessitated the deinstallation of six of the twelve reliefs. Contract riggers from More Specialized worked with museum conservators to transfer these reliefs to padded wooden A-frames that had been constructed so that they could be moved, with the reliefs on them, using a palette jack (Fig. 5). This deinstallation provided insight into the 1956 installation methods. Following standard masonry construction techniques, the relief fragments were assembled on top of marble-clad I-beams in the gallery, using copper alloy dowels installed into oversized holes in join surfaces, and between the fragments and the wall. The approximately 6" gap between the relief backs and the wall was maintained by these pins embedded in plaster at the wall surface, and by filling the gaps between the side edges and the wall with a 2" thick layer of plaster. Newspaper had been used behind the reliefs to contain the inner edges of the plaster (Fig. 6).

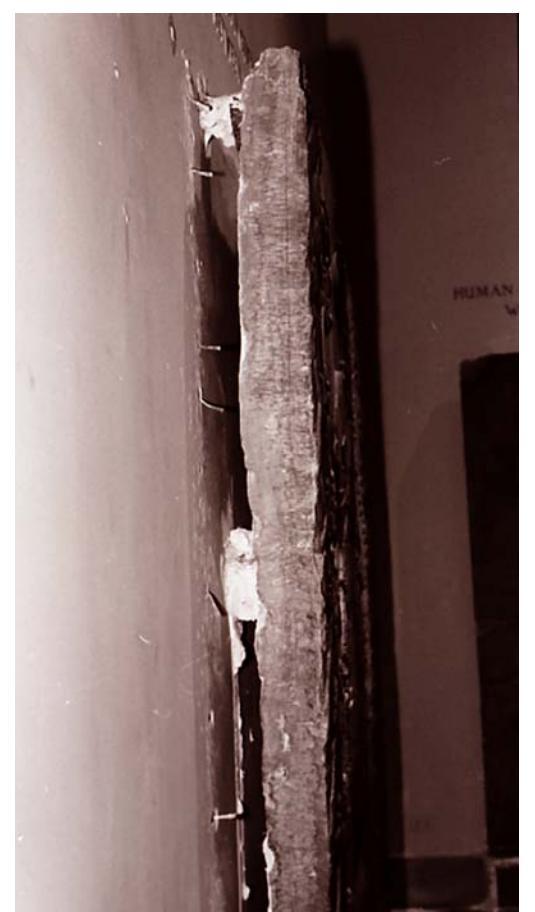
Figure 6. Deinstallation of reliefs in 1990 showing 1957 installation techniques where the reliefs were pinned to the wall and secured using plaster.

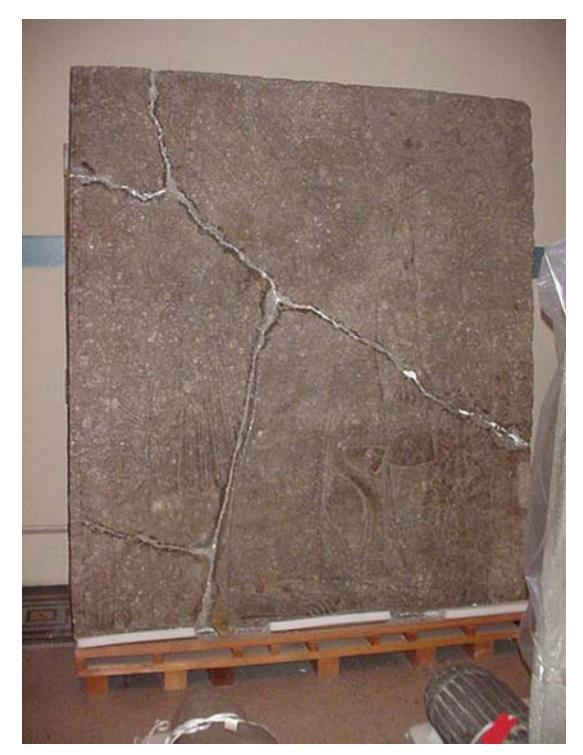
Figure 7. Relief on A-frame in storage, 2001.

The reliefs remained in storage in a closed gallery space on the A-frames until treatment could be carried out in 2001-2002 (Fig 7). The surfaces were grimy and had sustained graffiti and minor scratching and abrasion from years of open display in the BM galleries. The concrete around the break edges and the yellowed gutta percha residue were visually disturbing. Old installation paint was present on many of the edges. The plaster fills were cracked from deinstallation and were both unstable and unsightly, as they had discolored significantly over the years (Figs. 8,9).

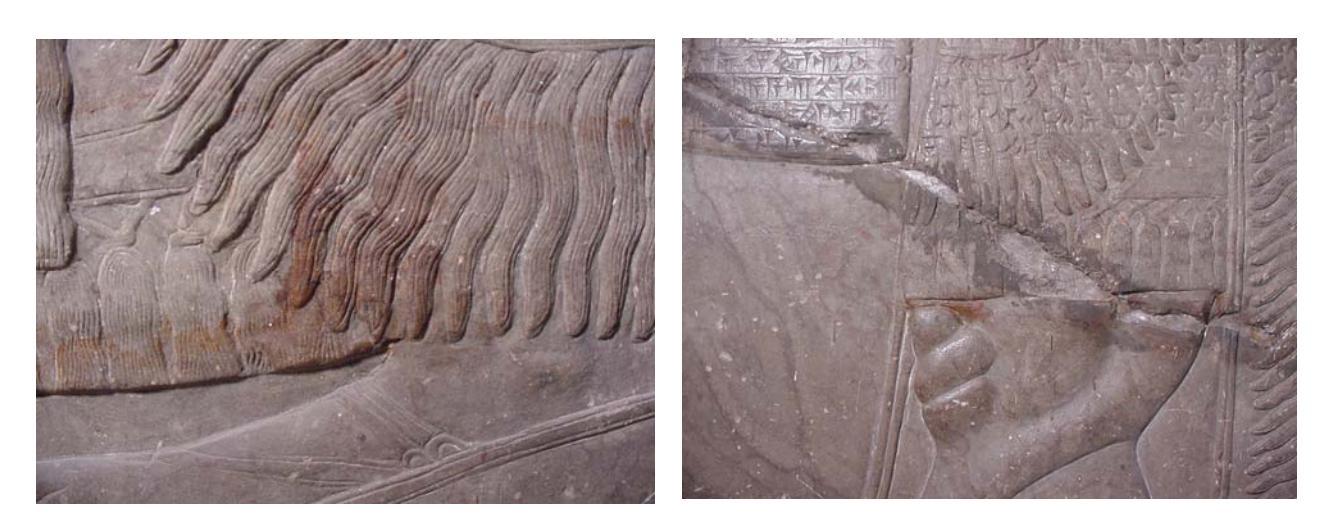
Figure 8. Detail of gutta percha residue.

Figure 9. Detail of cement along break edge.

Plaster fills in the joins were easily softened with deionized water. The cementacious material on the surface of the reliefs was unfortunately harder than the stone and was only minimally affected by water, organic solvents and dilute acid (pH around 2.5-3). Mechanical cleaning using an electric engraving pen/tool, fitted with a stainless steel point was found to be effective in reducing thick areas. A scalpel was also useful in reducing the material close to the stone surface.

Based on the above tests, steam cleaning followed by acetone/ethanol (1:1) in cotton wadding was found to be most efficient and effective in removing surface dirt and grime. This method also minimized exposing the stone to excess water and exposing conservators to excess solvents in an unventilated workspace. The decorated surfaces of all six reliefs were cleaned as follows. An area to be cleaned (approximately 1 foot square) was steam cleaned, followed immediately by wiping the surface with cotton wadding and/or Webril cotton lintless sheets saturated with an acetone/ethanol mixture (1:1). The use of acetone and ethanol not only removed additional grime and old paint residue, but also hastened drying of the water. The distance of the steamer nozzle from the surface of the reliefs was modified as required to provide the best results. This process was repeated until the surface was cleaned to the desired degree. Some areas of overpaint from the previous treatments were reversed with water. The cementacious fill materials were removed mechanically using a scalpel blade and electric engraving tool.

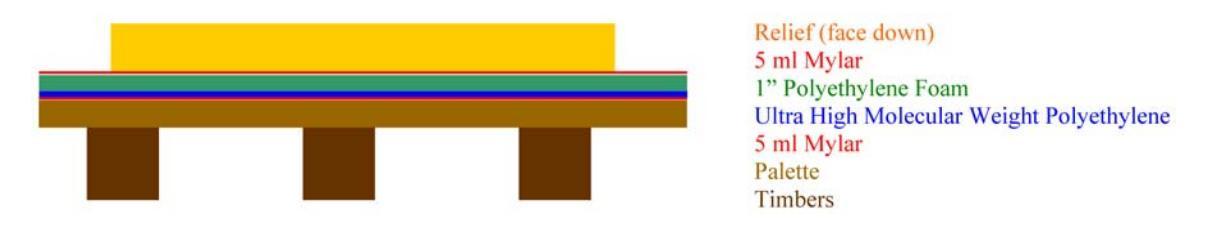
Figure 10. Relief package.

Contract riggers from More Specialized placed the reliefs flat, face down on padded wood palettes that were elevated to a comfortable working height with timber blocks. Before moving, the front surface of the reliefs were covered for protection with a layer of heavy gauge Mylar, followed by a layer of 1" thick polyethylene foam. Sheets of ultra high molecular weight polyethylene (UHMW) were placed on top of the foam. The UHMW polyethylene provides a slick, friction-reduced surface to assist in sliding the fragments of stone once separated. A second layer of Mylar was attached to the top surface of the wooden palette with staples (Fig. 10). The palette was then positioned against the padded face of the relief and secured with nylon straps.

The riggers winched this stone/palette package up off the A-frame using chain hoists hung on a mobile gantry positioned over each relief. The blocks of timber were strategically positioned to support the palette, as it was lower to the horizontal position. The backs of the reliefs were now exposed and accessible for treatment (Fig. 11).

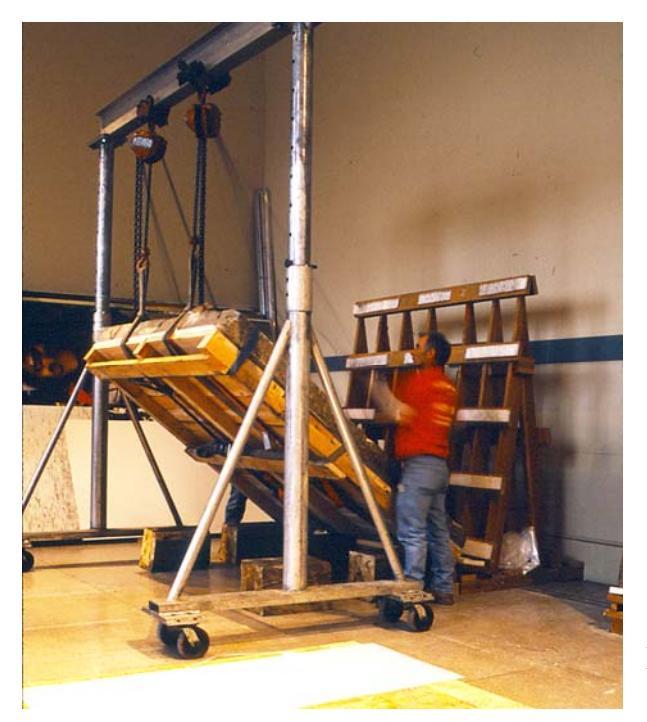
Figure 11. Reliefs are rigged, face down.

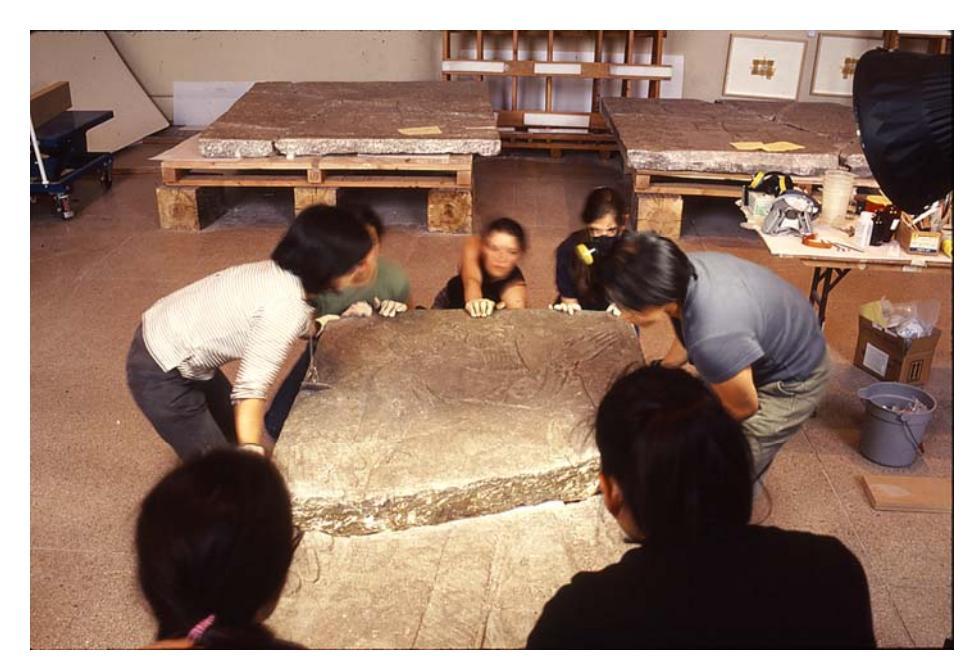
Figure 12. Horizontal assembly of reliefs.

The edges to be joined were coated with 2 coats of 10% B-72 in acetone and allowed to dry for 2 weeks. A recently published study had shown that the B-72 layer was unlikely to significantly undermine the strength of the epoxy in a structural join, and would aid in its reversal when necessary (Podany et al. 2001). One relief was assembled at a time. The epoxy was mixed in plastic containers using wood tongue depressors and applied with a brush onto one section at a time, to both sides of the adjoining break edge. Mylar strips had been placed under each edge of the stone to catch dripping epoxy. Just before pushing the two adjoining sections together, the Mylar was removed. Extra care was taken when fragments with pins were being joined to ensure good alignment. This process continued until each fragment was in place. Wedges were added as necessary to level or hold pieces in the desired position. This process was used for all four fragmented reliefs. Even with the multiple test assemblies performed prior the actual adhering together of the fragments, additional adjustments were necessary in the final assembly since not all activities could be precisely replicated (Fig. 12).

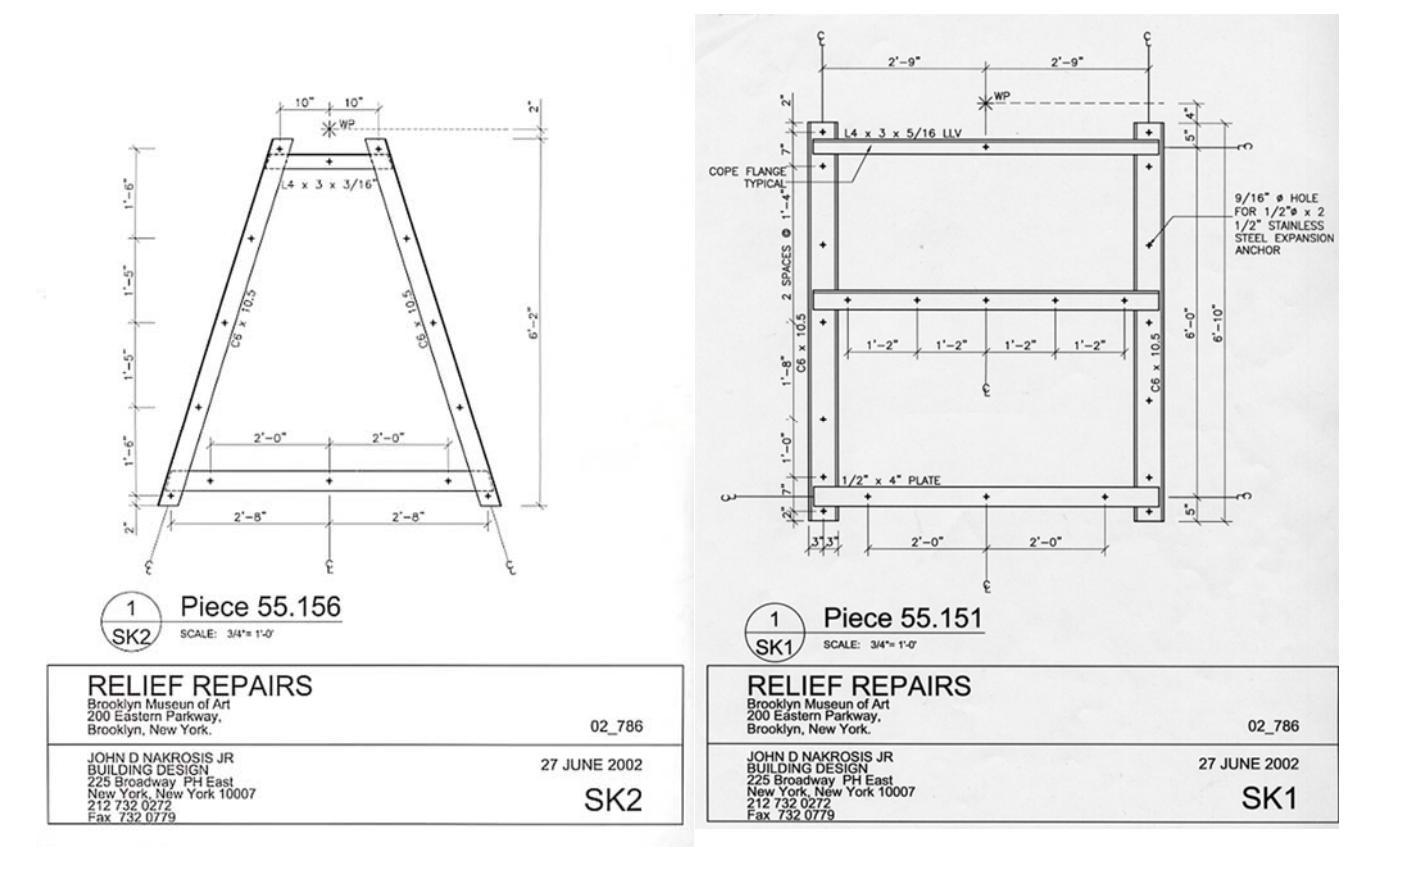
Figures 13 (left and 14 (right). Backing designs by John Nakrosis.

The final design chosen for a support was a steel structural backing, which was secured mechanically to each fragment of the four broken reliefs. The backings, designed by John Nakrosis of Nakrosis Building Design, were customized for each of the reliefs, the shape determined by the configuration of the breaks (Figs. 13,14). As determined by the engineer, the steel backing was attached to each fragment with at least two bolts. The backing members were made out of a combination of C6 x 10.5 or C4 x 7.25 steel channel, and L4 x 3 x 5/16 LLV. The steel backings were fabricated by D.V.S. Iron works. Holes were predrilled for the bolts used to attach the backing to the relief. The horizontal top section of each backing was used as the

connecting piece to a steel wall bracket that secured the reliefs to the wall. Since the backings were attached to the reliefs while vertical, steel hooks were welded to the top of the backings so that they could hang from the reliefs while we were working. The backings were coated with a neutral grey paint by the manufacturer to inhibit rusting. The two unbroken reliefs did not require a backing.

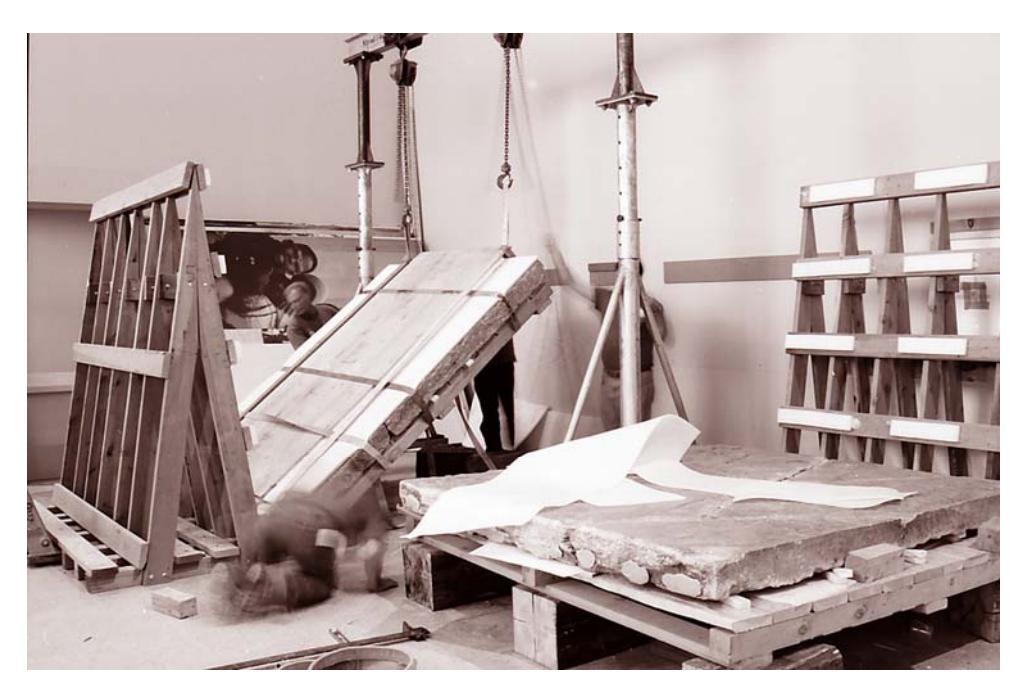
Figure 15. After assembly, reliefs get rigged upright onto A-frames.

Two of the repaired reliefs were rigged and returned to the A-frames without incident. These reliefs were strapped to the palette with nylon straps padded with Ethafoam. This package was winched up by chain hoists hung on a mobile gantry and placed on the A-frame, face in, in preparation to attach the backing. A third relief, 55.156, presented more of a problem. As the package was lifted, the adhesive joins failed instantly. The package was immediately placed back on the timber blocks. Neither injuries nor new breaks occurred, but this relief would have to be reassembled. The lifting method for the final fragmentary relief was adjusted to avoid more joint failure. In order to counter the inward pressure of the straps on the relief as it was winched, the face of the relief was sandwiched by covering with 1" Ethafoam followed by a large plywood board (Fig. 15). The lifting of this more rigid package was successful.

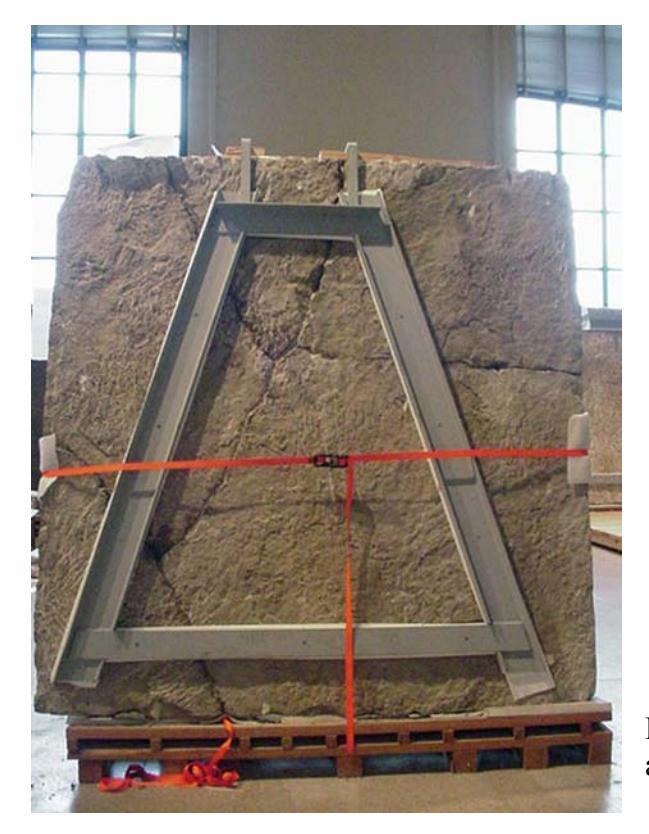
Figure 16. Backing in place with hanging hooks at top.

Before attachment, the backings were padded with 2-3 layers of 1/4" Volara foam adhered with PVA-AYAC in toluene. With the aid of several art handlers, the backings were placed on the backs of the reliefs, being held in position by the hanging hooks at the top. Wooden blocks, used as shims, were placed under the hooks in order to raise and level the backing to the appropriate location for each relief. Once the correct position was achieved, straps were placed around the backings and reliefs to help hold them in place. The predrilled holes in the steel members were used as guides for drilling the holes into the stone. Conservation drilled 1/2" diameter holes into the stone using a special Wedge-bit fitted in a hammer drill. Teams of two conservators were used for this process. While one person drilled, a second would gauge the drill insuring the desired angle of entry was maintained. The engineer advised that a minimum of  $1 \frac{1}{2}$  was necessary for the drilled holes to provide sufficient depth for secure anchoring of the bolts. The bolt length used in any one location was determined by the thickness of the stone in that area and the distance of the back surface of the stone to the backing. Depending on the length of a bolt used in a given area, the drilled hole depth in the stone was a minimum of  $1 \frac{1}{2}$ " but deeper at times depending on the thickness of the stone. The holes were vacuumed of the stone dust, and the bolts inserted. (Fig. 16)

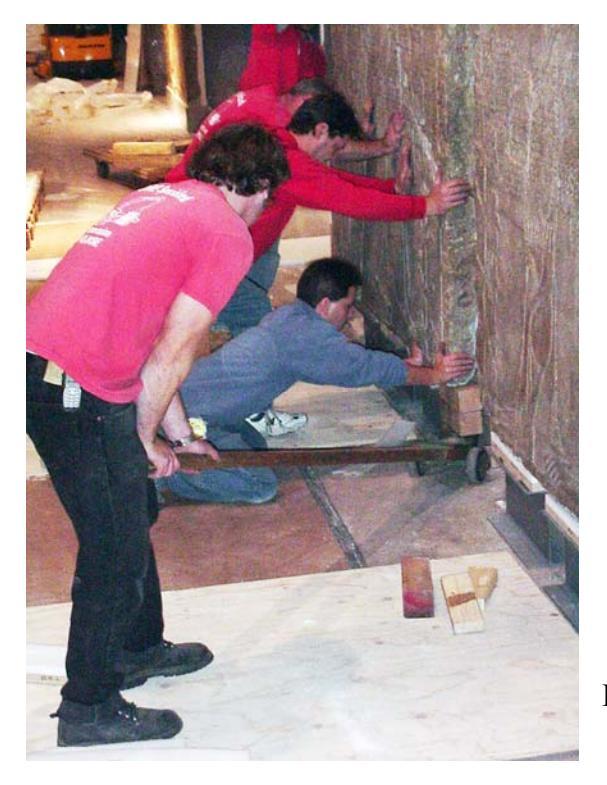
Figure 17. Installation, 2002.

The riggers returned to install the reliefs, which involved the use of 2 gantries, a forklift, a palette jack and a J-bar. Each relief was strapped with loops at the top. The arms of the forklift slipped through the loops of the straps overhead. The relief was lifted straight up, and moved into place, over the W-beams, with the assistance of riggers guiding it into place. Conservation staff adjusted the placement of the W-beams as needed. Once everything was in place, the bolts were simply slid into place. Fine adjustments could then be made. If one side needed to move slightly forwards or backwards, it was adjusted using a J-bar, while holding the other side in place (Fig. 17).

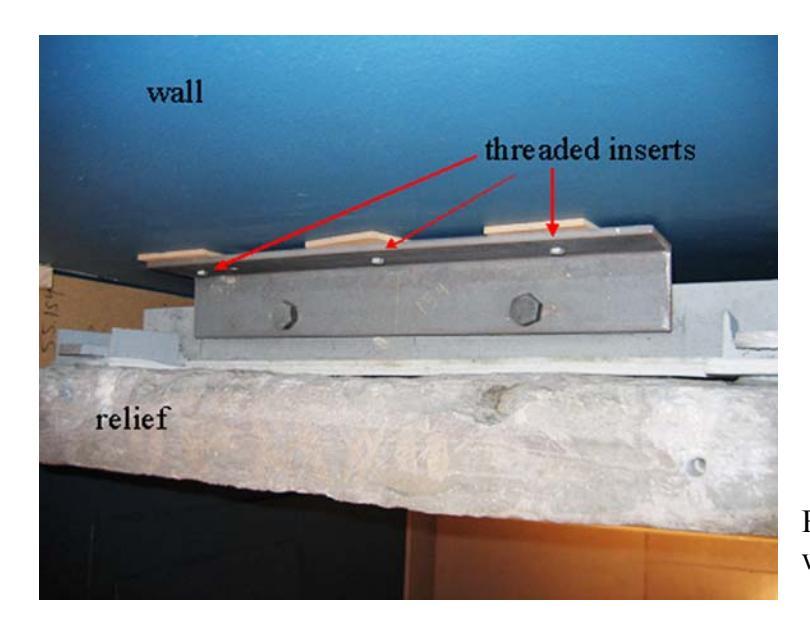
Figure 18. Installation, attachment to wall.

Medex shims were added or removed from the W-beams to level while lifting an edge with the Jbar. Also, further adjustments were made to bring the face of the relief into plumb. For almost all of the reliefs, they were leaning slightly backwards at the top. To compensate, the screws in the threaded inserts were loosened, resulting in the wall plate moving forward with the relief. The resulting gap between the wall plate and the wall was filled with finger shims cut from Medex (Fig. 18). This basic process of installation was carried out for all four reliefs with backings.

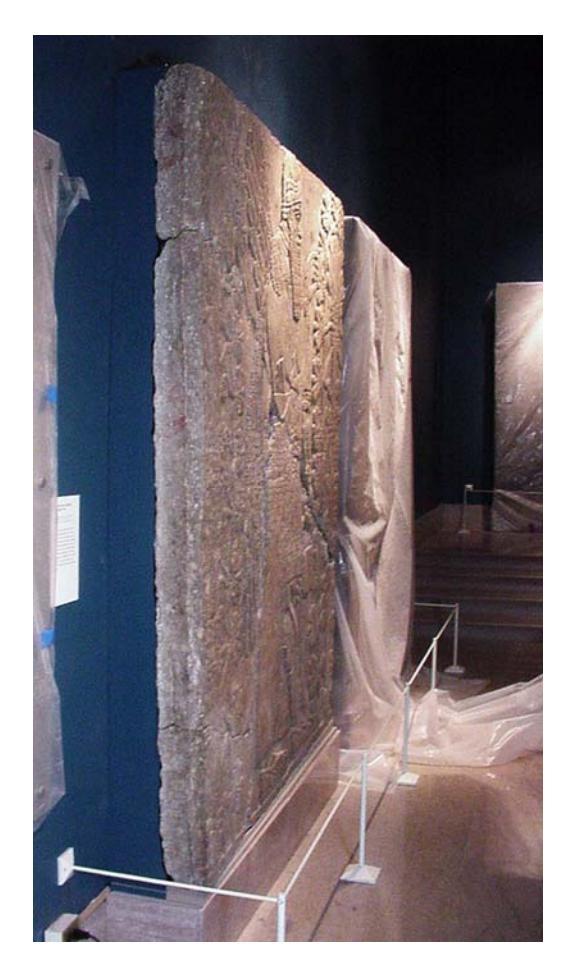
Figure 19. Medex "fills" between relief and wall.

Granite kick plates were fabricated and installed by an outside contractor. The reliefs had approximately 6" gaps on the left and right sides between the back edge and the wall, and of varying height along the bottom edge, which needed to be filled. As discussed before, in the 1950's installation this was done with plaster. We shaped <sup>1</sup>/<sub>4</sub>" Medex to fit into this void. After a rough cut was made to get a basic shape, the edges were further shaped with a Dremel tool for a snug pressure fit (Fig. 19). The boards on the side were painted the color of the gallery walls, as specified by the Design Department, and the area between the relief and granite, also filled with the shaped Medex, was painted a neutral beige.

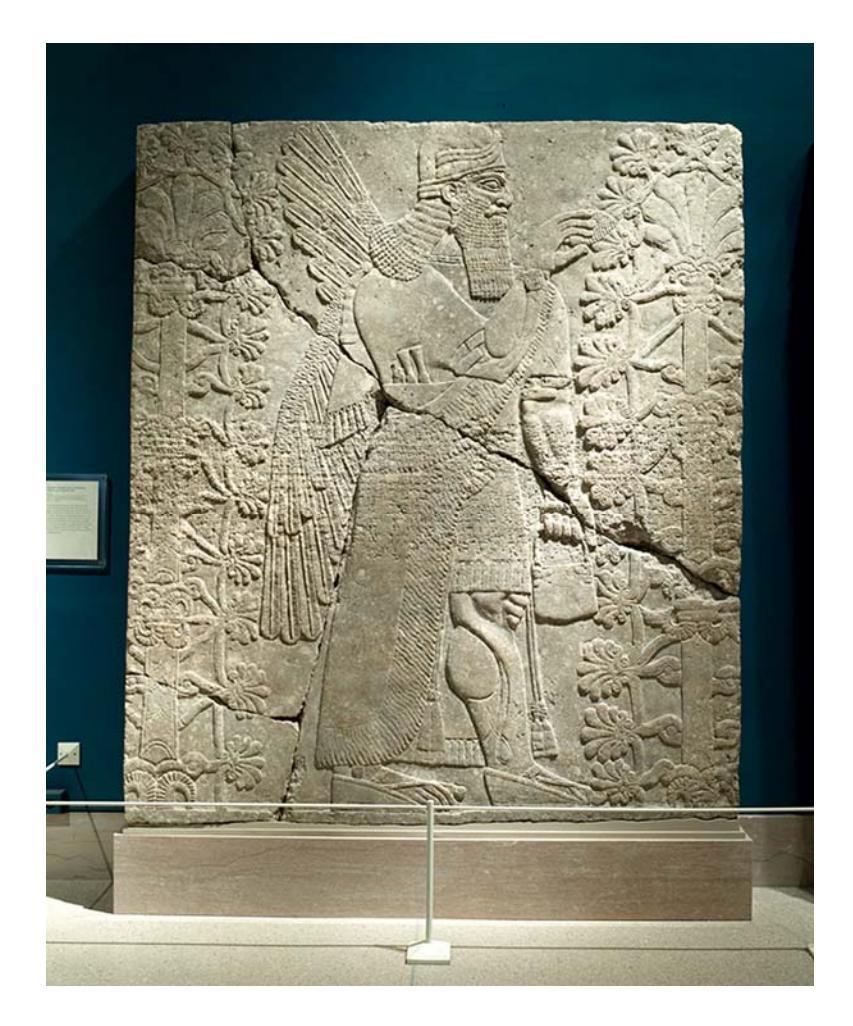
Figure 20. After Treatment, 2002.

After installation was complete, the surfaces of the reliefs were vacuumed with a soft brush and lightly wiped with acetone and ethanol on Webril wipes to remove any dust and grime that resulted from installation. After discussion with the Curator, Jim Romano, it was decided not to fill the break edges or compensate for losses. However, it was decided to tone out any remaining concrete and plaster ghosting along the break edges. Also toned out were any major disfiguring scratches. Liquitex acrylic emulsion paints were used (Fig. 20).
