**Preliminary Assessment
of an
Identified Illegal Drug Laboratory
at:**

**96 Hofer Lane
Evergreen, CO 80439**

FORENSIC APPLICATIONS CONSULTING TECHNOLOGIES, INC.
185 Bounty Hunter's Lane
Bailey, CO 80421

December 20, 2014

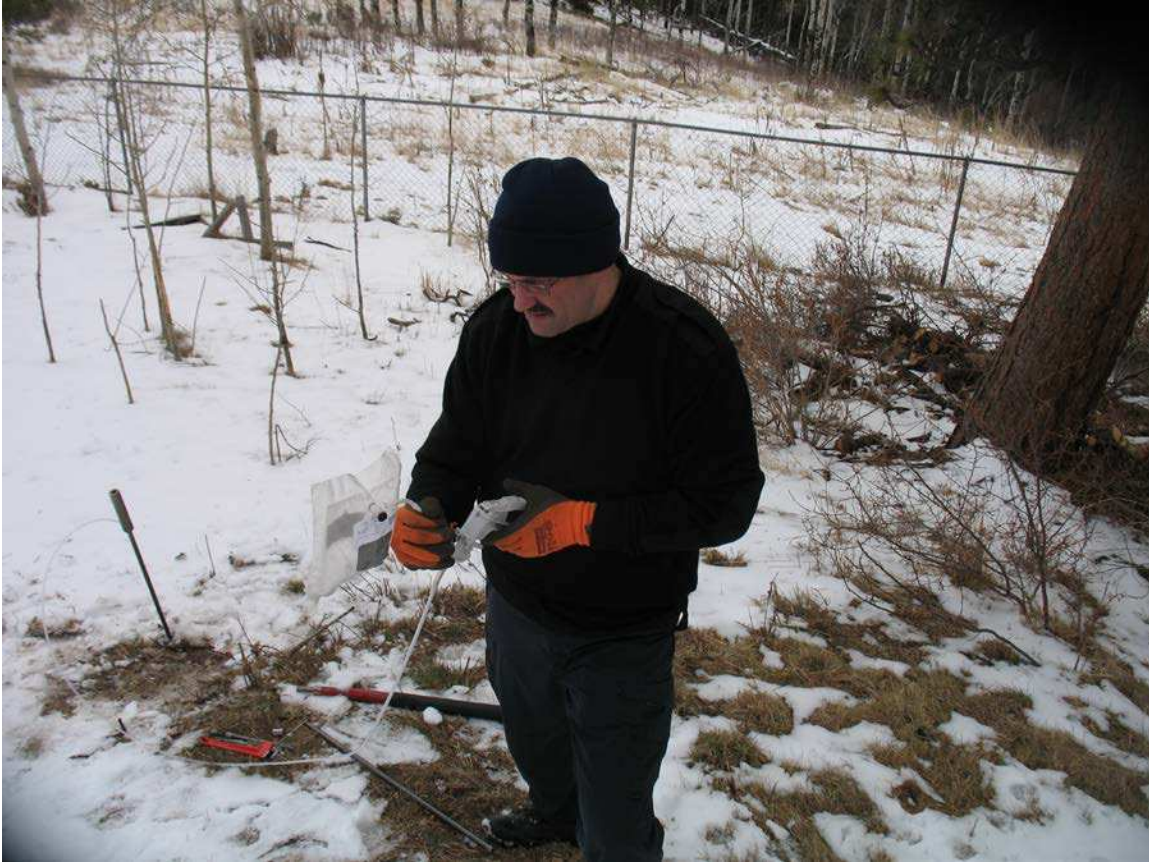
Photograph 1
Direct Push Soil Gas Sampling

To assess the soils around the septic tank and the leach field, FACTs employed direct push soil sampling techniques, wherein we drove an hollow gas sampling tip to a desired depth in the soils (in this case, our target depth was one meter). The tip is attached to a length of Teflon[®] tubing, and using an high-vacuum hand pump, soil gases are extracted into a Tedlar[®] gas sampling bag (See Photograph 1, below). Gases from the Tedlar bag are then introduced into suitable instruments for direct reading qualitative analysis (in this case, we measured broad range hydrocarbons).

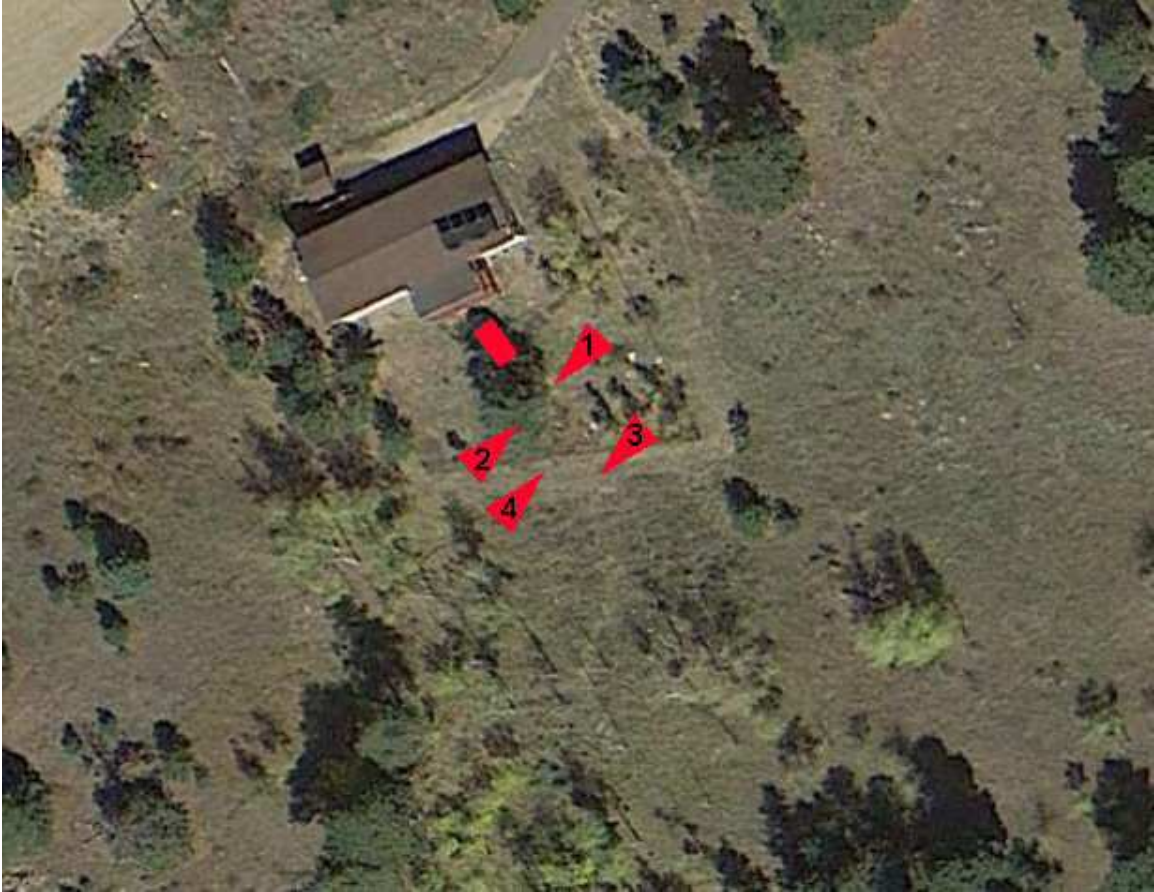
Figure 3
Soil Gas Probe Sampling Locations

The diagram that follows provides the approximate locations for each of the soil gas probe sampling locations.

Hole #	Depth (m)	BRH ppm	Vacuum (Hg")	Instrument Response (sec)
1	0.75	0.3	5	2
2	1	0.4	2	5
3	1	0.5	2	10
4	1	4.6	2	20

In the table above, designation ‘Vacuum Hg” is the pressure differential observed during the extraction of the soil gas and speaks to the issue of sampling train integrity, soil porosity and soil “communication.” A very low or zero reading would indicate a leak in the sampling system. In this case, the communication was relatively good and consistent with a rocky, packed regolith stratum; good communication in this case means soil gas was easily obtained.

The “instrument response” is the observation time in seconds taken to achieve the maximum reading. The faster the response to maximum reading, coupled with greater the hydrocarbon concentrations indicates contamination. In this case, the hydrocarbon levels were all very low, and even the highest value observed (Number 4), took 20 seconds to reach the maximum concentration.

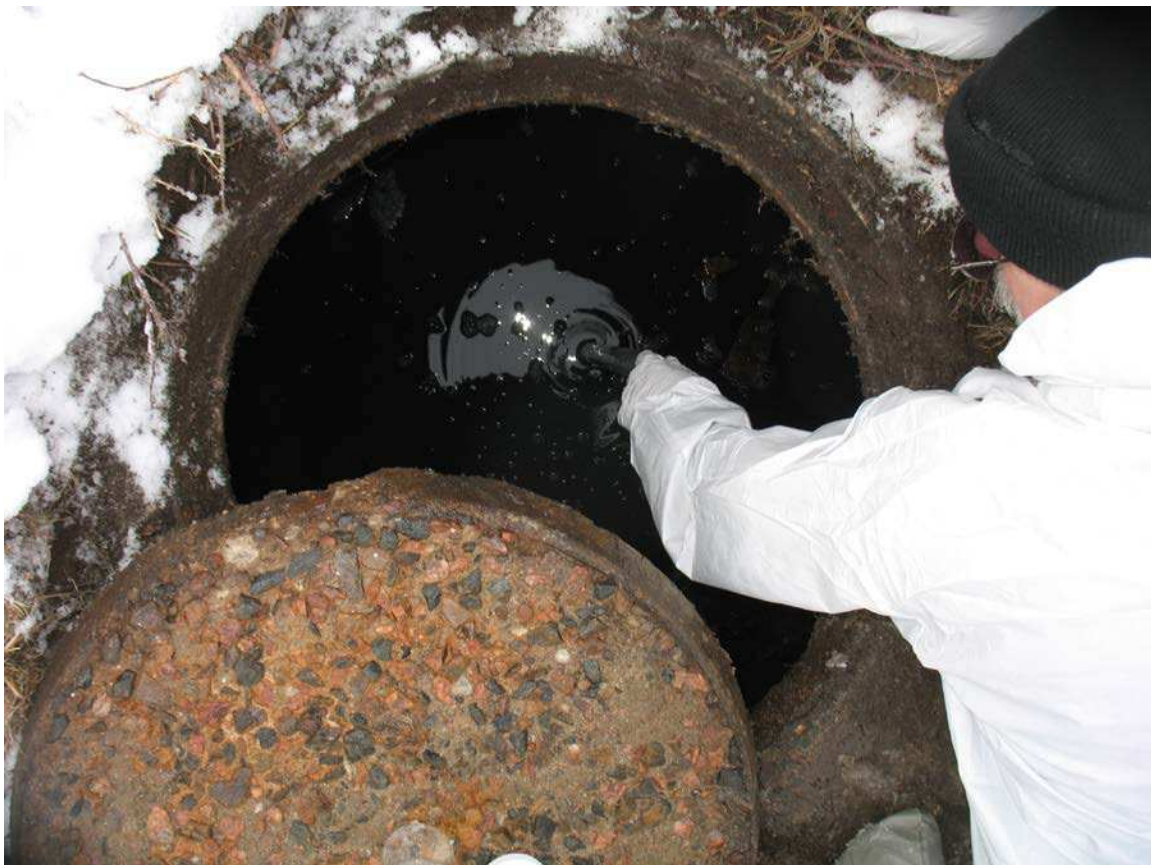
Photograph 2
Coliwasa Stratified Septic Tank Contents

Subjectively, we did not observe any odors associated with cyclic aromatic or aliphatic solvents. The vapor phase hydrocarbon concentration in the headspace above the holding tank liquid was less than 2 ppm.

Using a coliwasa, we collected a sample from the tank (see Photograph 2)

For this property, there were no visual indicators of illegal dumping into the sanitary sewer system. Based on these observations, we concluded that the septic system and the leach field can be excluded from the remediation process.

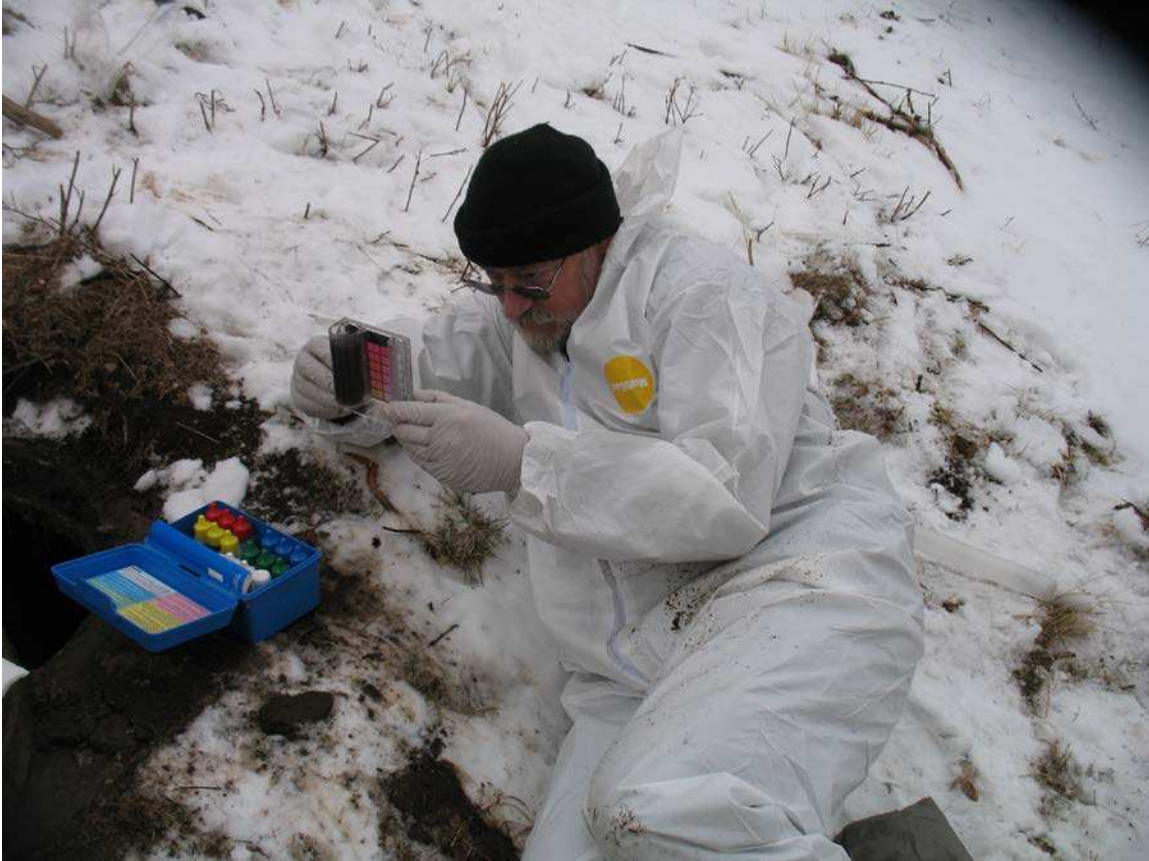
Photograph 3
Wet Chemistry Determinations of Septic Tank Contents

Using standard colorimetric wet chemistry, we determined that the pH of the septic tank contents was approximately 6.5 (See photograph 3, below).
