# Landsburg Reach

## Site Management Guidelines:

- Big Bend Natural Area
- Landsburg Reach Natural Area

*May 2005*

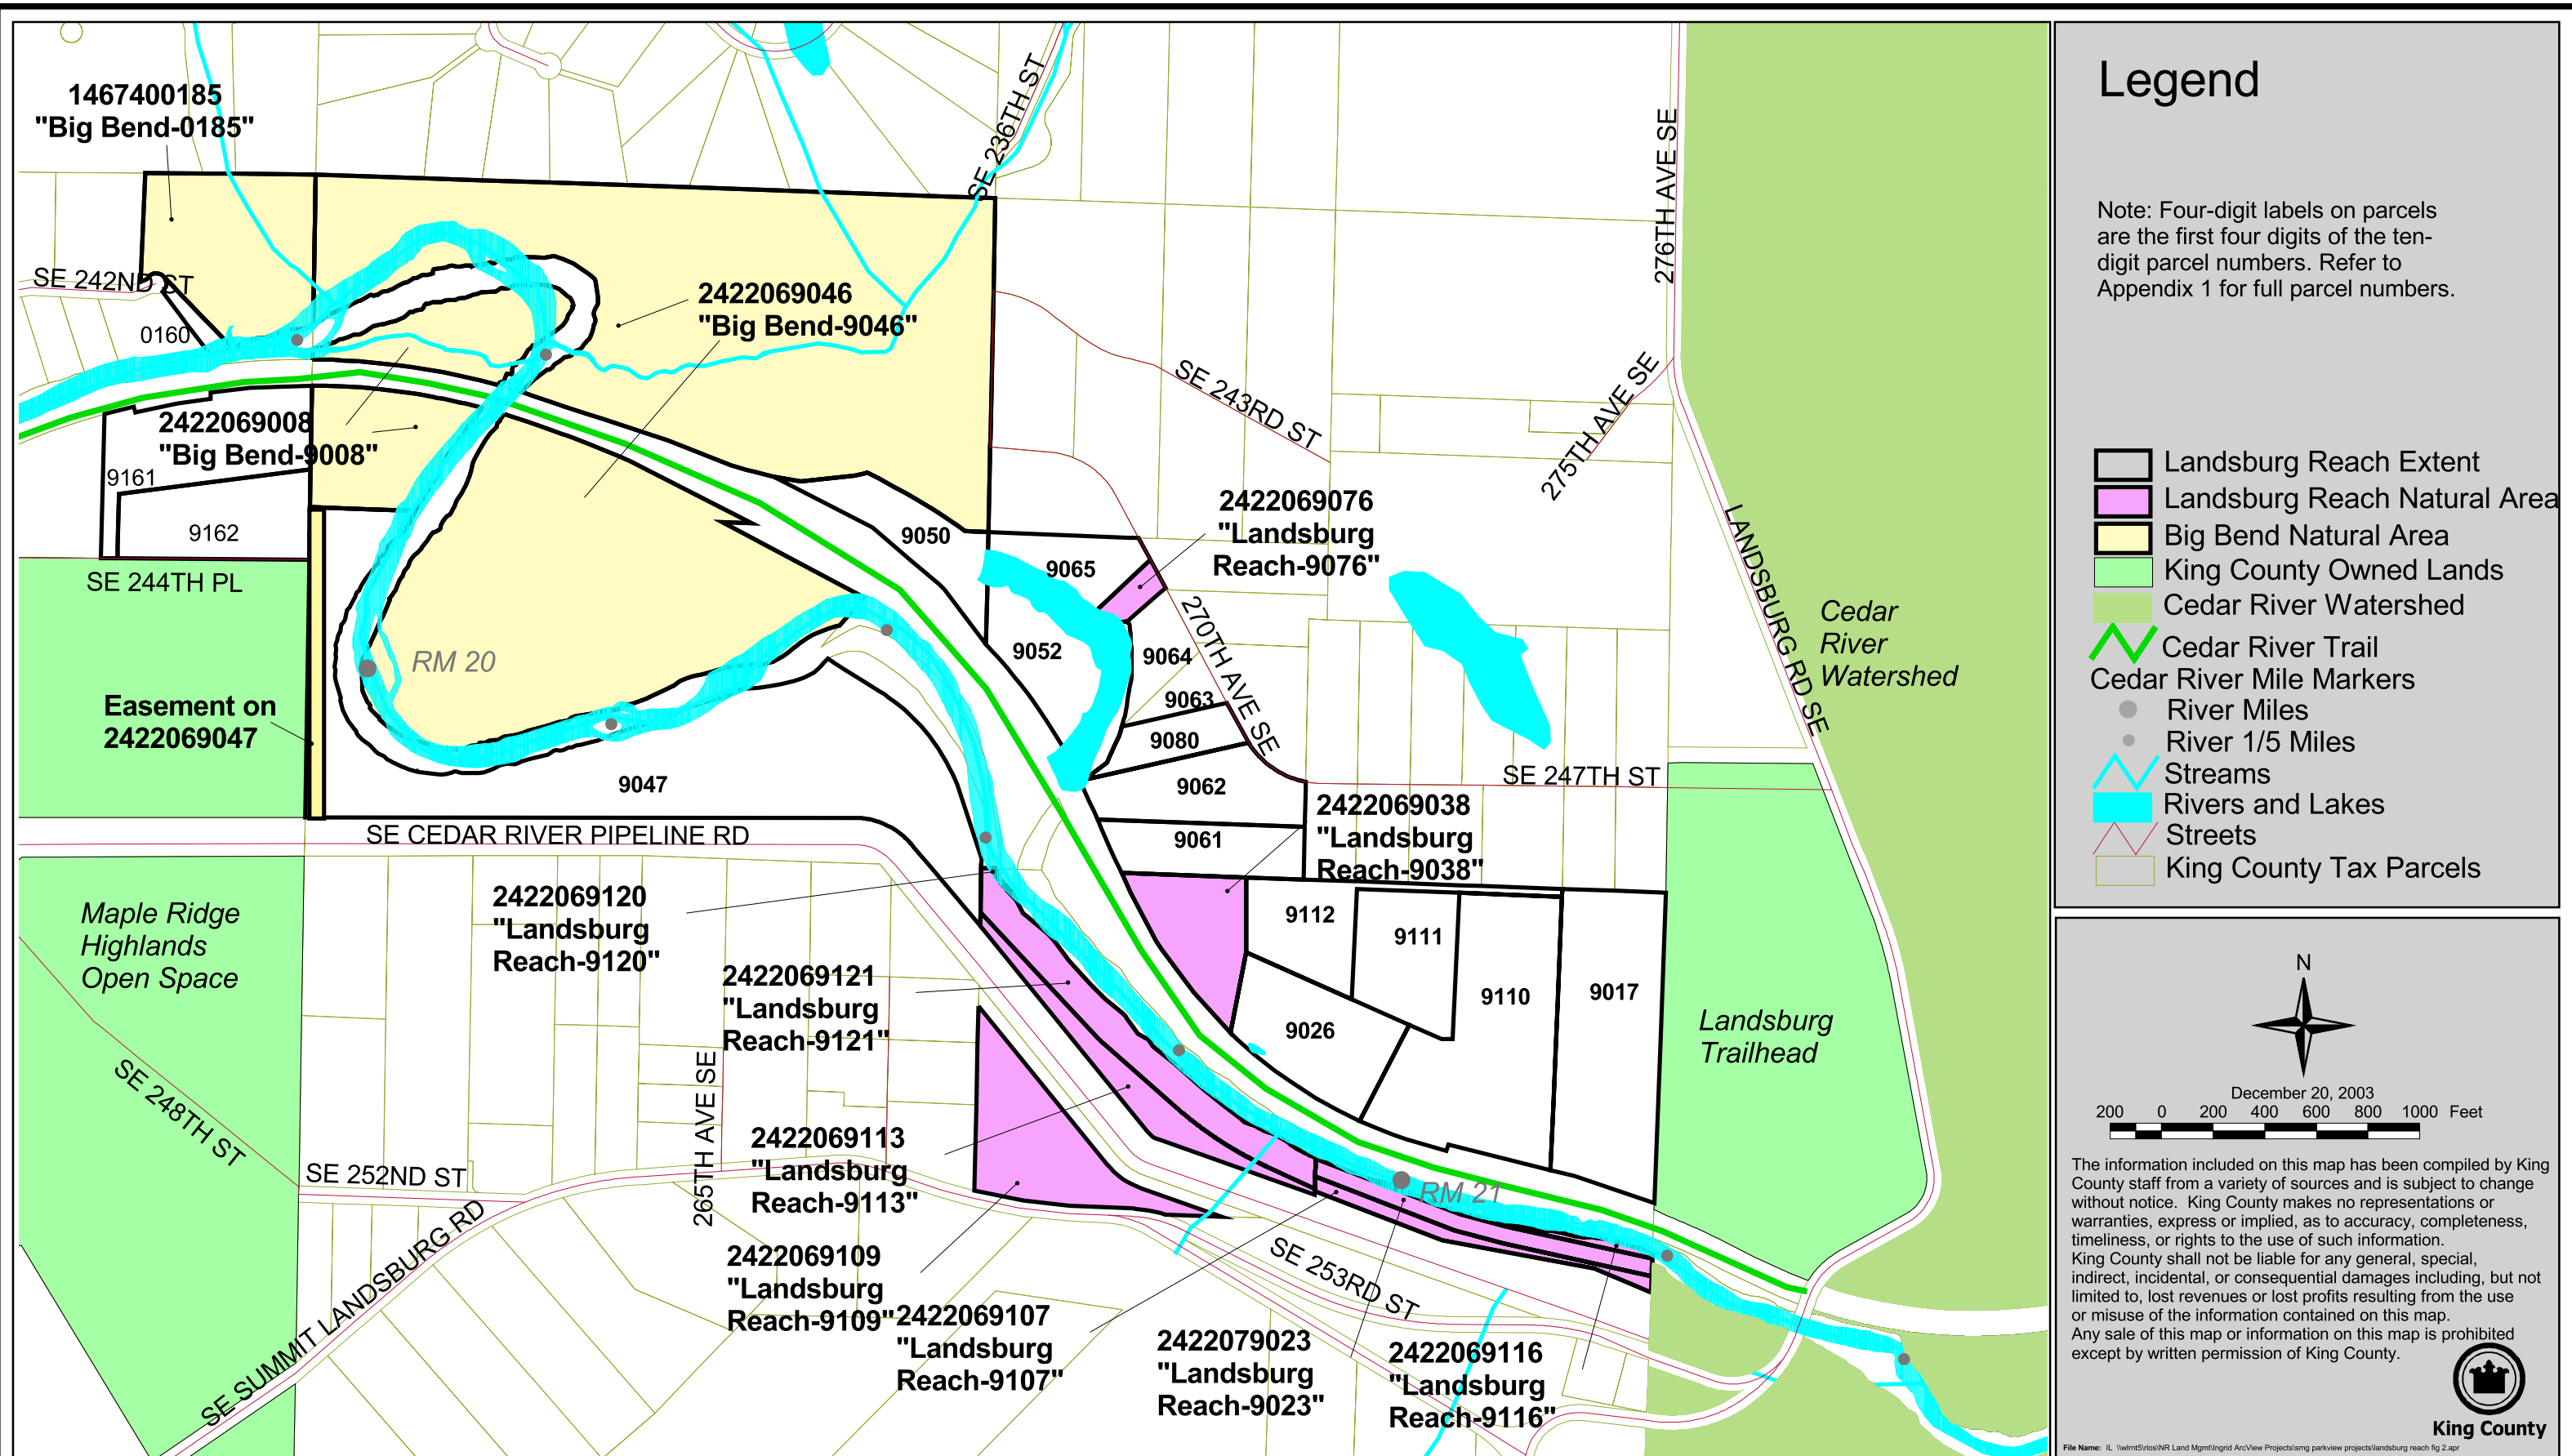
# Figure 1

## Landsburg Reach: Vicinity Map

Landsburg Reach is located approximately 1.25 miles east of the city of Maple Valley and the King County Urban Growth Boundary, which marks the eastern extent of urban development in the vicinity at this time. Refer to Figure 1 for a vicinity map, and to Figure 2 for a site map that shows parcel names and locations (parcel numbers for every parcel in the Landsburg Reach of the river are provided in Appendix 1). Table 1 provides general information about the location of each Natural Area. Tables 2 and 3 provide specific information for each parcel in the Natural Areas.

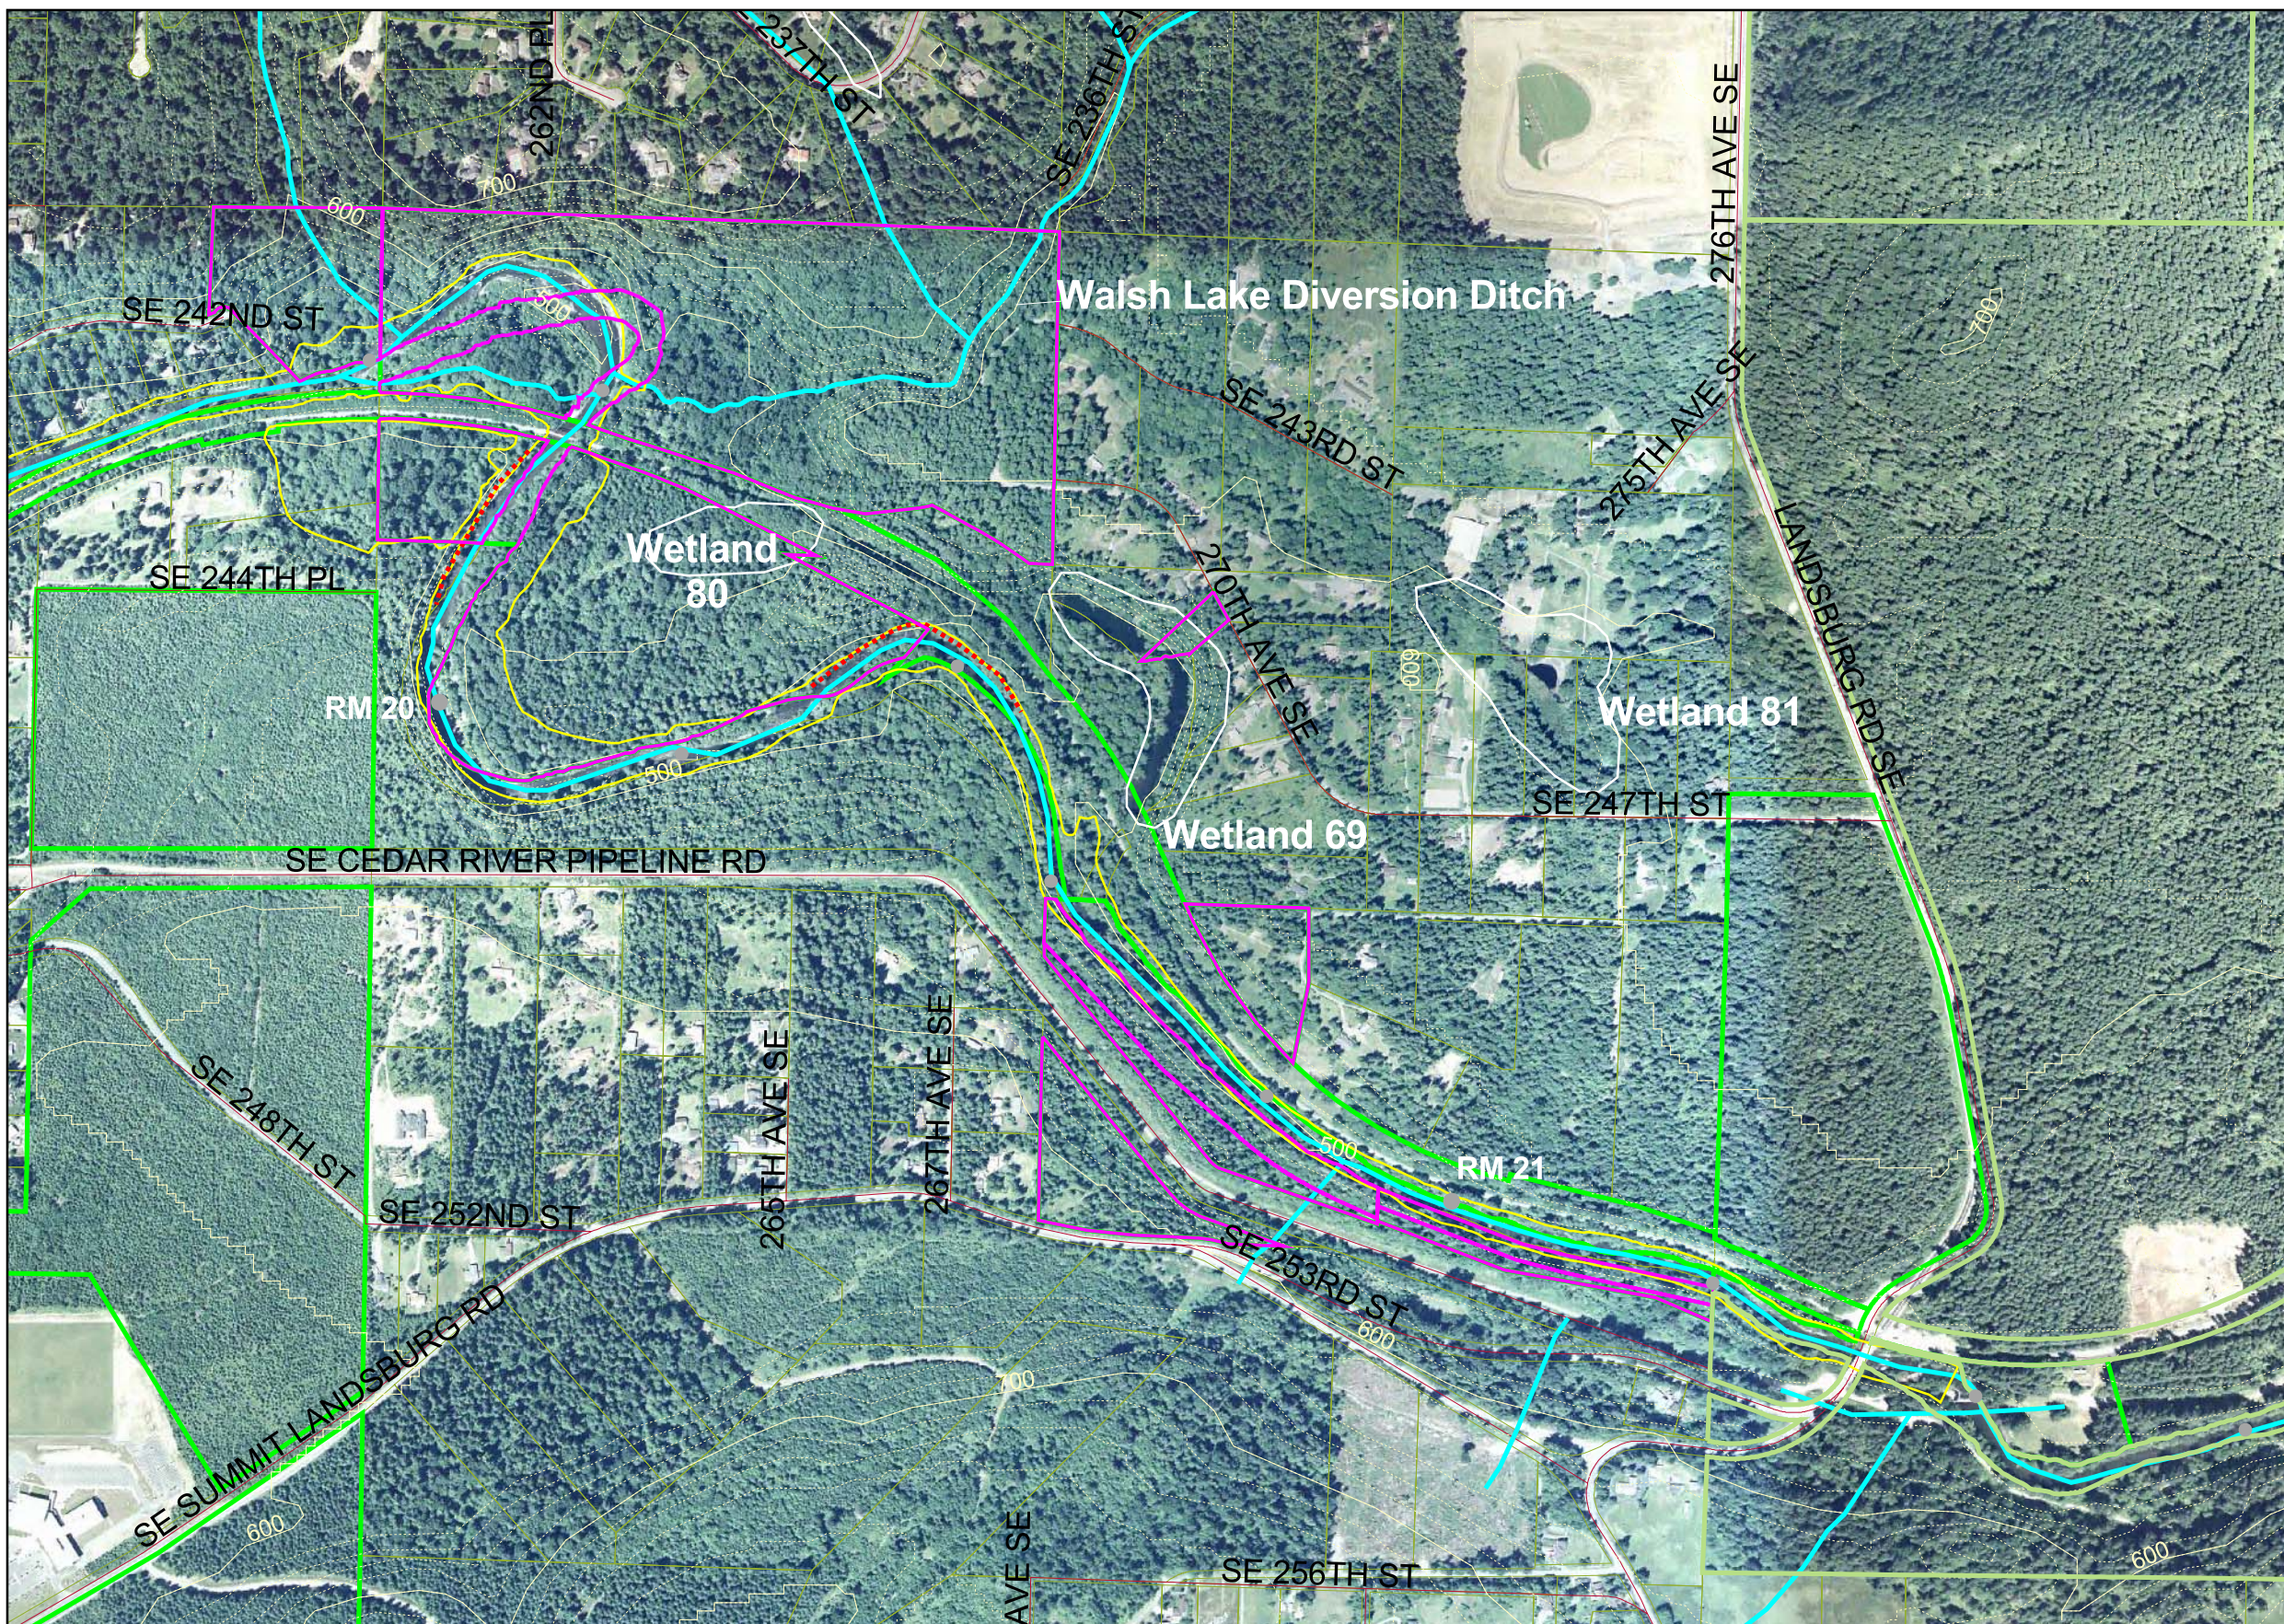
Aerial photos are from 2002.

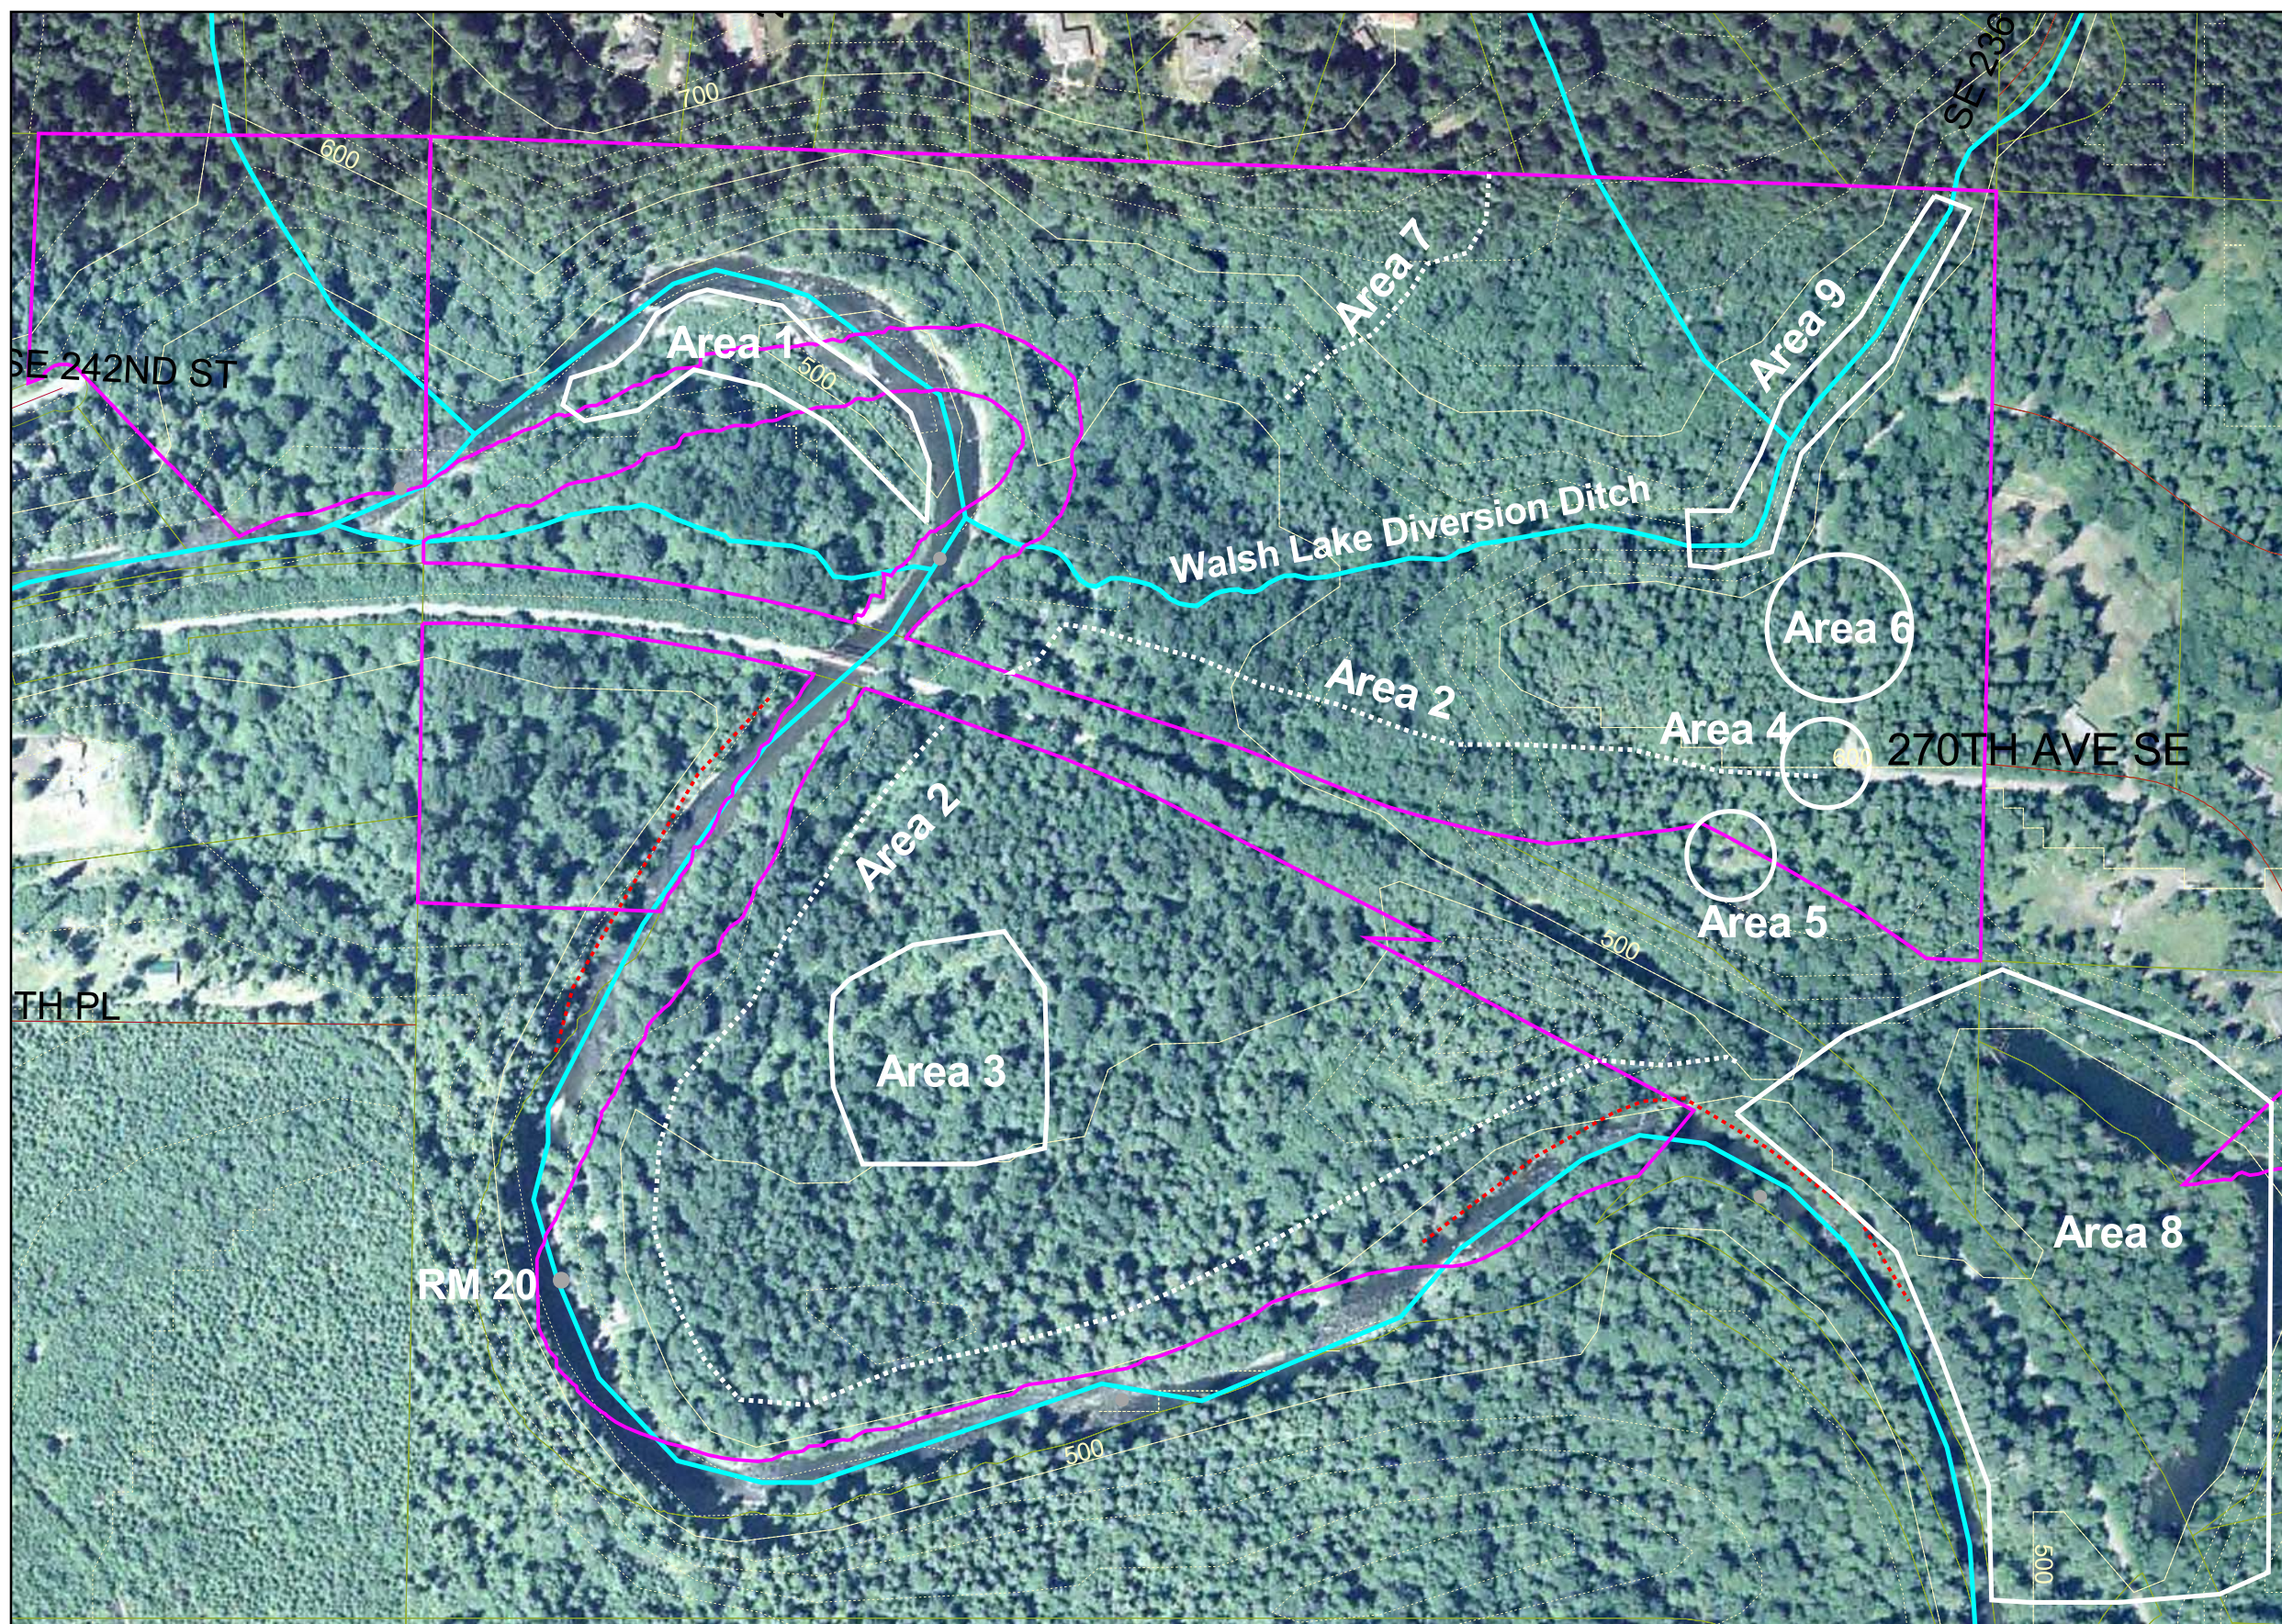
## Legend

*Preliminary identification of problem areas as described in text of Site Management Guidelines*

- Area 1: Invasive Species
- Area 2: Invasive Species on trails and trail use problems
- Area 3: Invasive Species
- Area 4: Entrance problems
- Area 5: Illegal use of adjacent property
- Area 6: Degradation of road
- Area 7: Trail use problems
- Area 8: Reconnection of oxbow
- Area 9: Erosion along stream

Immediately along the river there are areas of frequent disturbance, characterized by riverwash cobble soil, and predominantly shrub layers of vegetation that probably date to the last major flood events in the mid-1990s. This was observed most extensively in Big Bend-9008 parcel, marked as Area 1 on Figure 4,

Field work during the Fall of 2003 by King County NRL staff with restoration expertise identified items of high, medium, and low concern at Big Bend Natural Area, and made recommendations to address these concerns. These items will be addressed under appropriate respective headings below: ecological processes, structure, function, and public use. The main concerns are as follows (Miller pers. comm. 2003); “Area” numbers denote where these are labeled on Figure 4:
