National Register of Historic Places  
Registration Form

historic name The Virginia Apartments

street & number 1100 Paseo Boulevard [ n/a ] not for publication

Apartment Buildings on the North End of The Paseo Boulevard in Kansas City, Missouri

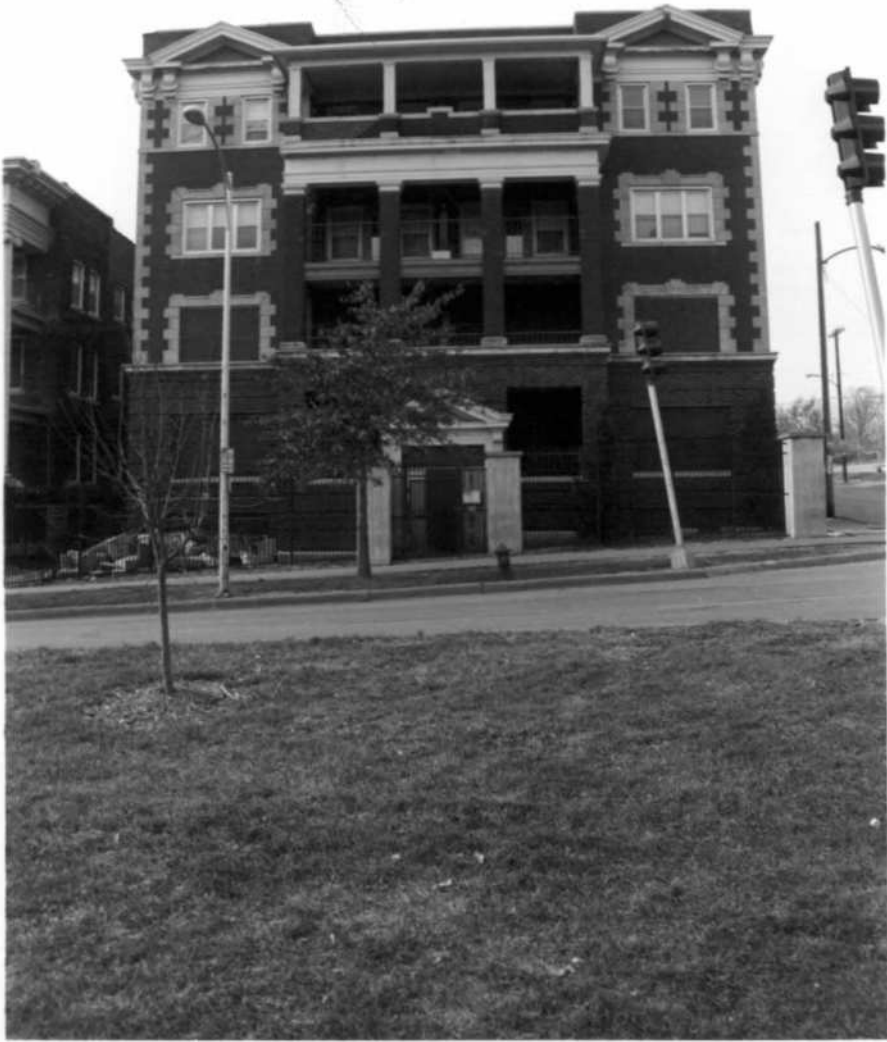
<u>Photo #</u>	<u>Description of Views. [ ] indicates camera direction</u>
1	East (front) elevation [W]
2	South (side) elevation from SE corner of building [NW]
3	Pediment and cornice detail on 4 <sup>th</sup> floor of east elevation [W]
4	North (side) and east (front) elevations from NE corner of building [SW]
5	Porch detail on east (front) elevation [W]
6	Porch detail on north (side) elevation [SE]
7	Main building entrance on east (front) elevation [W]
8	West (rear) and south (side) elevations from SW corner of building [NE]
9	Interior stairway
10	"Typical" apartment interior
11	Fire door in basement
12	Context: 1106 and 1100 Paseo (L to R) [W]
13	Context: 1100 and 1000 blocks of Paseo from the Terrace [NE] 1106, 1100, non-contributing liquor store (scheduled for demolition), Henderson House at 1016, and 1000 Paseo (L to R)

The east (primary) facade is three bays wide. The four-story front porch projects from the recessed central bay. *Four piers, of banded dark brick with deep brick lintels frame the first floor porch. The porch floors are concrete. An ashlar stone band is located at the top of the first floor porch and a short brick knee wall, capped with ashlar stone spans between the piers. Red brick columns span the second and third floors of the porch. The columns have square wood capitals and a simple square stone base. The porch has a substantial intermediate wood cornice, ornamented with egg-and-dart molding, located at the top of the brick columns between the third and fourth floors. There are short red brick pillars resting on the intermediate cornice and a brick knee wall spans between the pillars. The pillars and knee wall are capped with ashlar stone. Four square wood columns with simple wood capitals, rest on the brick pillars to frame the fourth floor porch. The porch is capped by a simple projecting wood cornice. The existing metal railings were installed in the 1975 HUD remodeling. The historic porch railings were simple wood balusters. The porch ceilings are plaster and there is significant peeling paint on the ceilings.*
