COLORADO CULTURAL RESOURCE SURVEY

Architectural Inventory Form

- 1. Resource number: **5PE.6500** Parcel number: **525120007**
- 2. Temporary resource number:
- 3. County: **Pueblo**
- 4. City: **Pueblo**
- 5. Historic building name: **John H. Crow House**
- 6. Current building name: **Russell and Yvonne Meyerhofer House**
- 7. Building address: **1919 North Grand Avenue**
- 8. Owner name: **Russell and Yvonne Meyerhofer**
- Owner organization:
- Owner address: **1919 N Grand Ave
Pueblo, CO 81003**

Pueblo North Side Neighborhood, Phase II

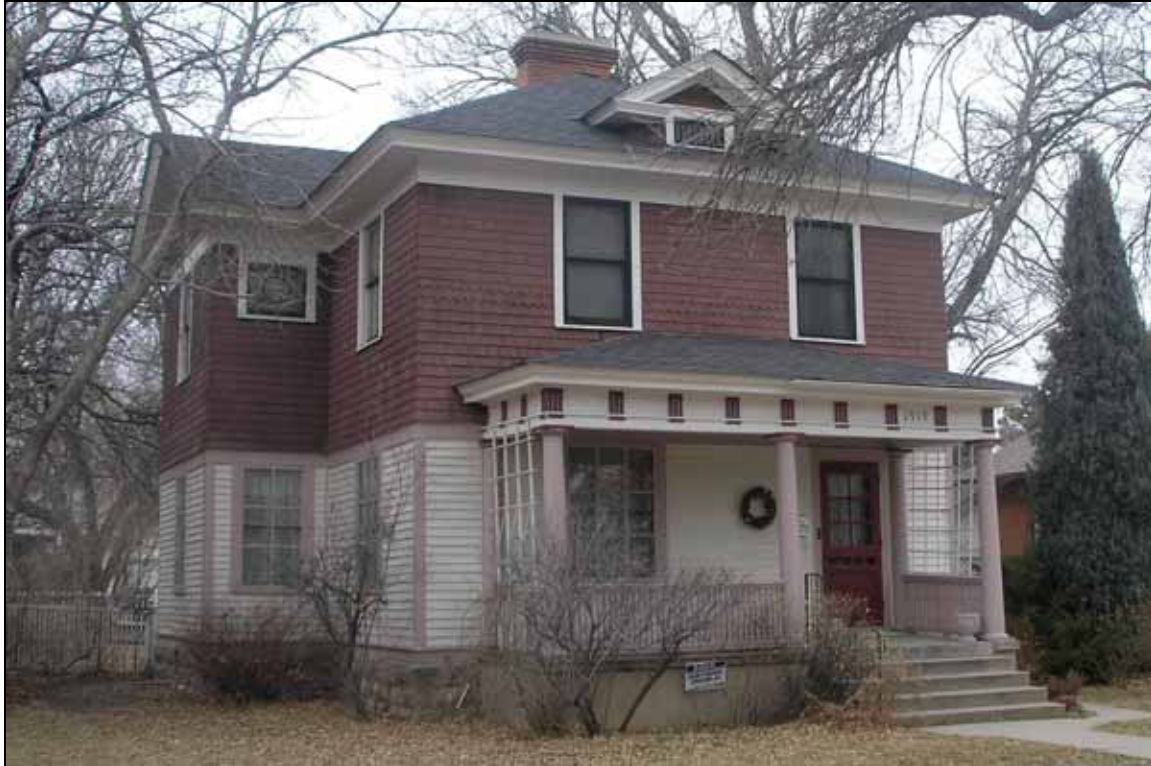
21. General architectural description:
Oriented to the east, this house rests on a foundation of regular-coursed, rock-faced, pink rhyolite ashlar, with raised and beaded mortar. White-painted wood siding, with pink-painted cornerboards, clad the exterior walls of the first story. Square-cut wood shingles, painted brown, cover the second story. A band of decorative, scalloped shingles divides the second story near the window sills. Windows are generally 1-over-1-light, double-hung sash, with black-painted wood frames. Those opening in the first story have multi-light storm windows and pink-painted wood surrounds. Windows in the second story have white-painted wood frames. Protruding from the roof's front (east-facing) slope is a dormer with a pedimented gable. It hosts a multi-light hopper or awning window. A decorative hopper or awning window, consisting of an oval ring with rays, pierces to the east elevation of the front-gabled wing protruding from the west end of the south elevation. The east end of the north elevation hosts a leaded-glass window. Opening in the rear (west) elevation, south of a small, shed-roofed mudroom, is a 1-beside-1-light window. The mudroom hosts 3 (vertical)-over-1-light windows. A hipped-roof porch spans most the asymmetrical front (east) elevation. It features a wood floor; wood balustrade with closely spaced, square balusters; and Doric columns. The Doric order extends to the porch frieze, which hosts evenly spaced triglyphs. Concrete steps approach the north end of the porch, aligned to the principal doorway. It hosts a single-light wood door, opening behind a wood-frame storm door. A secondary doorway opens in the east elevation. It has a single-light, paneled wood door, painted white. White-painted wood fascia, with projecting cornices, and beadboard soffit box the broadly overhanging eaves. A white-painted friezeband separates the walls from the soffit. The gables host eave returns. Gray asphalt shingles cover the main hipped roof and all other roof surfaces. Emerging west of the roof's apex is a massive, red-brick chimney, with corbelled cap.

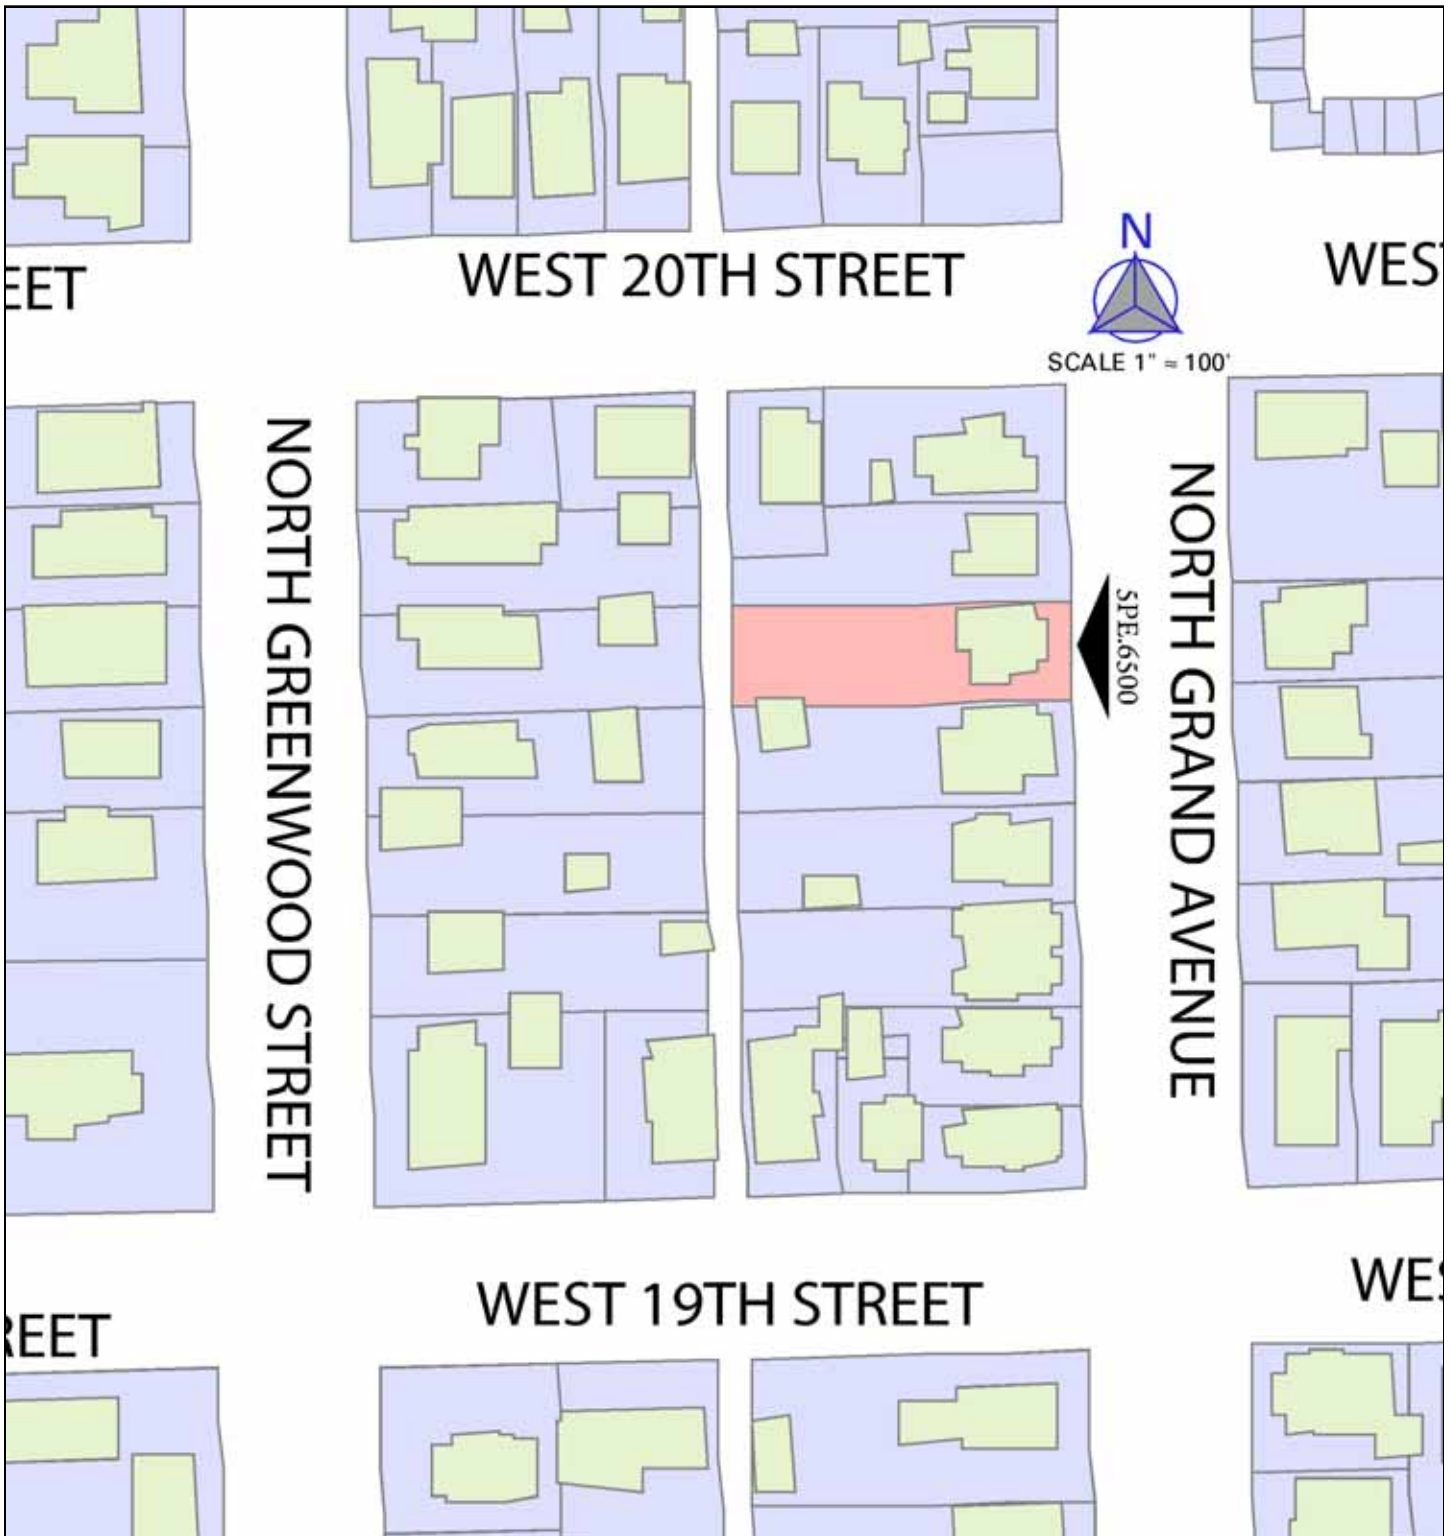
SKETCH MAP

mean sea level. The surrounding residential neighborhood features modest and large, 1- and 2-story houses. Setbacks from North Grand Avenue are generally the same on this block. This property is situated on the west side of the street, between 1915 North Grand Avenue to the south and 1921 North Grand Avenue to the north. Separating the street from the concrete sidewalk is a grass-covered strip. A planted-grass yard, with mature landscaping, covers the lot. Enclosing the back yard is a combination of chain-link, woven-wire, wood picket fences.
