FORM B - BUILDING

Address 12 Shirley Street

Historic Name Custance-Morse House

BUILDING FORM (12 Shirley Street)

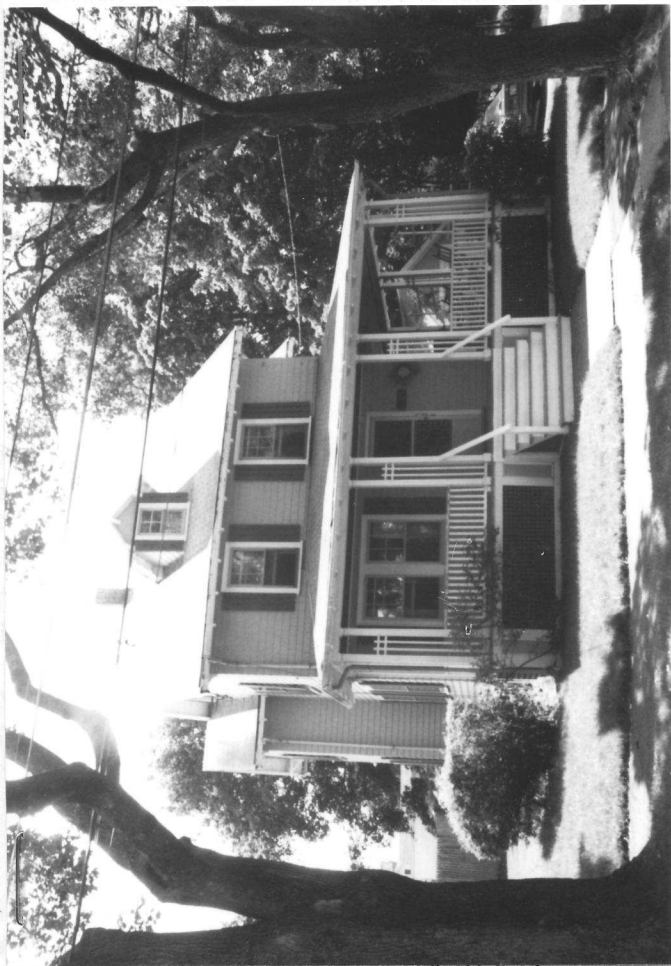
The house at 12 Shirley Street is an interesting example of the Craftsman style and bears some resemblance to the house at **118 Bedford Street**. The building remains nearly totally unaltered from its original, 1917, appearance. Resting on a rubble foundation, the 2 1/2-story, side-gabled dwelling is sheathed in wood shingles with an asphalt-covered roof and a brick, off-ridge chimney. The roof displays overhanging eaves which are supported by triangular braces and flared ends on the gable ends. The lateral eaves have exposed rafters. The front facade is two-bays wide with a sidehall entrance containing a glass-and-panel door. The facade is fronted by a single-story porch which wraps around to the west elevation. The porch is supported by pairs of thin square posts with capitols and bases, and are infilled by geometric stickwork. The porch columns are in clusters of three at the corners of the porch. Between the supports stick balusters rest on a wooden deck above a latticed airspace. The windows contain 6/1 sash with molded surrounds, exterior storm windows and vertical board shutters. Centered on the front roof slope is a gable dormer with small triangular braces. Projecting from the rear of the east elevation is a two-story gable which projects slightly with two windows on the first floor of the east elevation and a single window above. On the west side of the house the porch terminates at an additional two-story projecting gable. The secondary entrance on the front face of the projection has a glass-and-panel door. Both of the side gables display the same triangular braces as the main gables.

A driveway extends along the west side of the house, terminating at a gablefront garage with an overhead door. The building displays exposed rafters on the side elevations.
