OHIO HISTORIC INVENTORY

1. No. BUT-00144-01 REV 4. P	Present Name(s) Hall Auditorium		BUT-0014 4-01
2. County Butler 5. H	Historic or Other Name(s) Benton Hall, Administration Buildin	Name(s) Benton Hall, Administration Building

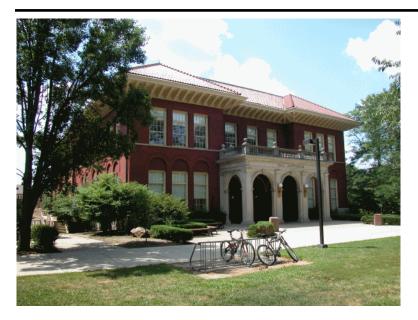
8. Site Plan with North Arrow

Hall Auditorium is located at the western edge of the Miami University campus, near Campus Avenue and East High Street. It faces onto the grassy area that is the location of Slant Walk. King Library was built immediately adjacent to the building in 1966.
